UNITED STATES AIR FORCE
AIRCRAFT ACCIDENT INVESTIGATION
BOARD REPORT

F-16C, T/N 88-0549

LOCATION: OSAN AIR BASE, SOUTH KOREA

DATE OF ACCIDENT: 6 MAY 2023

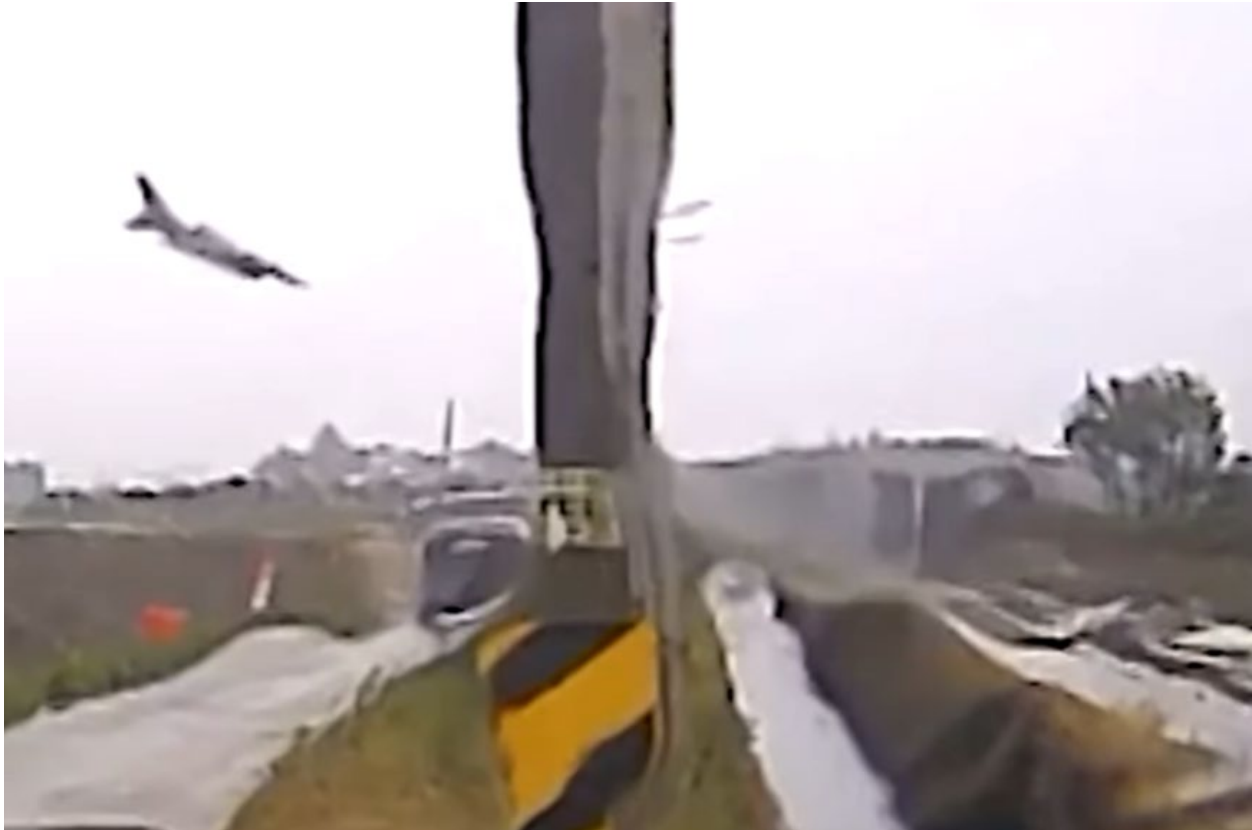
Figure 2: Surveillance Footage prior to MA Impact (Tab S-9)

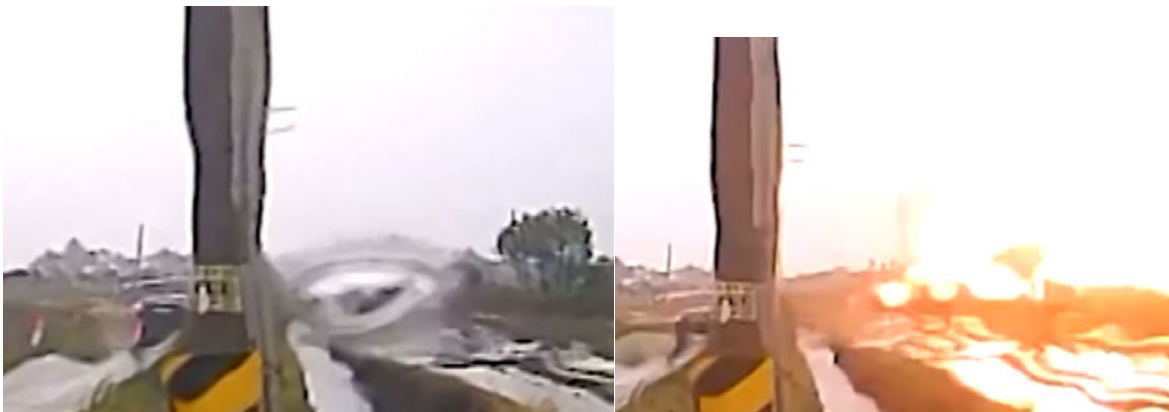
Figure 3 and Figure 4: Surveillance Footage of MA at Impact (Tab S-10 to S-11)

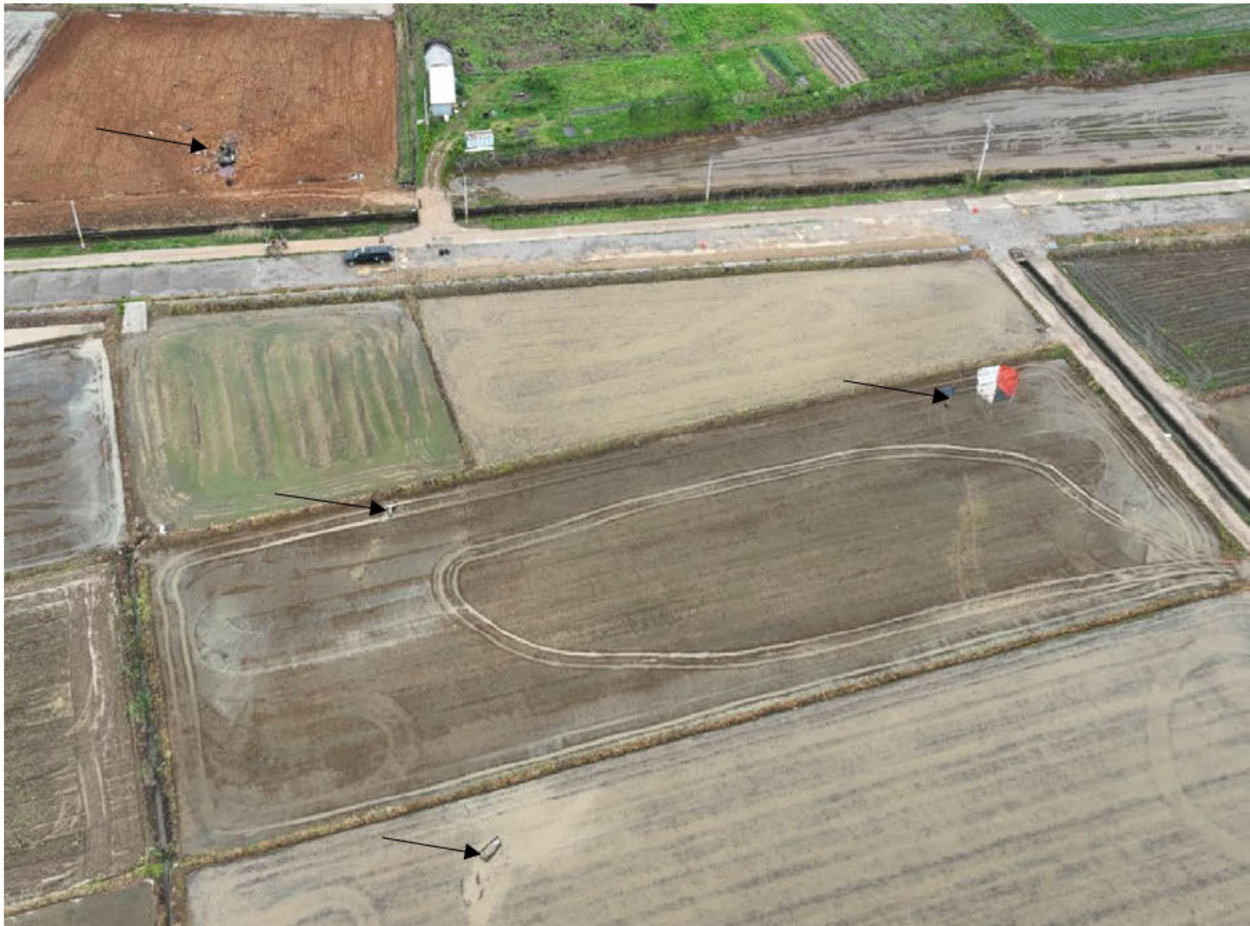
within a successful ejection envelope (Tab H-4 and H-48). The canopy and ejection seat landed within close proximity of the MA and MP (Figure 5) (Tab U-8). Analysis of the escape system shows the seat operated properly, with one exception of the beacon not operating (Tab J-39). It is unclear if the seat was in manual or automatic seat beacon position (Tab J-39). The MP was current and qualified in aircrew flight equipment (AFE) training, to include AFE fit check, Egress, and Emergency Parachute Training (Tab G-4). The seat kit was equipped with a personnel locator beacon (PLB), but the beacon failed to activate as designed when the seat separated from the pilot after safely exiting the aircraft (Tab H-31). There are no other AFE issues pertinent to this investigation. All flight and survival equipment had current inspections and performed as designed (Tab H-53 to Tab H-76). The survival vest and seat kit records indicated nothing was expired (Tab H-53 to Tab H-59).

Figure 5: Canopy, Seat, Chute, and MA points of impact (Tab S-4)
