**UNITED STATES AIR FORCE**  
**AIRCRAFT ACCIDENT INVESTIGATION**  
**BOARD REPORT**

**F-16C, T/N 88-0549**

**LOCATION: OSAN AIR BASE, SOUTH KOREA**

**DATE OF ACCIDENT: 6 MAY 2023**

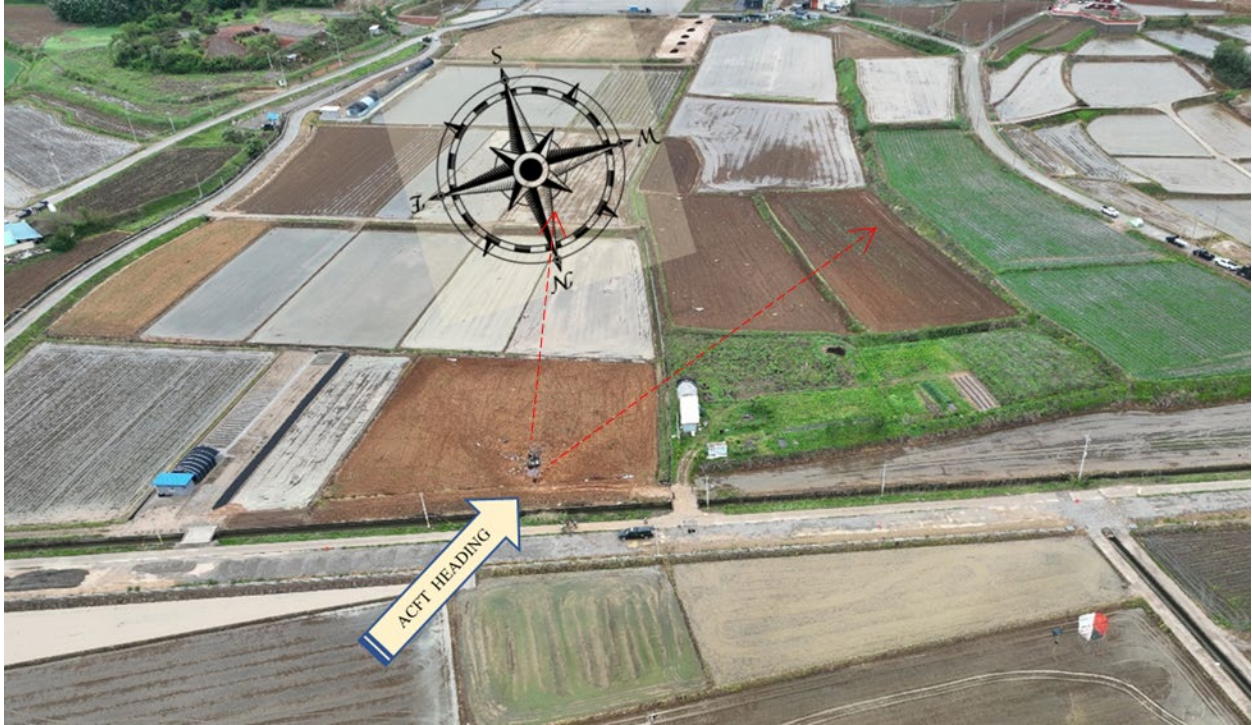
The MA crashed 8 nautical miles at a direction of 167-degrees (i.e. 0 degrees is directly north and 180 degrees is directly south) from Osan Air Base (Tabs U-8 and DD-48). Due to the low altitude at which the ejection was initiated, the MA crashed in close proximity to where the MP landed safely (Figure 1) (Tab U-8). The canopy and ejection seat were located relatively near the MA along its direction of travel (Tab U-8). Crash site examination and video surveillance video revealed a shallow, upright and right wing low high-speed impact in an open agricultural land impacting at an approximate heading of 210 degrees (Figure 2) (Tab U-7 to U-8).

Figure 1. Aerial view of impact location (Tab U-8)

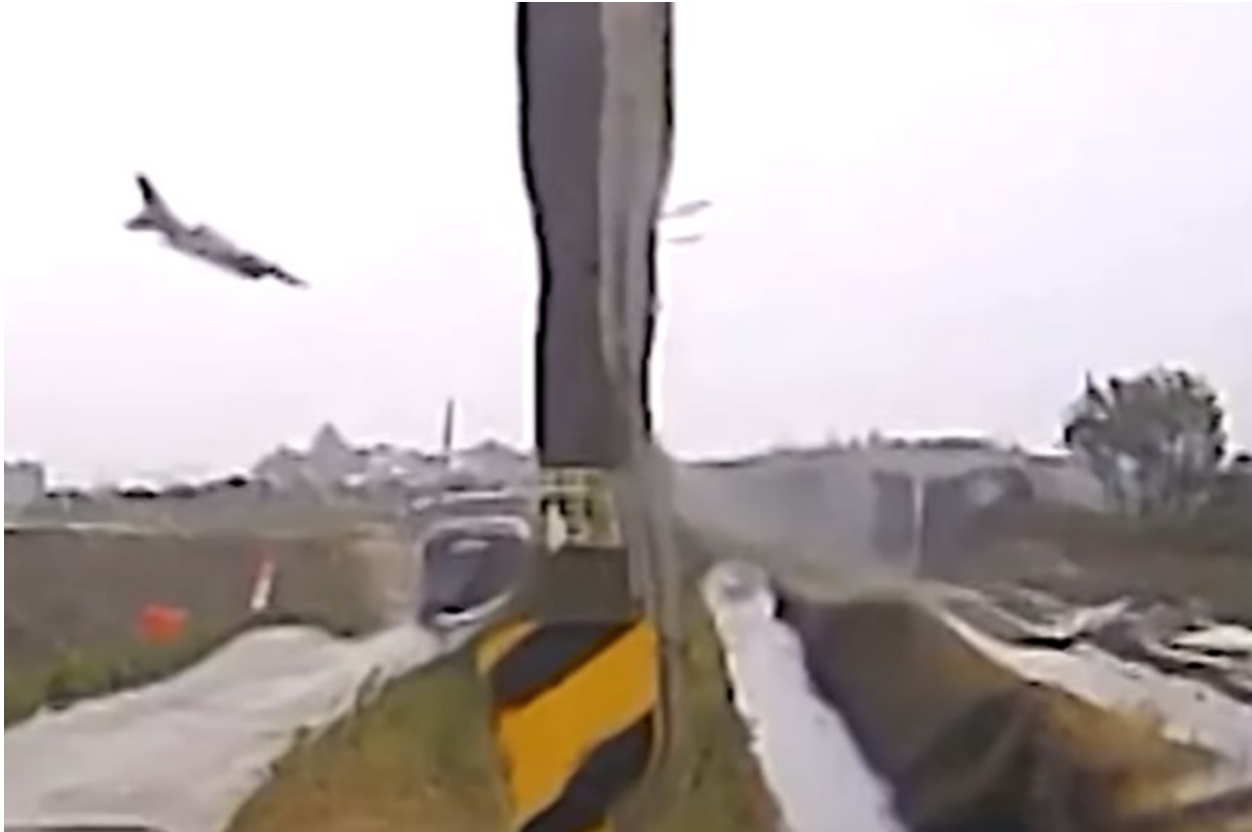
Figure 2: Surveillance Footage prior to MA Impact (Tab S-9)

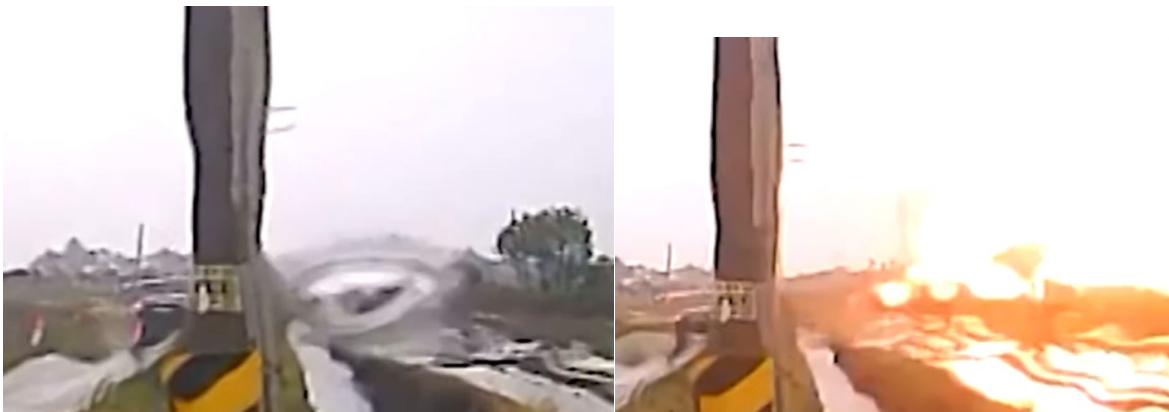
Figure 3 and Figure 4: Surveillance Footage of MA at Impact (Tab S-10 to S-11)

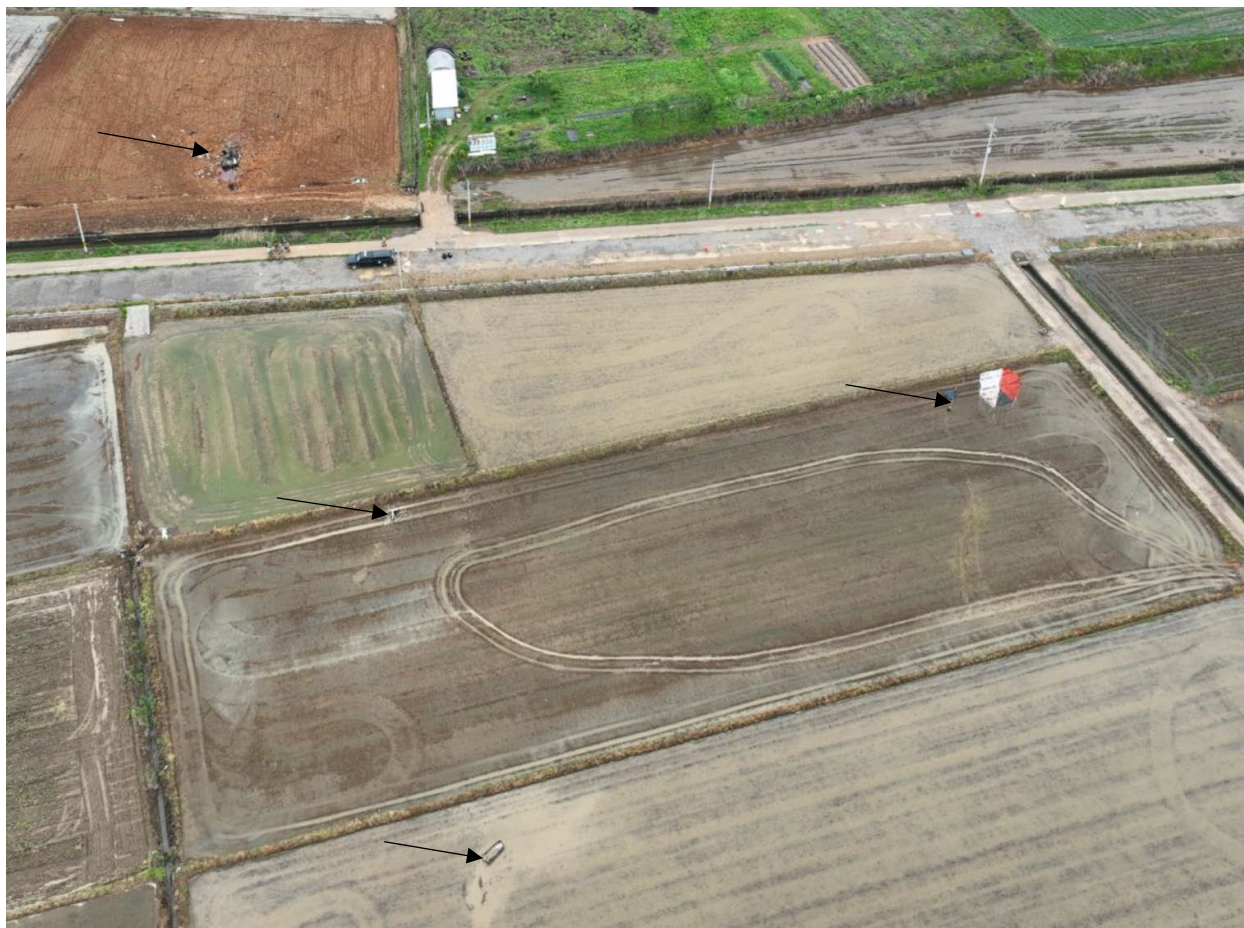
within a successful ejection envelope (Tab H-4 and H-48). The canopy and ejection seat landed within close proximity of the MA and MP (Figure 5) (Tab U-8). Analysis of the escape system shows the seat operated properly, with one exception of the beacon not operating (Tab J-39). It is unclear if the seat was in manual or automatic seat beacon position (Tab J-39). The MP was current and qualified in aircrew flight equipment (AFE) training, to include AFE fit check, Egress, and Emergency Parachute Training (Tab G-4). The seat kit was equipped with a personnel locator beacon (PLB), but the beacon failed to activate as designed when the seat separated from the pilot after safely exiting the aircraft (Tab H-31). There are no other AFE issues pertinent to this investigation. All flight and survival equipment had current inspections and performed as designed (Tab H-53 to Tab H-76). The survival vest and seat kit records indicated nothing was expired (Tab H-53 to Tab H-59).

Figure 5: Canopy, Seat, Chute, and MA points of impact (Tab S-4)

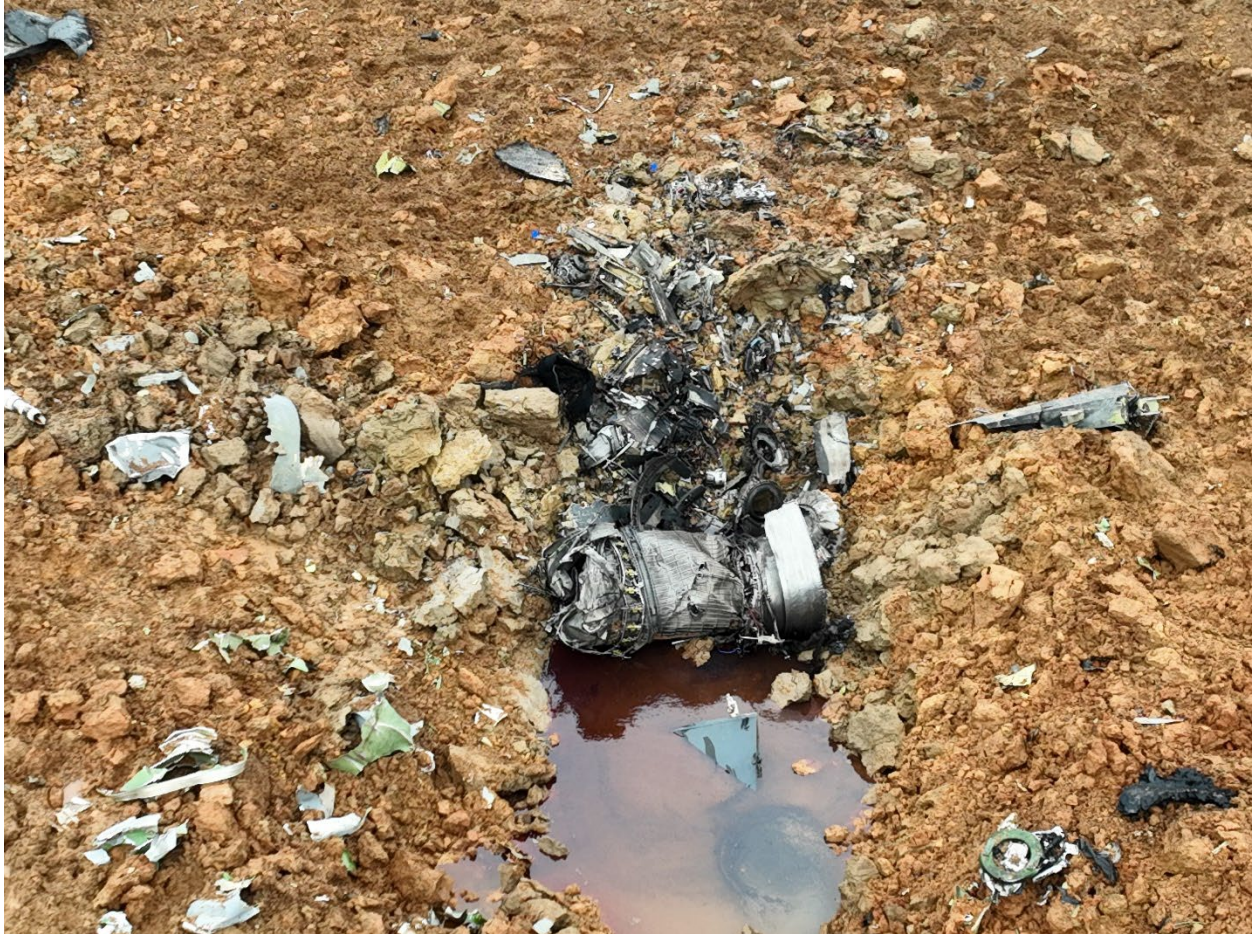
The MA impacted an open, wet (but not flooded) agricultural field in an upright, right wing low shallow angle crashing into the ground in the direction of travel, approximately at a 210 degree direction of travel (Tab U-7 to U-8). The majority of the MA was at the impact crater, with debris spread out from the point of impact then towards the south-southwest in the same direction of travel as the impact, an estimated 300 yards in an approximate 45-degree fan (Tab U-8). A narrow secondary debris field was adjacent to the impact crater, perpendicular to the MA direction of travel, and extending an estimated 50 feet (Tab U-8). There was a significant localized post-impact fire at the impact site (Tab U-6). The majority of the MA was broken into pieces ranging in size from a few inches to a few feet (Tab S-8). The largest debris recovered was approximately three to five feet long as seen in Figure 6 (Tab S-8).

Figure 6: MA Impact site with example of debris (Tab S-8)
