UNITED STATES AIR FORCE
AIRCRAFT ACCIDENT INVESTIGATION
BOARD REPORT

MQ-9A, T/N AF 12-4209
AFLCMC, Detachment 3
GRAY BUTTE AIRFIELD, CALIFORNIA

LOCATION: GRAY BUTTE AIRFIELD, CALIFORNIA
DATE OF ACCIDENT: 7 SEPTEMBER 2023
BOARD PRESIDENT: BRIGADIER GENERAL LANCE R. FRENCH
Conducted IAW Air Force Instruction 51-307
Volume One of Five

**MQ-9A, T/N 12-4209
GRAY BUTTE AIRFIELD, CALIFORNIA (CA)
07 SEPTEMBER 2023**

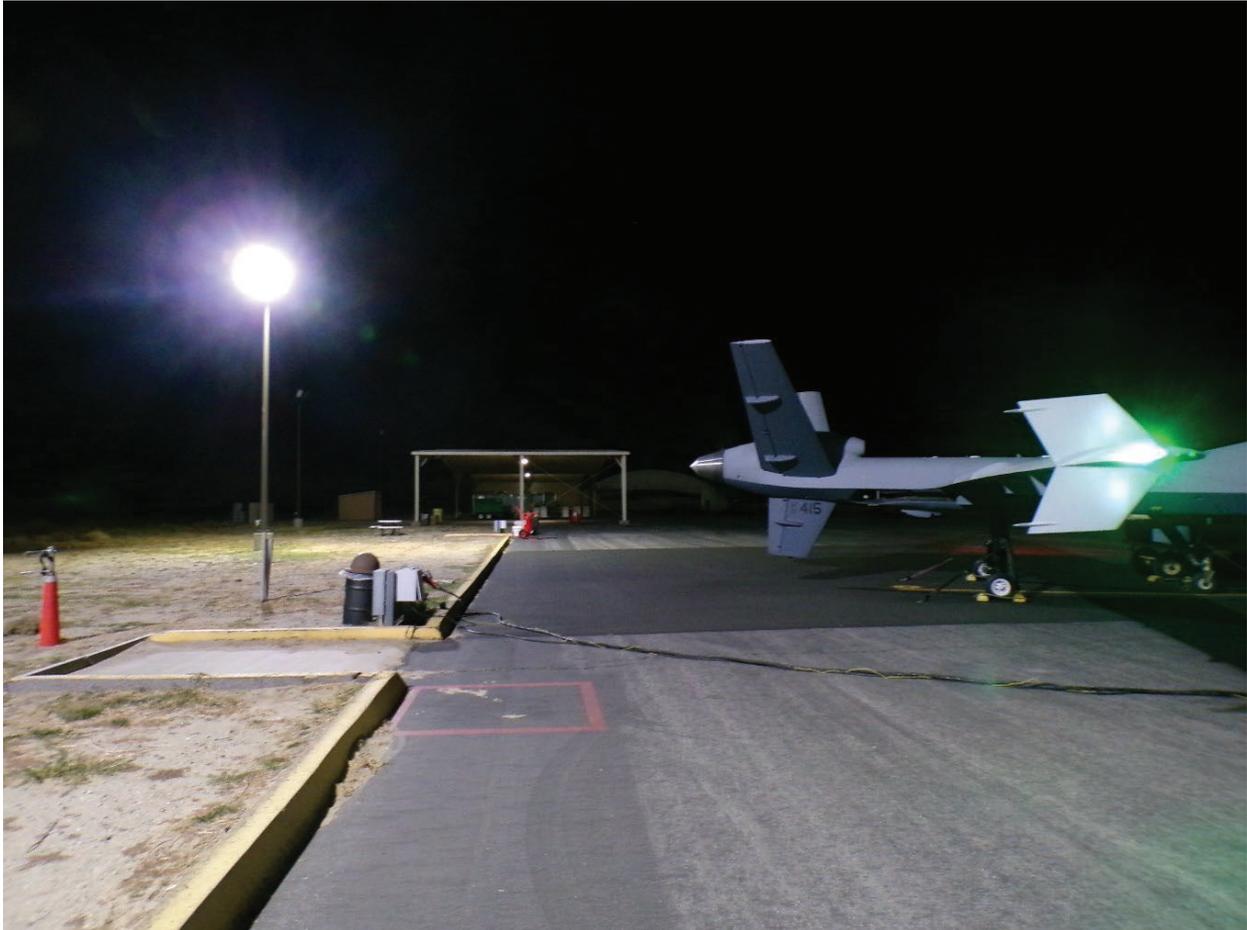
Figure #4 (Tab Z-6)

On 7 November 2023, the AIB coordinated with AFLCMC Det 3 to conduct a replication of the mishap sequence with an MQ-9A with engine running at the same power settings on aircraft spot 15, in the same twilight lighting conditions, and ramp stadium lighting that were present on 7 September 2023 (Tab Z-20).

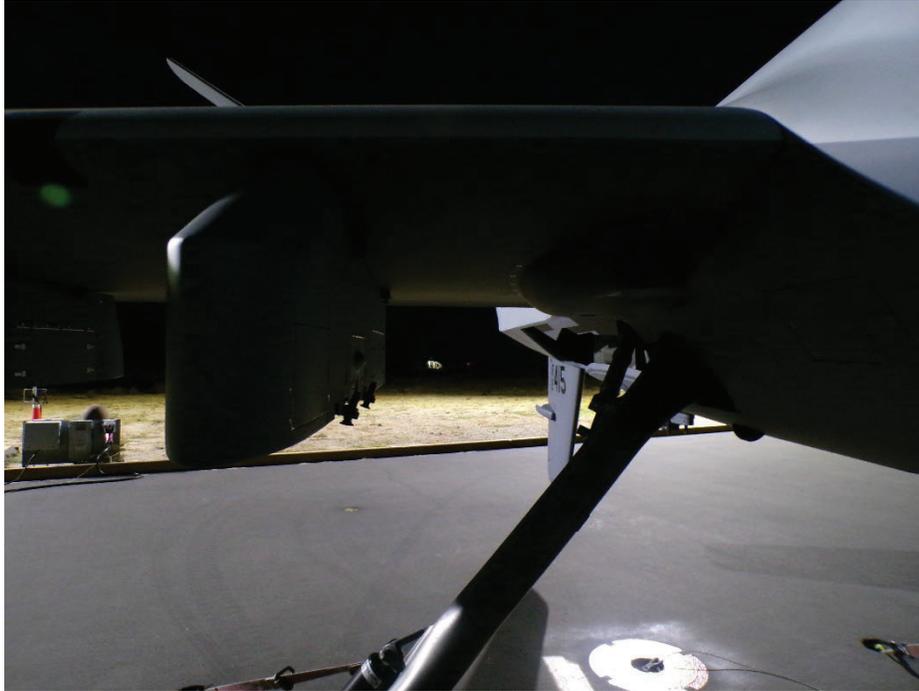
Figure #5 (Tab Z-4)

In that simulation, the spinning propeller was not visible when looking to the rear of the aircraft from the trailing edge of the right wing behind weapon station 6 (Tab Z-20).

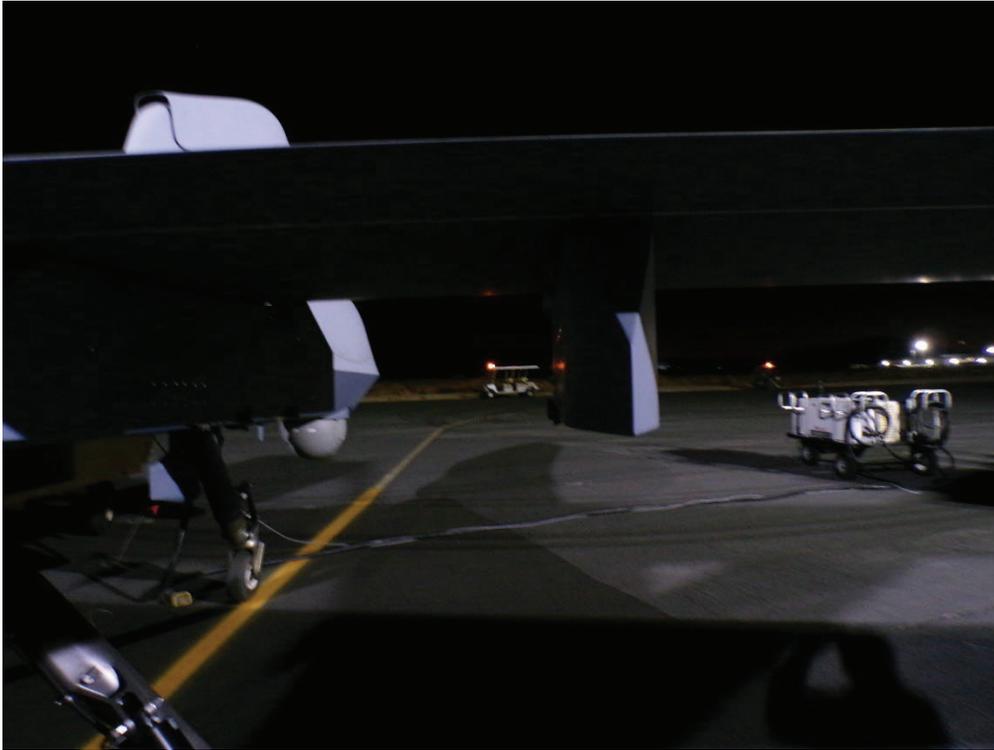
Figure #6 (Tab Z-9)

Under those lighting conditions, portions of the MA and MTE1's own body would have created shadows that made it difficult to see if concentrating on the handheld testing device, contributing to the loss of situational awareness (Tab Z-20).

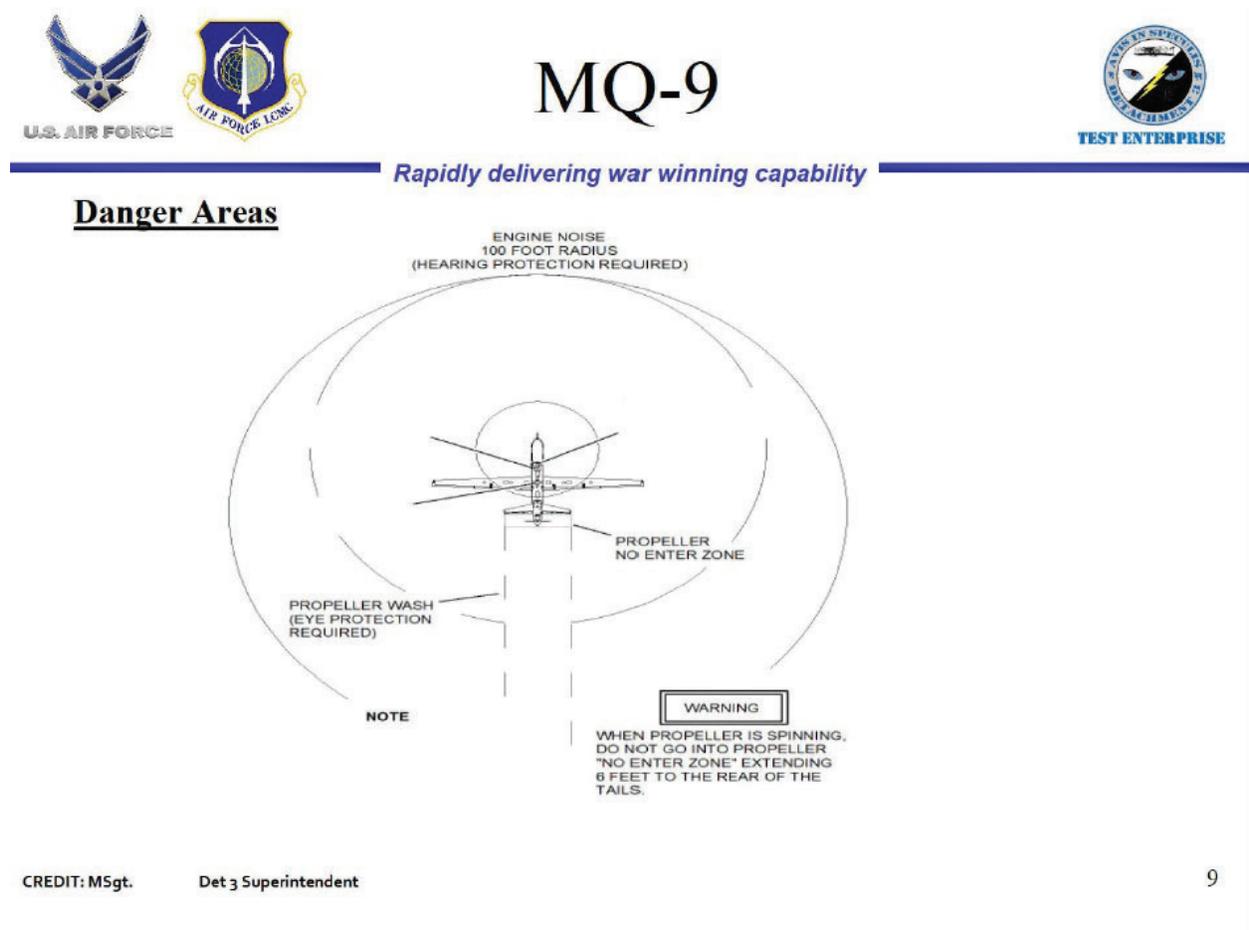
Figure #9: Det 3 Danger Area PowerPoint Slide

The training provided to new employees by AFLCMC Det 3 showed various radiation zones for various antennae (Tab O-26). The Detachment 3 provided diagram also identifies a “propeller no enter zone” that extended from the rear tip of each tail, back six feet to the tip of the propeller cone (Tab O-26). Further back from the propeller cone was identified as a “propeller wash zone” and only required the addition of eye protection (Tab O-26).

During the investigation, the AIB was only able to confirm MTE1 was instructed on the diagram provided by the Detachment 3 training, the least restrictive of the three diagrams (Tab G-12). This represented the smallest propeller danger area of the three documents, an area of approximately 22 feet by 6 feet (Tab O-52).

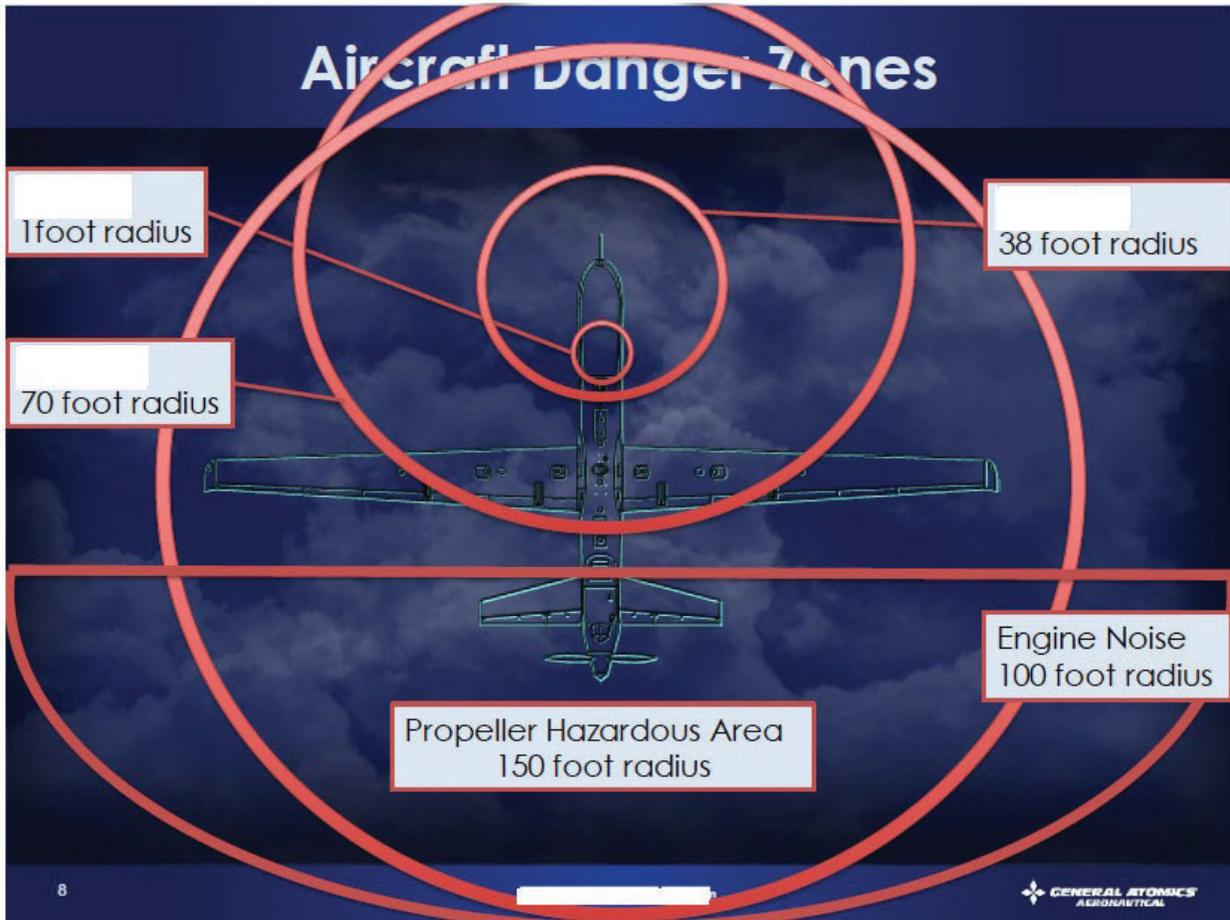
Figure #10: General Atomics, Aircraft Danger Zones PowerPoint Slide

In a briefing on safety and flightline basics provided by General Atomics, similar radiation zones are identified as in the Det 3 training, but the “propeller hazardous area” extends from the base of each tail out 150 feet in each direction and encompasses a half circle around the back of the aircraft (Tab O-3260).

In a briefing on safety and flightline basics provided by General Atomics, similar radiation zones are identified, but the propeller hazard zone extends from each tail out 150 feet in each direction and encompasses a half circle around the back of the aircraft, much more encompassing than the Det 3 training.

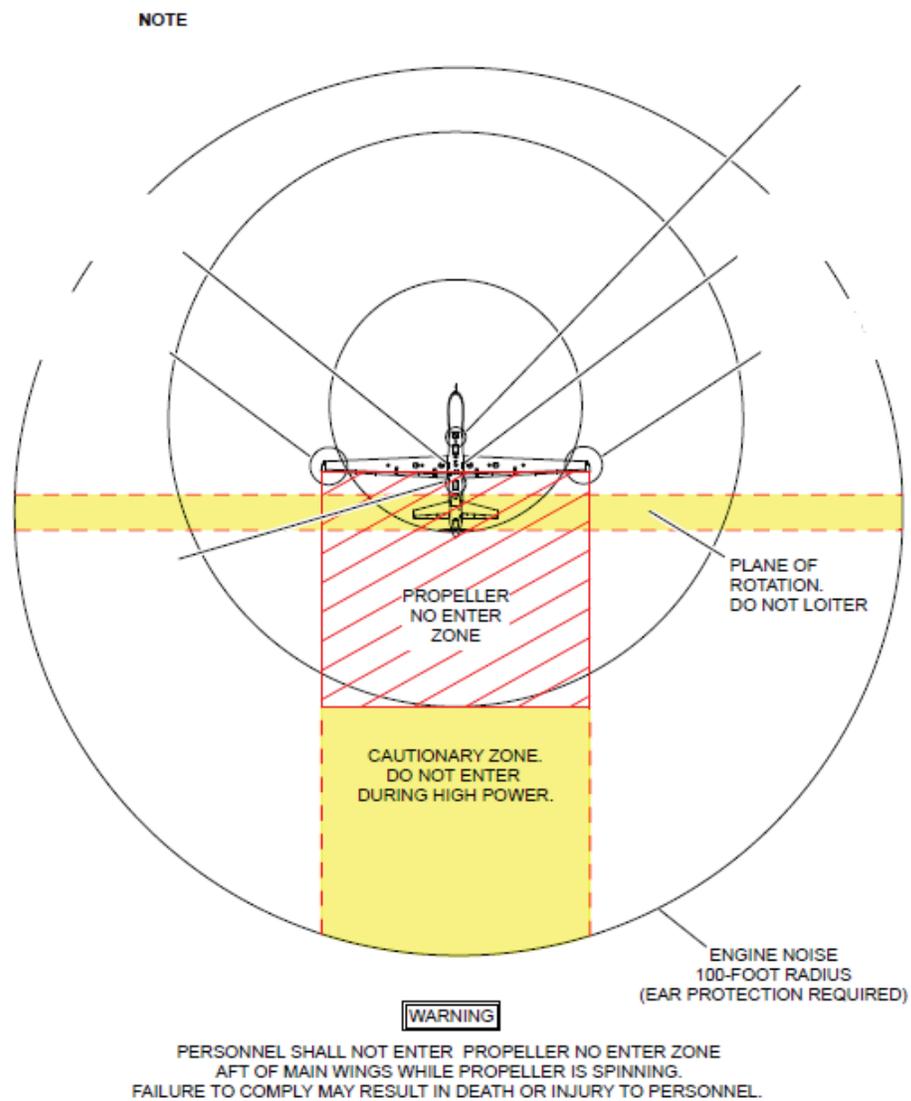
Figure #11: General Atomics, Technical Order, Aircraft Danger Areas

Finally, in a general maintenance procedure technical order the “propeller no enter zone” extends from the wingtips straight back 50 feet (Tab U-23). In addition, beyond that no enter zone for another 50 feet is an area identified as “Cautionary zone. Do not enter during high power.” (Tab U-23). In this same document in a red and white striped “WARNING” box is “Personnel shall not enter Propeller No Enter Zone aft of main wings while propeller is spinning. Failure to comply may result in death or injury to personnel” (Tab U-23).
