UNITED STATES AIR FORCE
AIRCRAFT ACCIDENT INVESTIGATION
BOARD REPORT

F-16C BLOCK 40 E, T/N 89-002023

DATE OF ACCIDENT: 17 November 2023

**EXECUTIVE SUMMARY
UNITED STATES AIR FORCE
AIRCRAFT ACCIDENT INVESTIGATION**

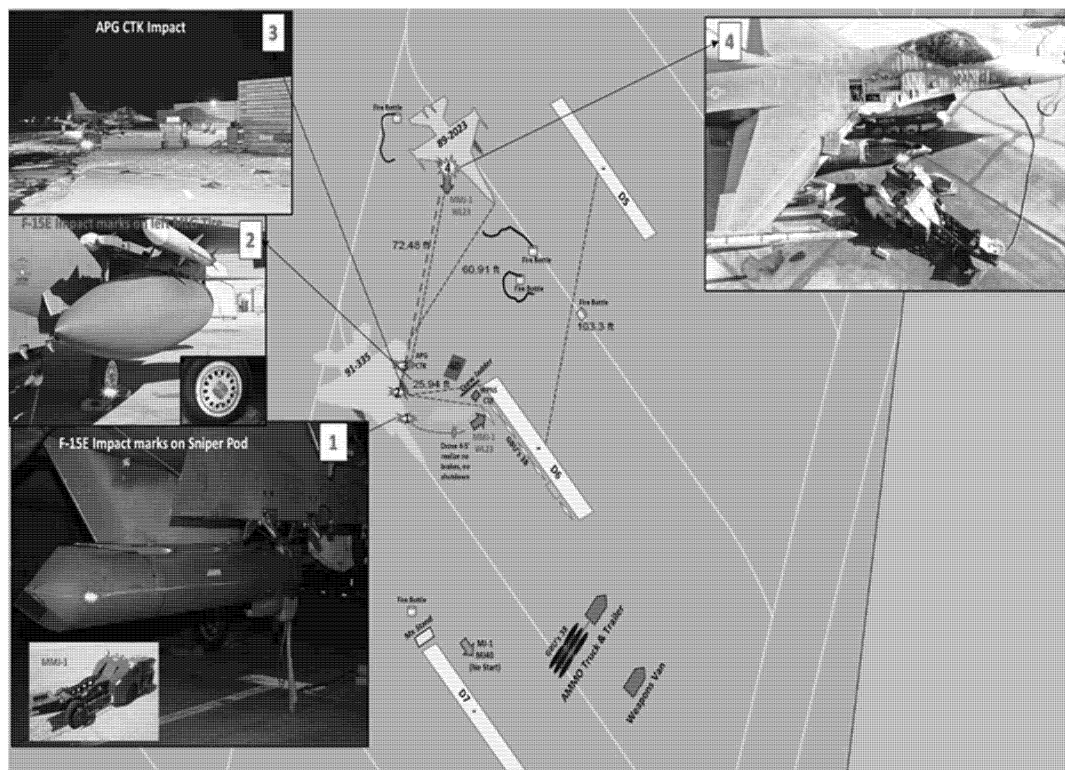
FIGURE 1

While continuing to travel in reverse, MMJ-1 hit the sniper pod (*Figure 1, item 1*) and MXLC2 hit his head and scraped his back on the bomb rack unit (BRU) of the F-15E, pinning him to the steering wheel and dashboard of MMJ-1. (Tabs R-26 to R-27, R-41 to R-42, R-55, R-67, V-2.4). MXLC2 reported going “unconscious” near this time. (Tabs R-27, V-3.6). MMJ-1 continued in reverse, hitting the left main landing gear tire (*Figure 1, item 2*) on the F-15E. (Tabs R-26 to R-27, R-41 to R-42, S-5). This impact significantly changed the direction of MMJ-1’s travel, sending it under the F-15E’s external fuel tank and also threw MXLC2 from the jammer. (*Figure 1*) (Tabs R-26 to R-27, R-67, T-9, V-2.4). MMJ-1 then hit a toolbox (*Figure 1, item 3*) and proceeded to travel unmanned in a direction toward the MA. (*Figure 1*) (Tabs R-26 to R-27, R-67, T-9, V-2.4 to V-2.5). It hit MA on the right fuel tank and caused a fuel leak. (Tabs R-18, R-57, R-69, V-2.5). A spark from the MMJ-1 ignited a fire, which engulfed the MMJ-1 and the right front side of the MA. (*Figure 1, item 4*) (Tabs R-18, R-69, V-2.5).

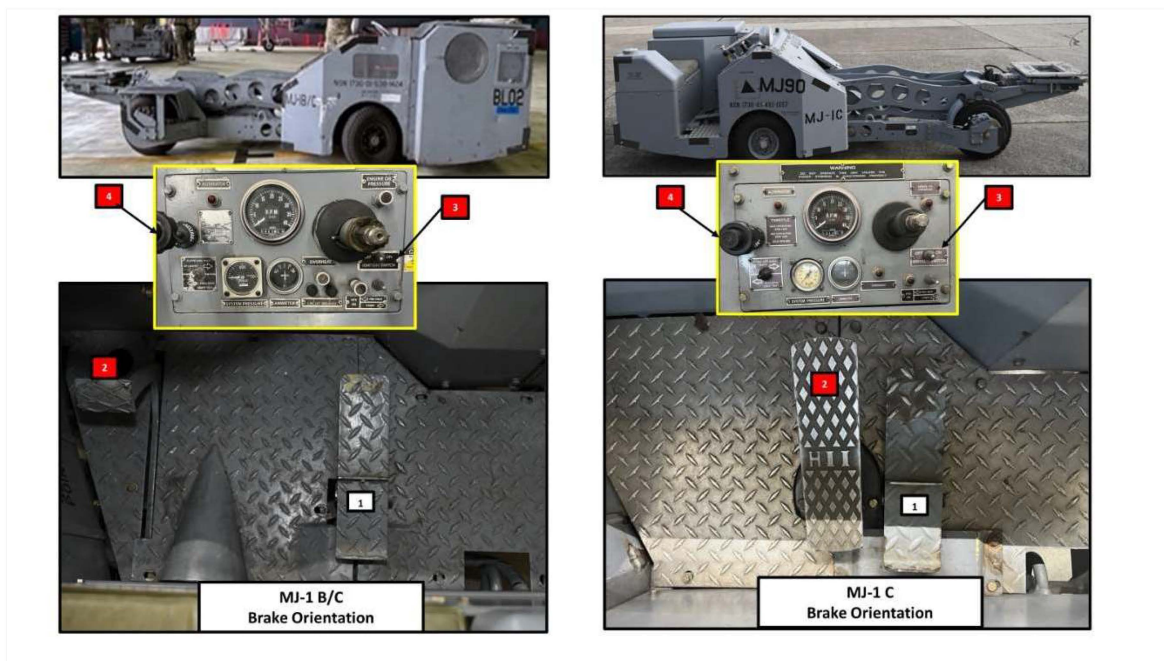
FIGURE 2

The MJ-1 B/C Aerial Stores Lift Truck “jammer,” “weapons loader,” or “bomb lift,” manufactured by Hydraulics International, Inc., in Chatsworth, California, is a lift truck used to transport, lift, and attach bombs, fuel tanks, pylons, and aerial stores weighing up to 3000 lbs. The mishap MJ-1 B/C (MMJ-1) failed to stop moving in reverse and collided with the MA, resulting in a fire and subsequent damage and destruction of the entire jammer. (Tab Z-6 to Z-8). Though the MJ-1 B/C model and MJ-1C model jammers are very similar, there are some major differences between them, including a different location of the brake pedal. (*Figure 2*, item 2). The distance between the brake pedal and the accelerator pedal in the MJ-1B/C model is 11 inches. The distance between the brake pedal and accelerator pedal in the MJ-1C model is 1 inch. (Tab EE-16).

1. Accelerator Pedal 2. Brake Pedal 3. Ignition Switch 4. Throttle

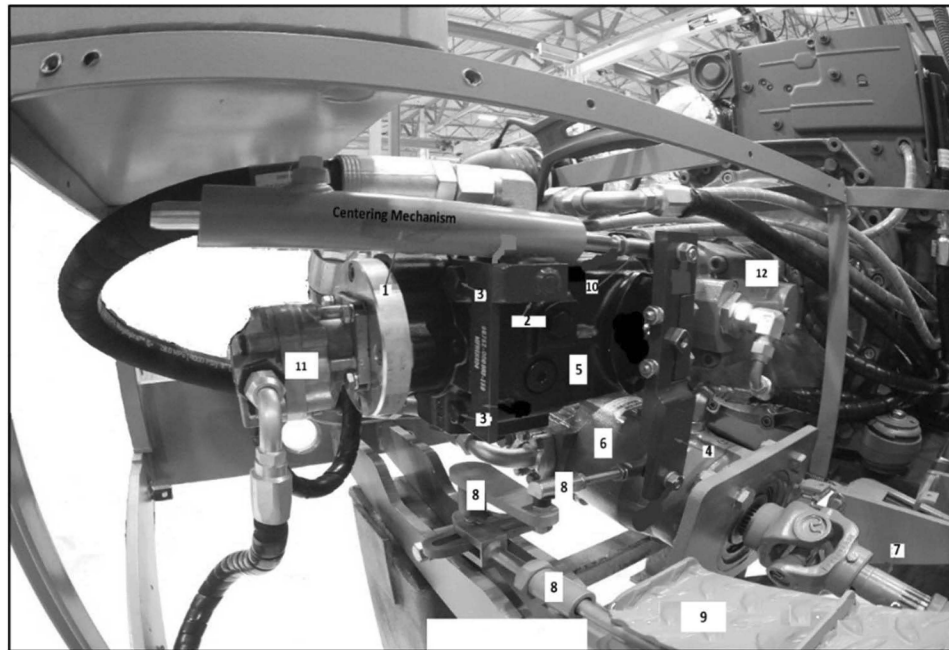
FIGURE 3

The MJ-1B/C utilizes a hydrostatic drive (*Figure 3*, item 1) for propulsion. An accelerator pedal (*Figure 3*, item 9) moves linkages (*Figure 3*, item 8) connected to the swash plate of a hydrostatic pump. (*Figure 3*, item 5). When the pedal is pressed, the swash plate is articulated to provide hydraulic flow to a hydraulic motor connected via drive shaft to the rear wheels. (Tab J-7). A spring-loaded device known as the centering mechanism, part number 201219025-01, is designed to move the swash plate back to a neutral position when the operator removes his or her foot from the accelerator pedal. (Tab J-7). The internal reservoir of the centering mechanism is filled with MIL-PRF-83282, or equivalent, hydraulic fluid and is self-contained. The exterior of MMJ-1's centering mechanism was completely burnt, as were the inner parts after they were removed from

the centering mechanism body. The mishap centering mechanism did not contain any MIL-PRF-83282, which would have been burned off from the fire. (Tab J-36).

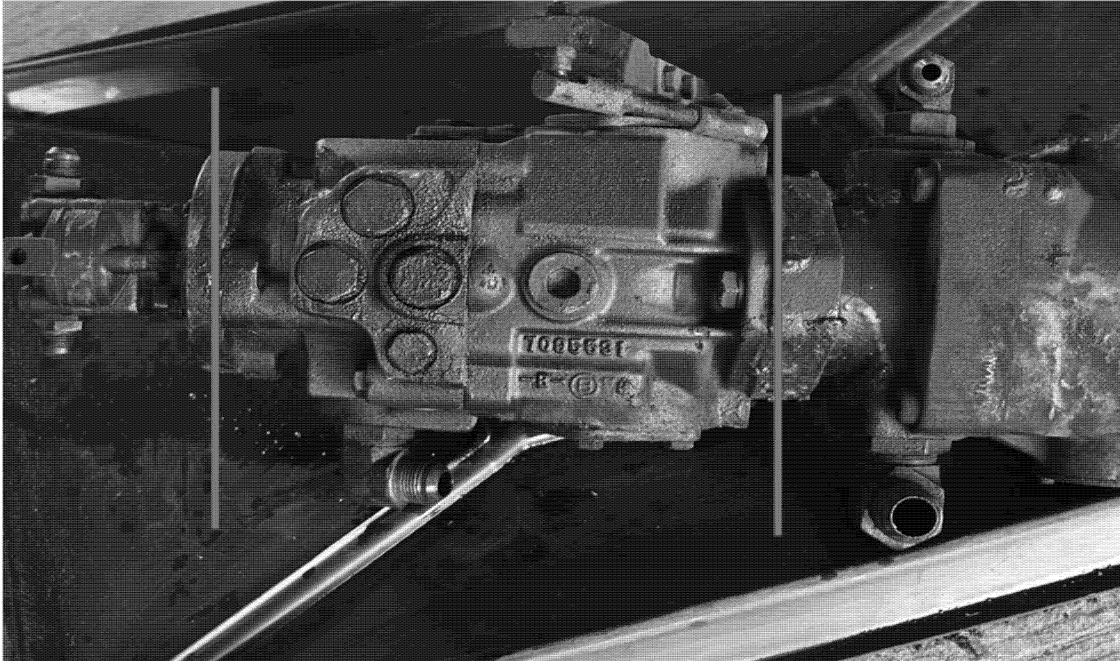
FIGURE 4
Hydrostatic Pump

The drive system of the bomb lift consists of the diesel engine, hydrostatic pump, hydrostatic motor, and an automotive-type steering mechanism. Power from the engine is transmitted to drive the rear wheels by means of a hydrostatic drive system. This consists of a fluid coupling between the engine and differential. A variable displacement hydrostatic pump is connected to the engine, and a fixed displacement hydrostatic motor is connected to the differential. The hydrostatic pump draws fluid from the hydraulic reservoir tank and directs the fluid at high pressure to the hydrostatic motor which is coupled to the differential by a conventional drive shaft. The amount of fluid delivered from the pump to the motor controls how fast the bomb lift moves. The flow rate of the pump can be varied by changing the engine speed with the throttle control and with the accelerator pedal, which changes the stroke (displacement) of the pistons within the pump. Forward and reverse directions are controlled by the driver by actuation of the directional control lever to the right of the instrument panel. A mechanical linkage between the hydrostatic pump and the operator's directional control varies the position of the pump's swashplate to direct the fluid going to the hydrostatic motor to cause the lift truck to move forward, reverse, or stay in neutral. When the drive control on the instrument panel is pushed forward and the accelerator pedal is fully

depressed, the stroke of the pistons within the pump are at their maximum stroke output, and the bomb lift will travel at its maximum speed. When the drive control is centered, there is no stroke of the pistons within the pump and the lift truck does not move regardless of engine speed. When the drive control is pulled back, the direction of fluid flow is reversed, and the lift truck moves in reverse. By combination of engine speed and displacement control, the lift truck is capable of a speed of approximately 15 miles per hour in forward or reverse. Generally, the normal operating speed of the engine should be adjusted between 1500 and 1800 RPM with the throttle, and lift truck speed controlled by the accelerator pedal. (Tab FF-23).

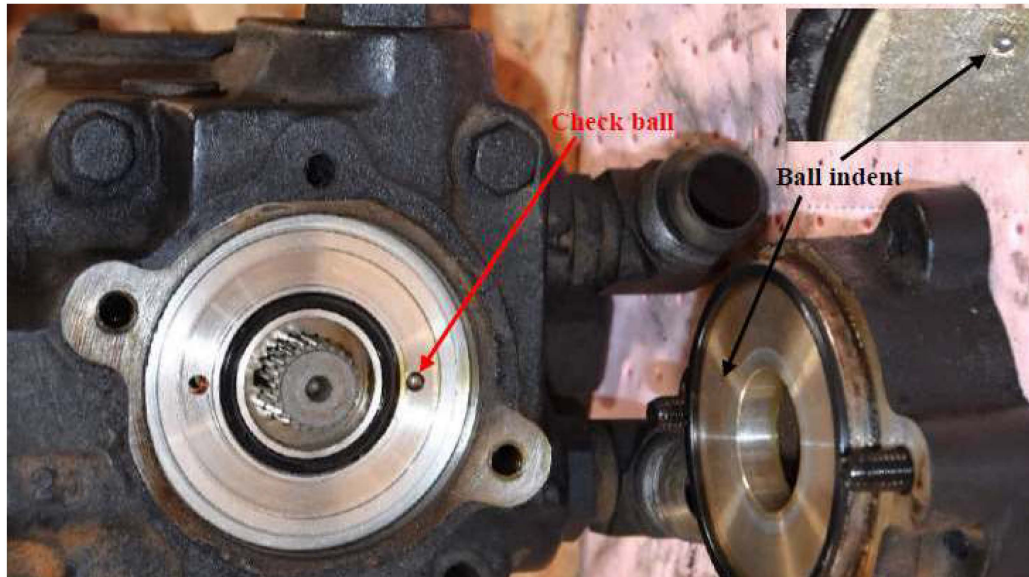
FIGURE 5
Rear Spacer Rear Adapter Flange

However, the laboratory analysis did find that a check-ball within the drive pump's rear spacer had impacted the inner surface of the rear adapter flange, leaving a noticeable indent on the surface.

(Tab FF-7). (*Figure 5*). This check-ball is free floating and designed to relieve pressure inside of the drive pump. (Tab FF-28). An inspection of a new, unused hydrostatic drive pump by AIB members found the surface of the rear adapter flange to be smooth and without indent. (Tab FF-28). The indent to the adapter flange in MMJ-1's hydrostatic drive pump was determined to face to the right, rear of the jammer. (Tab FF-28). The maximum pressure inside of the drive pump is 1800 pounds per square inch, which would not be sufficient to cause the indent in MMJ-1's adapter flange mating surface. (Tab FF-28).

I further find by a preponderance of the evidence that the impact of MMJ-1 to the F-15E's landing gear more likely than not caused the hydrostatic drive pump to stick and fail in the reverse position, thus propelling MMJ-1 toward the MA without a driver. This is supported by the indentation found

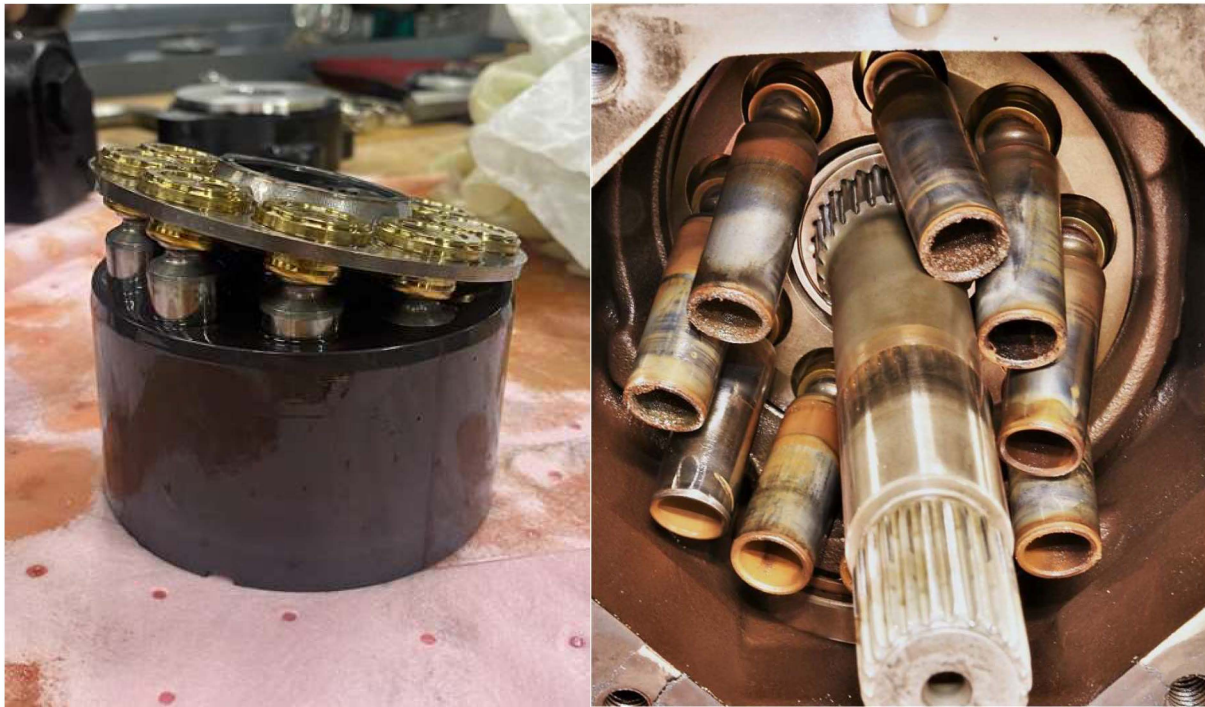
FIGURE 6

The main control lever on a new, unused hydrostatic drive pump was also moveable with minimal pressure. (Tab FF-28 to FF-29). It could be moved by hand between forward, neutral, and reverse smoothly and with only a small amount of force. (Tab FF-28 to FF-29). The pistons of the new, unused hydrostatic drive pump also moved within the cylinder block housing smoothly and with extreme precision, indicating an exact engineering fit. (*Figure 6*). The same hydraulic fluid that was present throughout the hydrostatic drive pump was found to lubricate the pistons and their movement in the cylinder block. (Tab FF-29).

Pistons in Cylinder Block (New Unit)

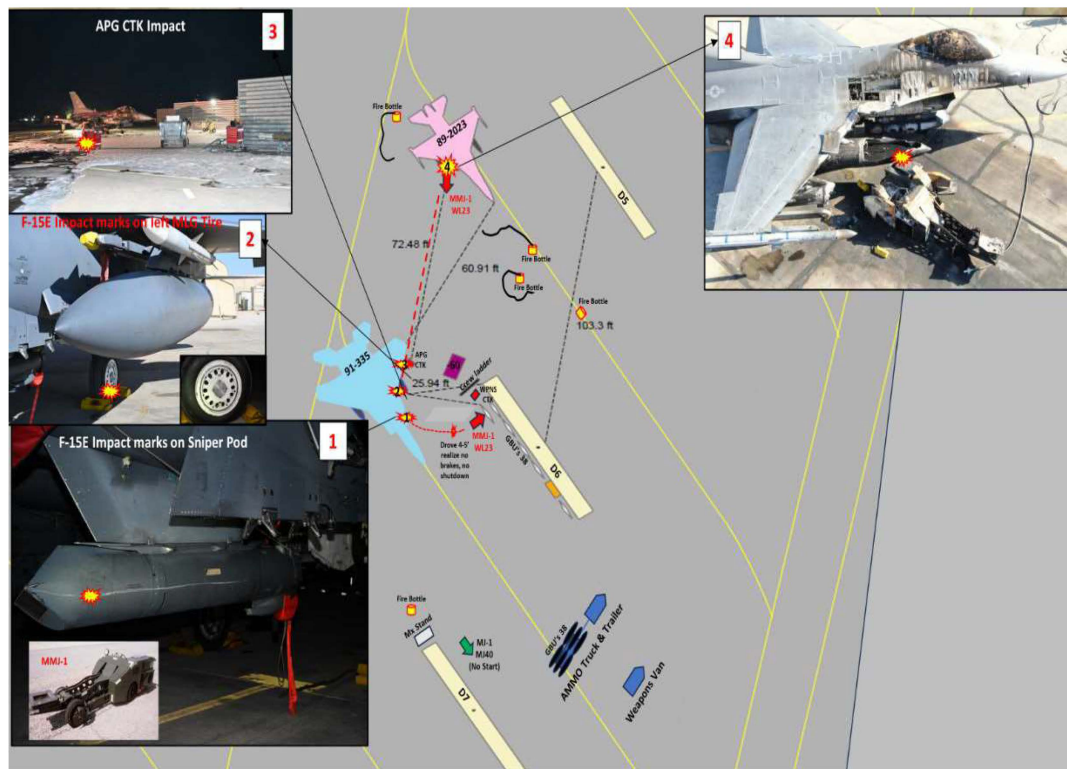
FIGURE 1

MMJ-1 proceeded to hit the F-15E’s sniper pod (Figure 1, item 2) and left center main landing gear tire (Figure 1, item 1). After impacting the landing gear, the MMJ-1 changed its course of direction, hit a toolbox (Figure 1, item 3), and MXLC2 was thrown from MMJ-1. MMJ-1 continued to travel without a driver at a high rate of speed towards the parked Mishap Aircraft (MA), F-16C, S/N 89-002023. MMJ-1 impacted the MA on the right external fuel wing tank, causing the tank to rupture and leak fuel onto the still running MMJ-1 (Figure 1, item 4). The MA’s external wing fuel tank and MMJ-1 tank quickly caught fire resulting in total damage of the MMJ-1 and significant damage to the MA.

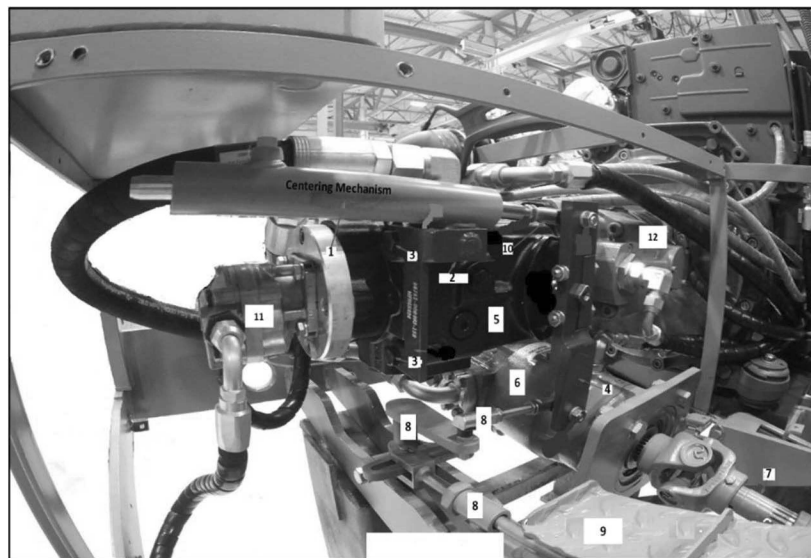
FIGURE 2

1. Centering Mechanism 2. Bracket-Centering Mechanism 3. Bracket Bolts w/safety wire holes 4. Lever- Centering Mechanism 5. Hydrostatic Pump 6. Hydrostatic Drive 7. Driveshaft 8. Linkage 9. Accelerator Control 10. Ball Joint 11. Steering Pump 12. Piston Pump
