**UNITED STATES AIR FORCE**  
**ABBREVIATED AIRCRAFT ACCIDENT INVESTIGATION**  
**BOARD REPORT**

**MQ-9A, T/N 13-004245**

**DATE OF ACCIDENT: 31 AUGUST 2025**

**Abbreviated Accident Investigation, conducted pursuant to Chapter 12 of Air Force  
Instruction 51-307**

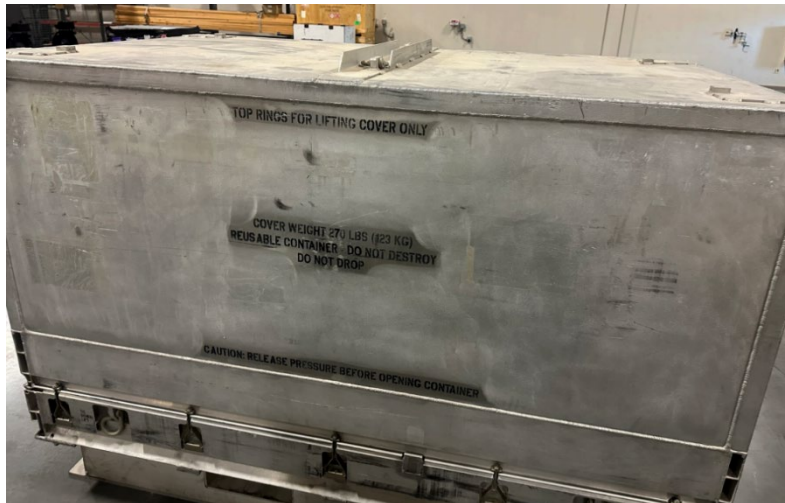
Figure 1. MQ-9 Engine Storage Container (Tab Z-3)

Prior to the mishap, the MA engine was replaced as part of the 3,000-hour engine inspection (Tab D-32, D-44). The MC was not aware of the replacement (Tab V-2.4). The mishap occurred on the first flight after the replacement (Tabs D-86, D-97, V-9.2). The MA engine core was serviced and inspected by Honeywell on 18 April 2025 (Tab D-176). During the inspection of the MA engine, Honeywell noted three observations in addition to normal wear: the propeller governor cable was chafed and replaced, the FCU was replaced due to a missing log card with a new FCU overhauled in April 2025, and the compressor seal was leaking and replaced (Tab J-6). It was postulated that the FCU also had a damaged internal wire that was not identified during the inspection (Tab J-8). This is because during a standard inspection at Honeywell, the top cover of the FCU is not removed (Tab J-6). The engine core was received by Tinker AFB on 24 April 2025, reassembled and sent to Creech AFB 5 June 2025 (Tab J-7). Figure 1 below shows the container the engine is stored in during shipping and remains in until ready for installation (Tab Z-3). The engine was installed on the MA on 28 August 2025 with a likely damaged FCU (Tab D-44). The FCU's internal wiring failed during flight likely due to chaffing against the chassis of the FCU (Tab J-8). This chaffing likely caused voltage to get sent to the Fuel Shutoff Valve (FSOV) to command close, starving the engine of fuel (Tab J-8).

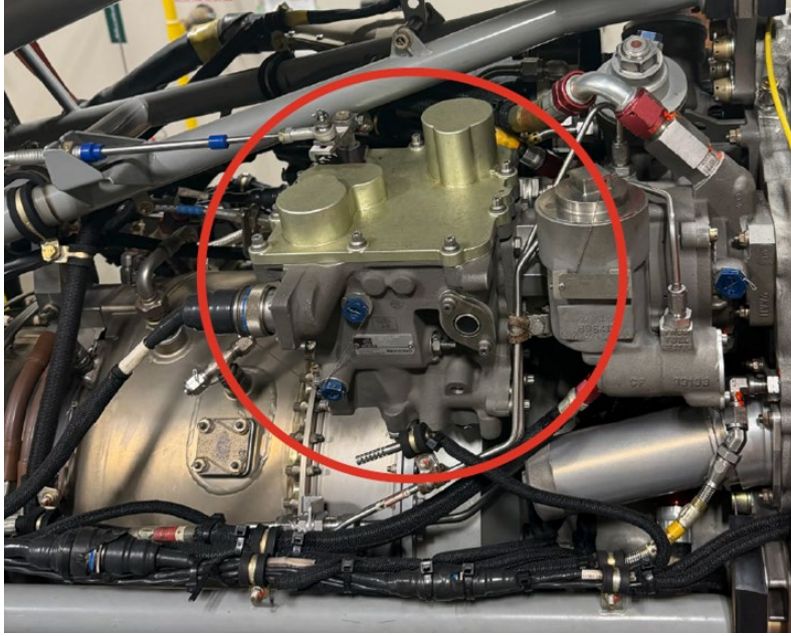
Figure 2. Fuel Control Unit (Tab Z-5)

The FCU meters fuel to the engine to increase or decrease torque in response to commands from the engine controller (Figure 2) (Tab J-9). The fuel flow to the engine is regulated by a main metering valve in the FCU (Tab J-9). Engine compressor discharge air pressure is supplied to the FCU through a metal line (Tab J-9). The torque motor within the FCU will open and close in response to commands from the engine controller to bleed excess pressure to maintain desired control pressure (Tab J-9). The main metering valve moves based on changing pressure to allow lower or higher fuel flow to the engine (Tab J-9). The FCU also mechanically limits fuel flow if engine speeds exceed the set limits of the OSFG (Tab J-9). The OSFG is a mechanical system that is the most downstream fuel control measure, the purpose is so that it can override any upstream fuel metering regardless of engine control mode (Tab J-9). The FSOV in the FCU is responsible for shutting off fuel to the engine (Tab J-9). It is electronically triggered when the engine is commanded to shut down from the GCS ignition (Tab J-9).

General Atomics reports that there are known examples of the FCU sensor wire chaffing within the FCU (Tab J-10). During previous testing of an FCU Honeywell observed a relay wire shorting and sparking (Tab J-10). This could be a source of voltage to command the FSOV closed and cause the FCU sensor failure (Tab J-4, J-10). The FCU internal wire likely failed, due to chaffing against the chassis, causing the FSOV to suddenly close (Tab J-10). This starved the engine of fuel, resulting in the loss of engine torque and combustion of the MA (Tab J-10).

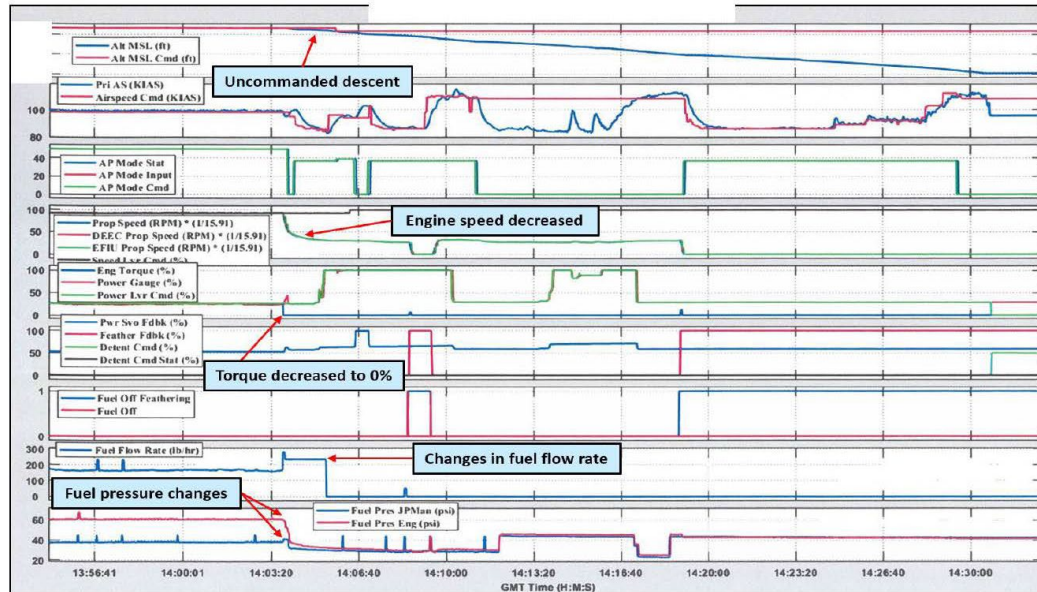
Figure 3. Mishap Data Log (Tab J-14)

There was an indication of a spike in fuel flow rate then a decrease to zero, as shown in figure 3 below (Tab J-14). General Atomics was able to reproduce this in their lab during Fuel System testing (Tab J-7, J-10). This was achieved by suddenly closing the FSOV that is upstream from the FCU (Tab J-7). This suggests that the FSOV was un-commanded closed during the mishap (Tab J-7).
