UNITED STATES AIR FORCE
AIRCRAFT ACCIDENT INVESTIGATION
BOARD REPORT

KC-46, T/N 17-6033

LOCATION: SEYMOUR JOHNSON AIR FORCE BASE, NORTH CAROLINA

DATE OF ACCIDENT: 8 JULY 2025

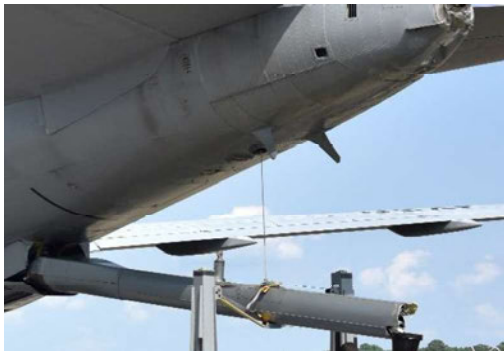
During the mishap the two structural tubes of the boom were stressed immensely causing them to crack and then separate slightly forward of the U-Tail assembly, causing the Aft end of the boom along with the U-Tail and telescoping tube to detach and plummet into the ocean (Tab S-5). The detached portion of the boom was never recovered. It is unclear whether the structure was cracked while in contact with MA2 due to stress. The impact of the boom striking the fuselage caused the latch hook-eye to shear off leaving a hole directly between the remaining hoist cable and shock absorber (Tab S-5). The shock absorber also ruptured upon the impact, deflating it completely (Tab S-14).

Remaining portion of boom (Tab S-5).

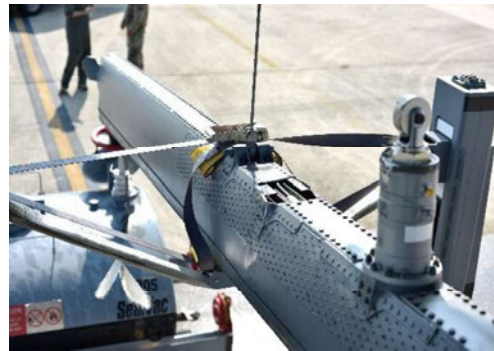
Missing latch hook eye (Tab S-14).

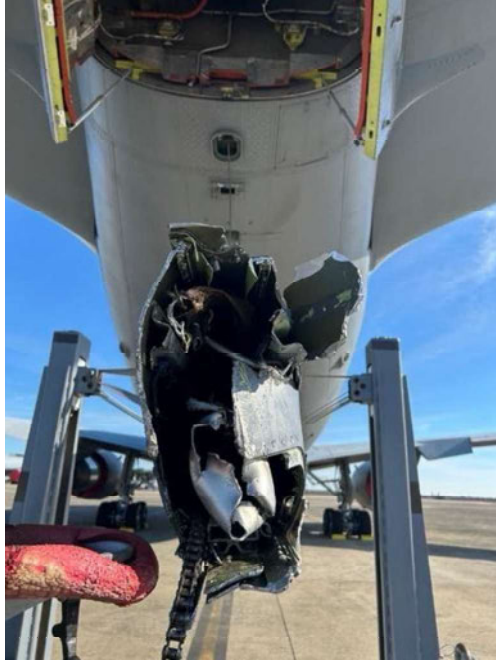
The separation tore all the wiring, hydraulic tubing, and the telescoping chains and cables leaving only a small portion of the chain intact and hanging freely from the outer tube (Tab Z-3).

Break point of boom (Tab Z-3).

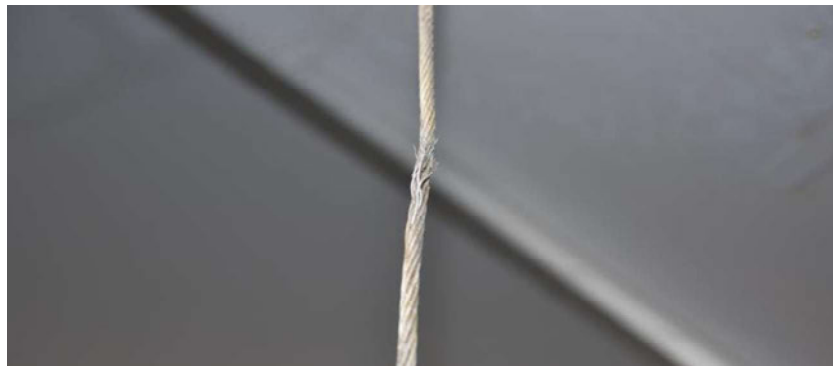
The boom hoist cable remained attached to the hoist motor and the structure of the boom but was noticeably stressed beyond limits and fraying significantly (Tab S-22).

Hoist cable (Tab S-22).

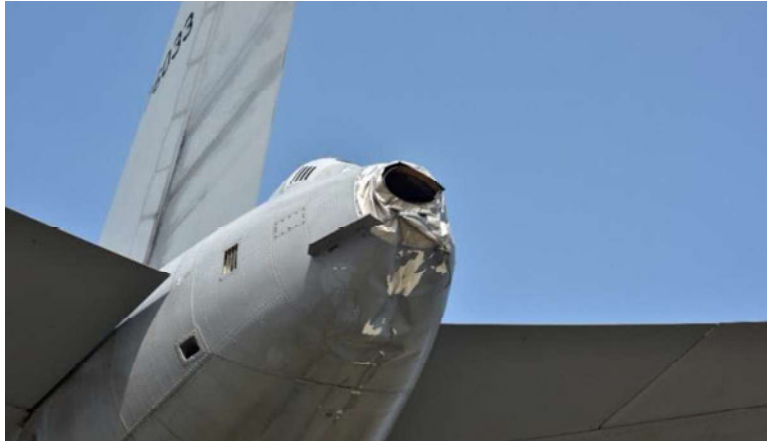
Due to the impact of the boom to the fuselage, MA1 sustained damage to the APU access doors, the APU exhaust, the APU exhaust deflector, and the aircraft tail section (Tab S-6).

Tail-cone of MA1 (Tab S-6).
