UNITED STATES AIR FORCE AIRCRAFT ACCIDENT INVESTIGATION BOARD REPORT

F-16CM, T/N 88-0479

35TH FIGHTER SQUADRON 8TH FIGHTER WING KUNSAN AIR BASE, REPUBLIC OF KOREA

LOCATION: KUNSAN AIR BASE, REPUBLIC OF KOREA DATE OF ACCIDENT: 11 DECEMBER 2023 BOARD PRESIDENT: COLONEL PHILIP D. LANCASTER Conducted IAW Air Force Instruction 51-307

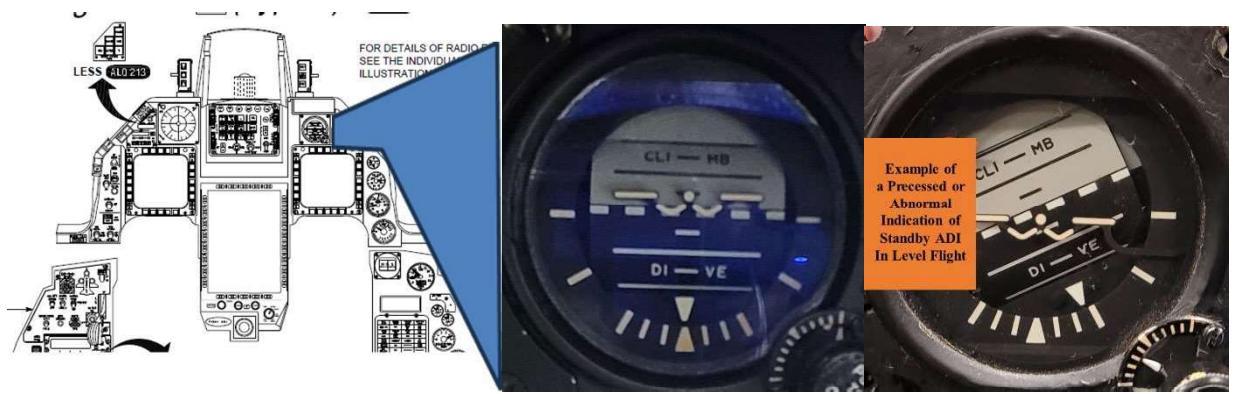
While taxiing to the end of runway (EOR), the MP noted the standby attitude indicator (SAI) had precessed (drifted off the correct setting) and was indicating slight pitch and bank errors. *See, e.g., Figure 3 below.* (Tabs V-1; Z-8 to Z-10; BB-7). Note that most of the pilots interviewed testified to routinely seeing poorly performing SAIs (Tabs N-1; V-1; V-3 to V-5; V-8). Once stationary at EOR, the MP re-caged the SAI, correcting the errors. (Tab V-1). The correction was applied more than two minutes prior to takeoff in accordance with (IAW) TO 1F-16CM-1. (Tabs V-1; BB-7). The MP was ready for takeoff at 08:20:21. (Tab Z-6).

Figure 3. Cockpit Arrangement, Normal SAI, and Precessed SAI. (Tabs Z-8 to Z-10).

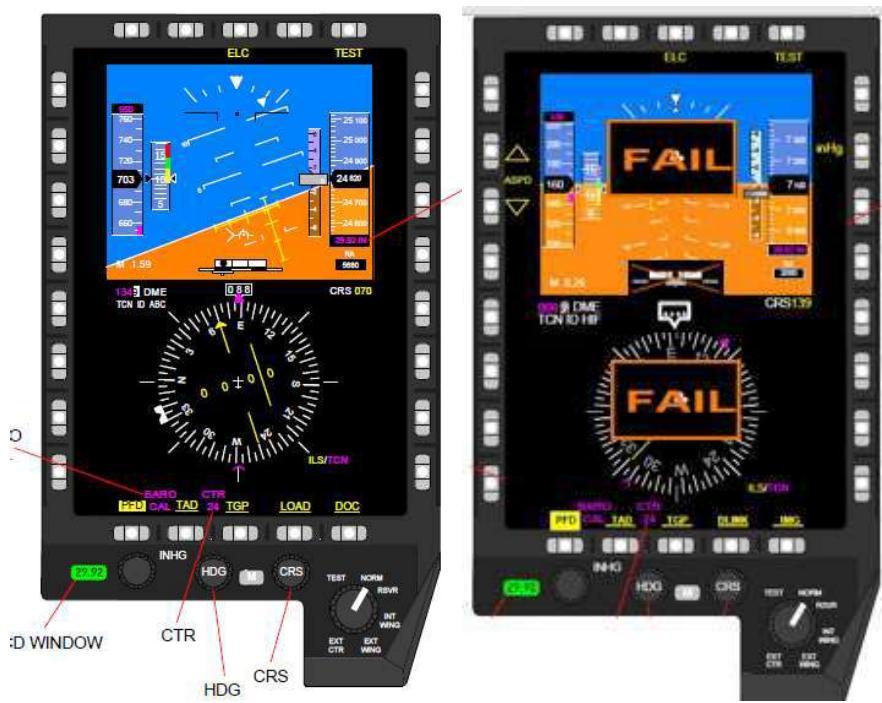
An EGI failure is similar to an MMC failure with a notable difference; during EGI failure the attitude indicator (ADI) and horizontal situation indicator (HSI) are replaced with the word FAIL on the CDU. *See Figure 4 below.* (Tabs BB-11; Z-11 to Z-12). During the interview, the MP stated

Figure 4. Normal CDU and Example of EGI Fail CDU. (Tabs Z-11 to Z-12; BB-11).

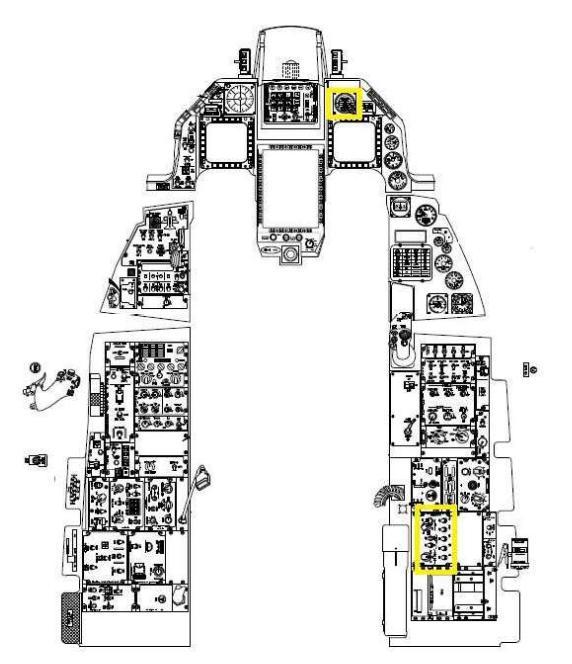
Figure 5. F-16 Cockpit Avionics Panel, with EGI Control (Lower Right) and SAI (Upper Right) Highlighted in Yellow. (Tabs Z-14; BB-7).

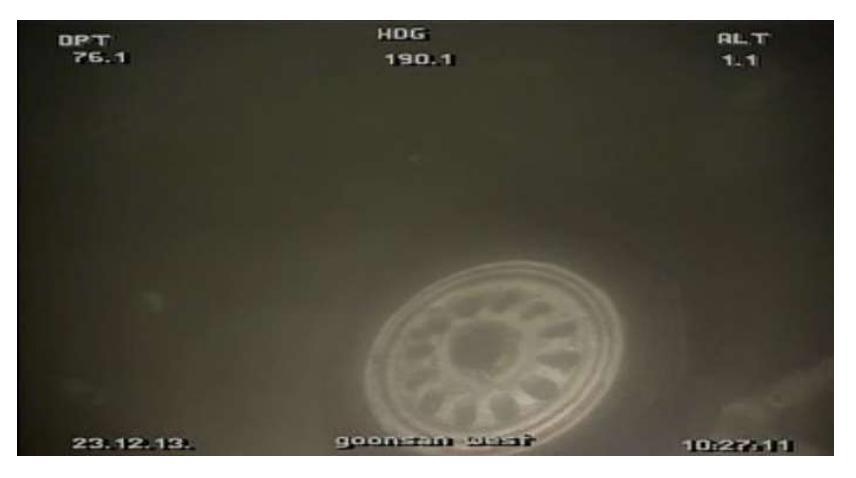
Figure 6. Underwater Debris of MA. (Tab S-1).

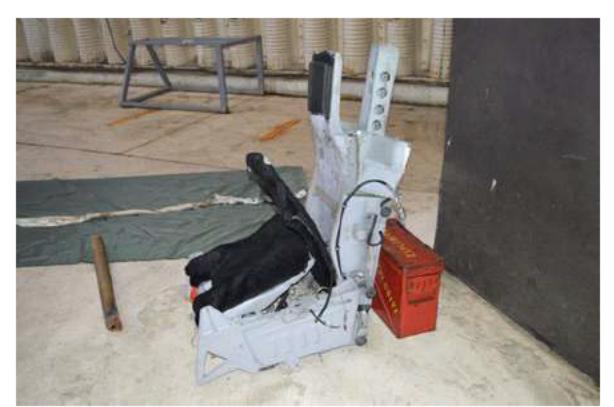
and altitude that the seat will not deploy the drogue (small) parachute installed for seat stabilization during ejection. (Tab BB-2). The seat operated properly during ejection. (Tab V-1). The egress system was inspected per the 30-day, 12-month, and 36-month requirements. (Tab DD-1). The MP was current and qualified in AFE training, to include AFE local procedures, 120-day fit check, egress ejection training, and water survival training. (Tab DD-4). The seat was equipped with a personnel locater beacon (PLB), and the beacon was found to be in the automatic mode when the seat was recovered. *See Figure 1*. (Tab Z-7). The beacon is designed to transmit a warning tone on various frequencies. Beacon transmission could not be verified. (Tab BB-6). There are no other AFE issues pertinent to this investigation.

Figure 7. Ejection Seat. (Tab Z-5).

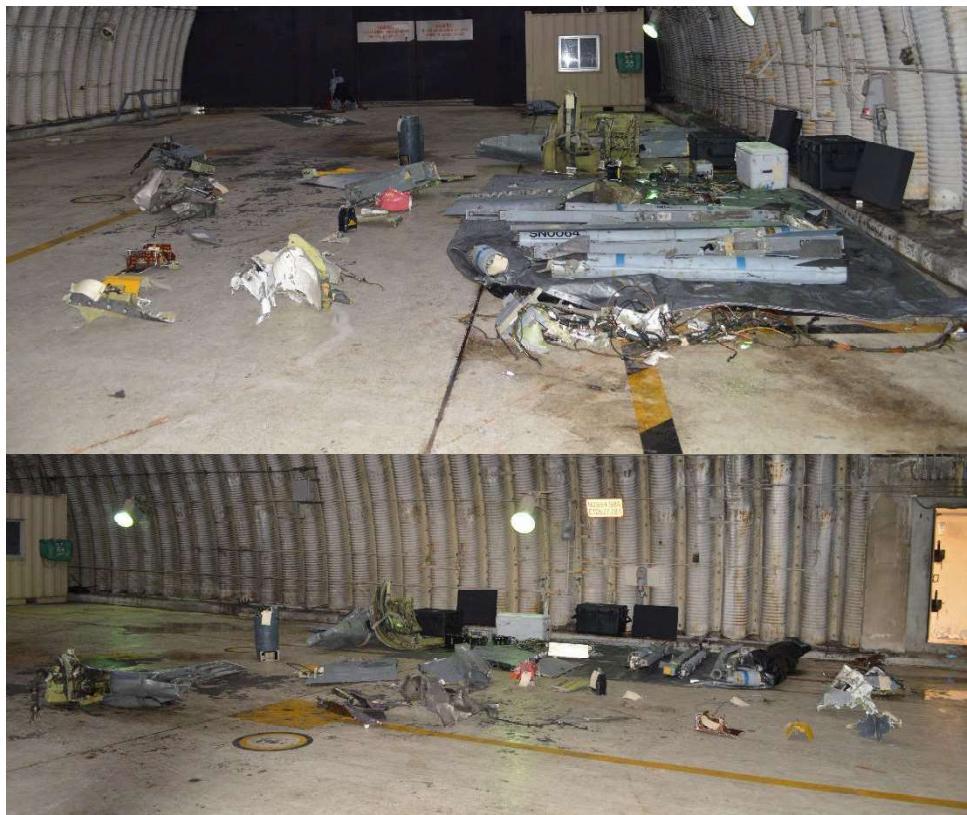
Very little wreckage is recovered to date. *See Figure 8 below.* (Tabs Z-2 to Z-3). The right rear of the aircraft contains the CSMU. A portion of the right rear of the aircraft was recovered, but the CSMU was not attached. No portions of the EGI were recovered. The EGI for the MA was manufactured by Northrop Grumman. (Tab AA-7).

Figure 8. MA Wreckage. (Tabs Z-2 to Z-3).
