UNITED STATES AIR FORCE
GROUND ACCIDENT INVESTIGATION
BOARD REPORT

**SEARCH AND RESCUE TACTICAL VEHICLE –
SIDE BY VEHICLE
S/N SRTVSXVD21AFM060**

**TYPE OF ACCIDENT:
Tactical Vehicle Serious Injury**

LOCATION: North Field, Tinian, Northern Mariana Islands

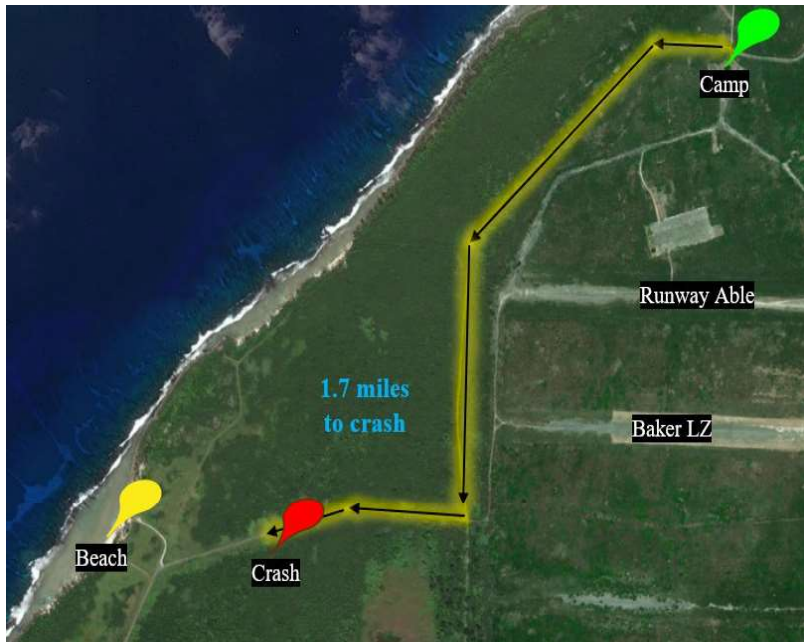
Figure 3: Highlighted area showing camp site, MV route towards Chulu Beach, and mishap site (Tab Z-4)

The MV departed the road to the left and entered the thick vegetation (Tabs R-77, R-97, and V-4.9). The MV completed a counterclockwise right leading rollover, coming to rest back on its tires against trees more than 30 feet from the road (Tabs R-77, R-97, O-4, and V-5.4.). Neither MA1 nor MA2 were wearing seatbelts or other personal protective equipment (Tabs V-3.6 and V-8.4 to V-8.5). MA1 was ejected from the MV and sustained serious injuries, resulting in permanent paralysis below the waist (Tabs V-4.9 and Tab X-4). MA2 was ejected from the MV (Tabs V-3.6 and V-8.6). During the rollover and after ejection, the MV struck MA2 causing life-threatening injuries to include a pelvic fracture and internal abdominal injuries, which has resulted in numerous corrective surgeries and an above-the-knee amputation (Tabs V-8.7 and Tab X-5 to X-6).

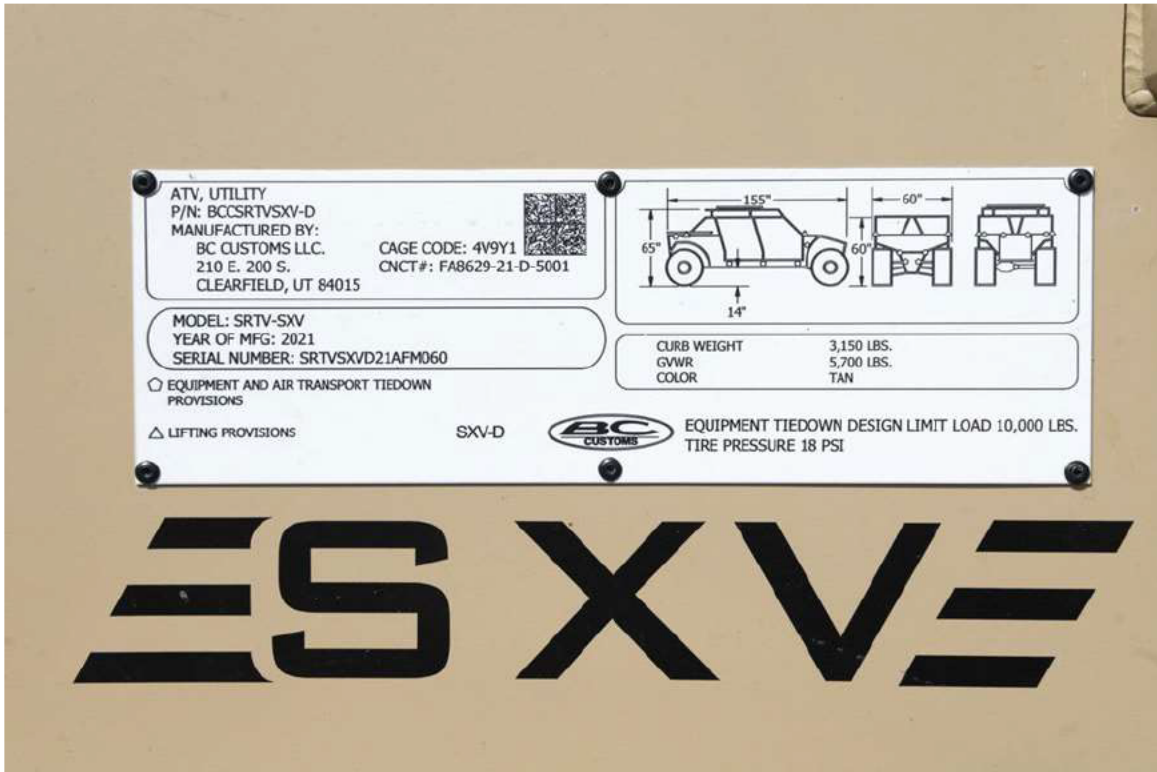
The SRTV-SXV, S/N SRTVSXVD21AFM060, had recently been delivered to 31 RQS, with the acceptance limited technical inspection (LTI) dated 17 January 2023 (Tab U-3). No maintenance documentation or evidence of inspections were present on the MV at the time the GAIB took custody (Tabs A-7 to A-11 and V-11.3-11.4).

Figure 9: MV data plate identifying OEM and S/N (Tab S-91)
