UNITED STATES AIR FORCE
AIRCRAFT ACCIDENT INVESTIGATION
BOARD REPORT

CV-22B, T/N 10-0054

**21st SPECIAL OPERATIONS SQUADRON
353rd SPECIAL OPERATIONS WING
YOKOTA AIR BASE, JAPAN**

DATE OF ACCIDENT: 29 NOVEMBER 2023

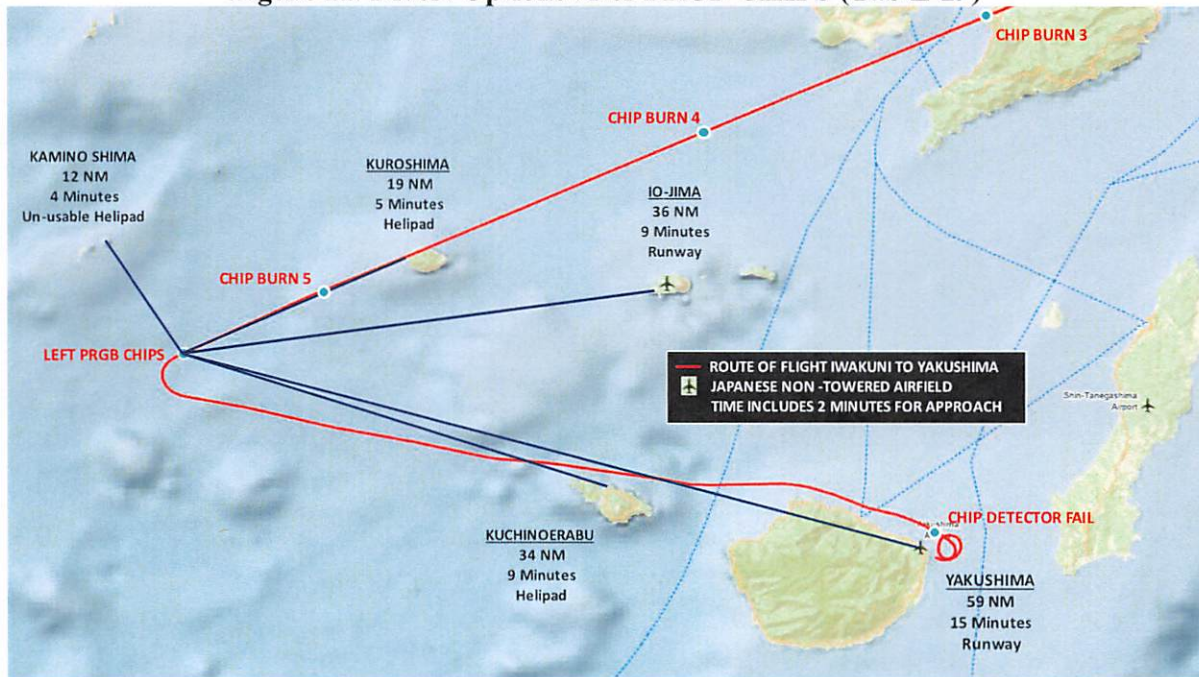
Figure 11. Divert Options after PRGB CHIPS (Tab Z-29)

At this time, closer divert possibilities existed, including a vertical landing option at Kuroshima, and a roll-on landing option at Satsuma-IoJima Airport, which is represented in Figure 11 (Tab Z-29). Four minutes after the PRGB CHIPS caution post, without further discussion of divert options, the MC began a gradual descent to 1,000 feet MSL to setup the MA for entry into the aircraft traffic pattern at Yakushima airport (Tabs DD-49, and II-58).
