UNITED STATES AIR FORCE
GROUND ACCIDENT INVESTIGATION
BOARD REPORT

UA-HMMWV, L/P 12L00750

**341st Missile Security Forces Squadron
341st Missile Wing
Malmstrom Air Force Base, Montana**

**UA-HMMWV, L/P 12L00750
US HIGHWAY 89, MILE MARKER 59
21 OCTOBER 2023**

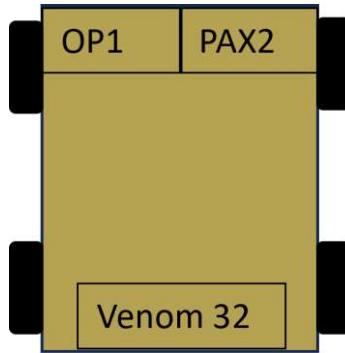
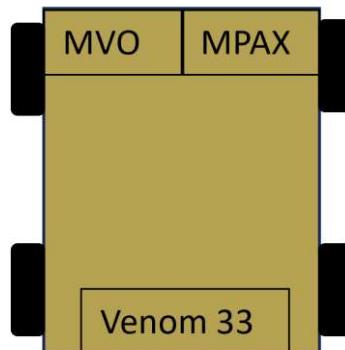
Figure 4-1 (Tabs AA-17, EE-74, Tab EE-142, and Tab EE-159)
Diagram of Team Positions

Venom 32 left Alpha-06 as Venom 33 shut the cattle gate leading to Alpha-06 (Tabs AA-17 and EE-142). OP1 relayed that Venom 32 pulled off Hwy 89 while on the route from Alpha-06 to MAFB to wait for Venom 33 to catch up (Tabs AA-17, EE-142, and FF-8 to FF-9). As MVO drove, MV was followed by another vehicle containing two passengers, Samaritan (SM) 1 and SM2 (Tab EE-177 to EE-181). SM2 relayed he was following the MV closely up through a canyon, northbound on Hwy 89, matching MV's speed, traveling approximately 35 miles per hour (MPH), and the MV met up with an UA-HMMWV that pulled out in front as the MV approached (Tabs EE-181 and FF-8 to FF-9). SM1 and SM2 relayed that the first UA-HMMWV was positioned on the right, north of the turn-off to Highway 427 (Tab EE-181 to EE-182). Soon after, SM1 and SM2 stopped their vehicle for approximately two minutes to work on something then continued on the same route the UA-HMMWVs had taken and came upon the wrecked MV at 1828L (Tab EE-180 to EE-184).
