UNITED STATES AIR FORCE
AIRCRAFT ACCIDENT INVESTIGATION
BOARD REPORT

T-6A, T/N 08-3915

**89TH FLYING TRAINING SQUADRON
80TH FLYING TRAINING WING
SHEPPARD AIR FORCE BASE, TEXAS**

DATE OF ACCIDENT: 13 MAY 2024

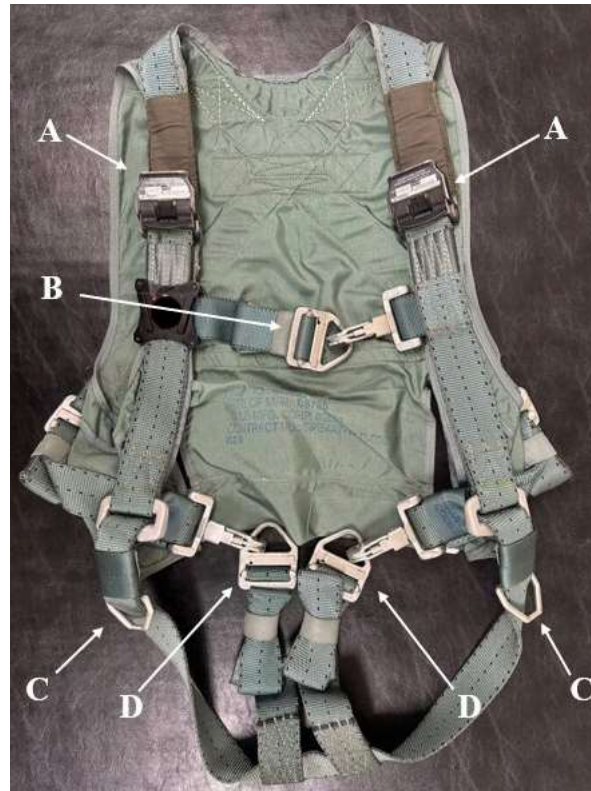
T-6A pilots wear the PCU-15/P harness (or the PCU-16/P for smaller stature personnel) as part of their flight equipment (Figure 1) (Tab MM-3). The harness connects the wearer to the recovery parachute straps via left and right connection points called Frost fittings (A) (Tabs Z-5, KK-12 & MM-3). The harness also has an adjustable chest strap comprised of an ejector snap and V-ring (B), two D-rings to connect to the Seat Survival Kit (SSK) (C), and two adjustable legs straps each comprised of an ejector snap and V-ring (D) (Figure 1) (Tabs KK-11 to KK-12 & MM-3).

(Figure 1: Typical PCU-15/P Harness) (Tab Z-1)

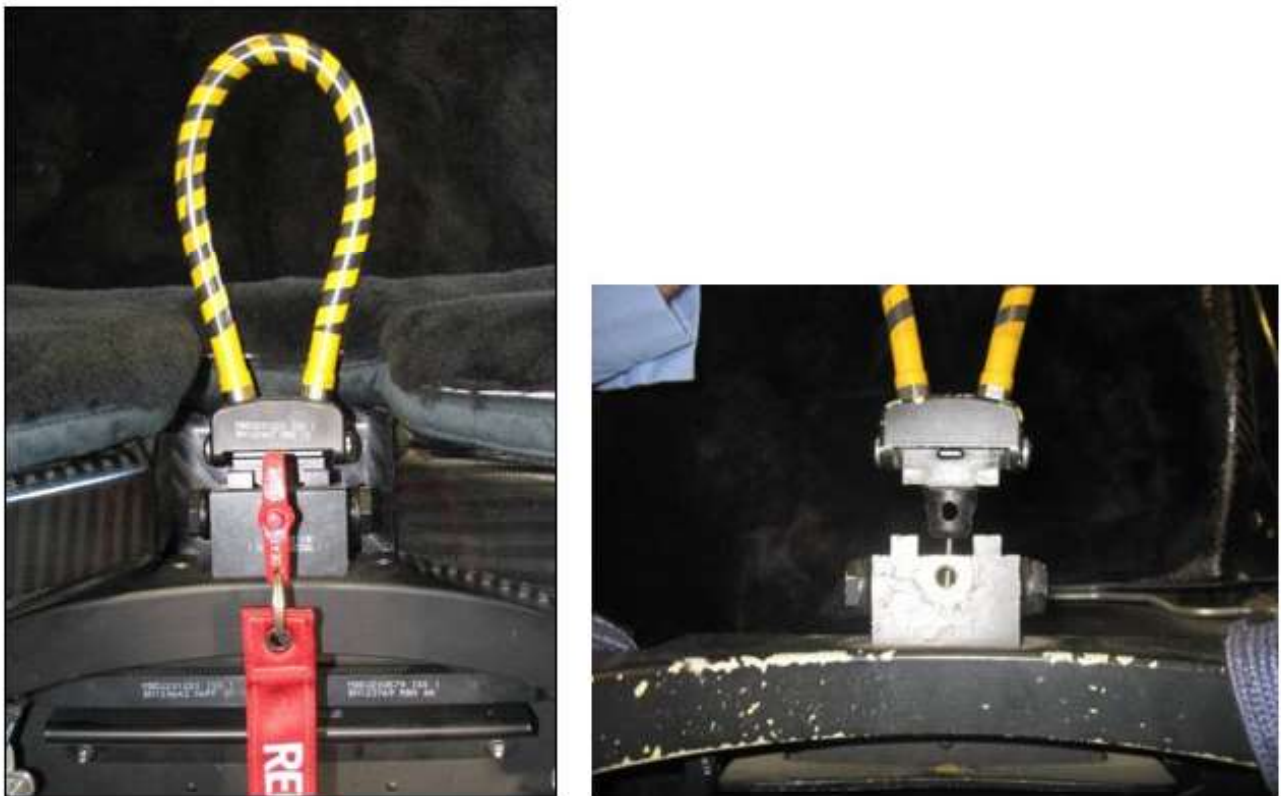
After landing, the pilots install the seat safety pin in the ejection seat during the After Landing Checklist (Tab KK-15). When fully installed, the pin prevents actuation of the ejection control handle (Figure 5) (Tabs KK-4 & KK-15). The seat safety pin locks in place with two spring loaded detent balls that engage the handle to keep it secure, requiring the pilot to depress a push button on the stem to release the pin (Tabs J-56 & R-11.10). If not fully installed, the pin may be dislodged from the seat, enabling actuation of the ejection control handle (Tab KK-15).

(Figure 5: Typical T-6A Ejection Control Handle: Handle fully stowed and safety pin inserted (left), safety pin removed, and handle pulled (right)) (Tab MM-2)

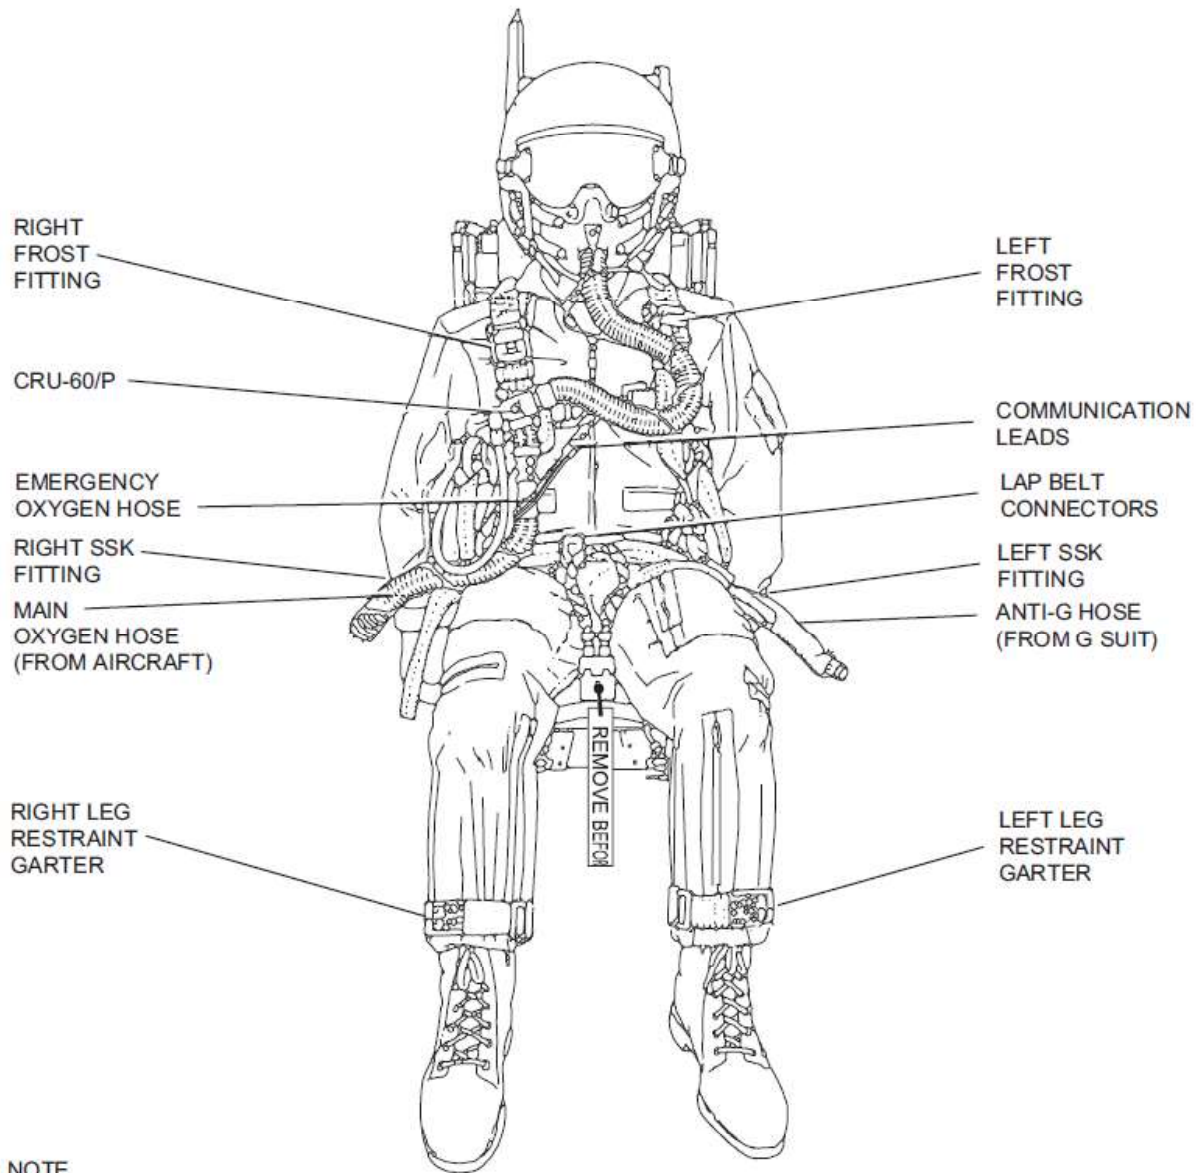
The pilot connects to the ejection seat system at 11 points: left and right Frost fittings (parachute connection), communication line, emergency oxygen hose, lap belt, left and right SSK fittings, main oxygen hose, anti-G hose connection, and left and right leg restraint garters (Figure 6) (Tabs KK-11 to KK-13).

(Figure 6: Pilot Hookup) (Tab Z-5)

connections during the taxi back to parking was a common practice for the MIP (which testimony revealed the MIP did on the MIP's first flight that morning) as well as other instructor pilots in the T-6A (Tabs R-11.7, R-14.11 & R-25.8 to R-25.10). The After Landing Checklist, Engine Shutdown Checklist, and Before Leaving Aircraft Checklist in the T-6A Flight Manual do not include information on when to disconnect from the ejection seat (Tabs R-11.7, R-20.6 & KK-15 to KK-16). Disconnecting from the various seat connection points produces audible clicking sounds that may be heard by the other pilot as occurred on the MIP's first flight that morning (Tab R-25.8). The MIP remained connected to all other connection points (Figures 1 & 6) (Tabs V-3.3, V-5.5 to V-5.9, V-16.8 & V-28.6).

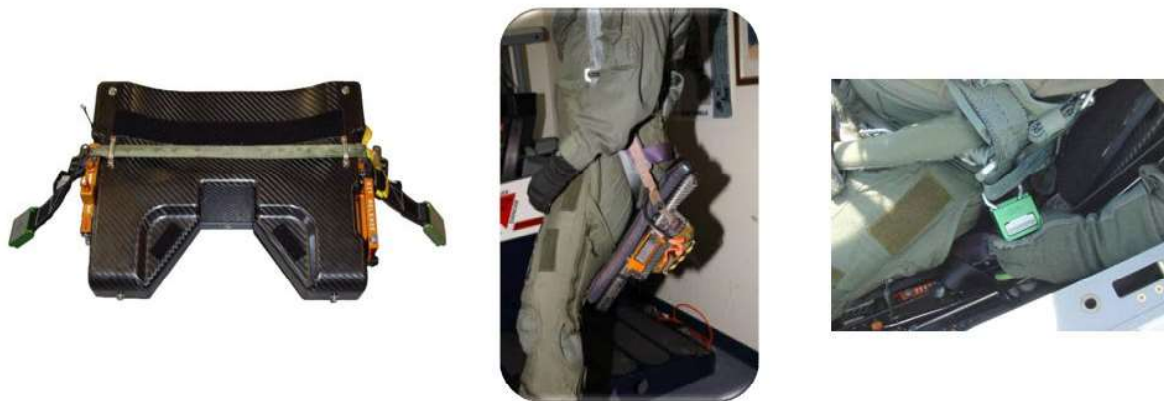
The SSK is fitted in the seat pan (Tab KK-12). The SSK is secured in position by a fiberglass upper lid assembly which forms part of the pilot's sitting platform (Tab KK-12). The SSK incorporates a pilot selectable automatic deployment unit which allows the pack to be deployed onto a lowering line either automatically or manually during parachute descent (Tab KK-12). The automatic deployment unit (ADU) and radio beacon are attached to the seat by two cables (Tab KK-12). They are attached to the seat forward of the ADU mode selector valve (Tab KK-12). Prior to strapping in, the pilot selects either manual (MANUAL) or automatic (AUTO) with the selector valve on the right side of the seat, under the seat cushion (Tab KK-12). When the selector valve is set to automatic, the SSK is lowered automatically 4 seconds after seat/pilot separation, suspended on the lowering line (Tab KK-12). If the selector valve is set to manual, the pilot must pull the manual release handle located opposite the automatic deployment unit to lower the SSK (Tab KK-12). One end of the lowering line is formed into a loop which is attached to the fabric container (Tab KK-12). The other end is connected to the left SSK attachment strap on the pilot's harness (Tabs V-28.7& KK-12) (Figure 7).

Figure 7: Typical T-6A SSK (left), Typical T-6A SSK Attached to Pilot (center), Typical T-6A SSK Buckled to Pilot Harness (right)
(Tabs MM-1 to MM-2)

The RCP SSK was located on the ground near the MIP and the ejection seat (Tabs V-27.3 & Z-12). The SSK did not deploy as intended during the ejection sequence, instead staying attached to the seat casing (Tabs J-39, V-28.8 to V-28.9 & Z-12). The left SSK buckle was found with the SSK, while the right SSK buckle was found attached to the MIP's harness (Tabs V-28.12, Z-1, Z-12 & Z-13).
