UNITED STATES AIR FORCE
GROUND ACCIDENT INVESTIGATION
BOARD REPORT

UA-HMMWV, R/N 10L00805

TYPE OF ACCIDENT: Motor Vehicle

LOCATION: Weld County, Colorado

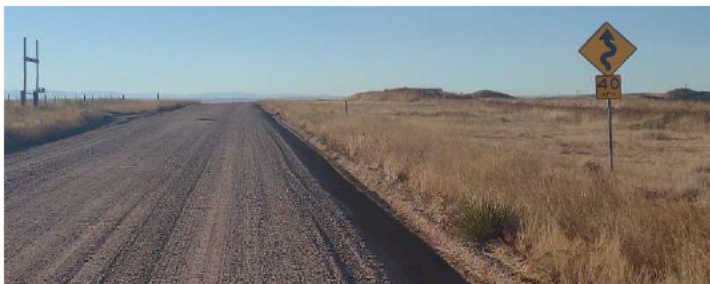
Figure 4-2 (Tab DD-11)
40 MPH Sign Approaching Mishap Site

MVO described that he was on the road for approximately 15 minutes before the mishap occurred (Tab R-19). 16 September 2023 was not the first time MVO traveled on CR 112 (Tab EE-14). The default speed limit on unposted Weld County Roads is 55 MPH (Tabs O-3 and EE-12). The Weld County recommended speed limit approaching the curve where the mishap occurred is 40 MPH (Tab DD-11).

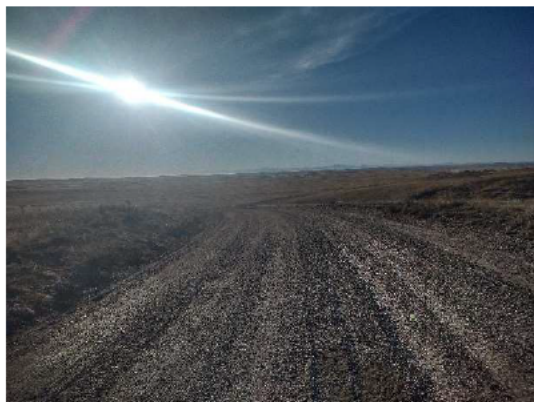
**Figure 4-5 (Tab DD-8)
Photo of Approach to Mishap Site-
East to West on CR 112
6 December 2023**

MVO was driving in the middle of the road (Tab R-19). He started going downhill a little and then braked more (Tab R-19). The steering wheel locked up and he had difficulty turning the steering wheel back to the middle of the road (Tab R-19). He started to brake more, and the steering wheel locked up more (Tab R-19). As MVO tried to come to a complete stop, he hit a patch of “wash-boarding” on the road and lost traction, which is when the MV began to slide and turn (Tab R-20). The MV’s vehicle type is not equipped with antilock braking system (ABS) (Tabs EE-23 and EE-34). The Operator’s Manual for MV’s UA-HMMWV model states that in hazardous conditions like ice and snow, sudden braking will cause wheels to lock and vehicle to slide out of control, causing damage to vehicle and injury or death to personnel (Tab BB-54).

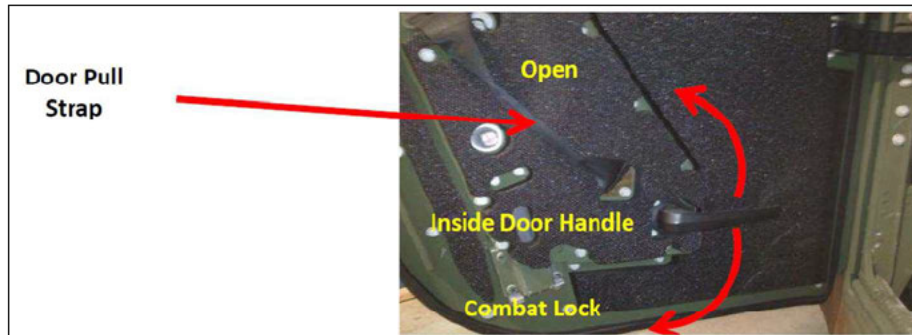
**Figure 6-2 (Tab EE-62)
Operation of a Combat Lock**

(b) Analysis. The combat locks engage and disengage on all MV doors (Tab DD-47 to DD-55 and DD-85). The front right door was damaged during the mishap and the combat lock was unable to be function tested with the door fully closed (Tabs S-20, DD-50, and DD-85). The door strap retention bolts were ripped out of the MV's body when the door was overextended (Tabs S-63, DD-50, and DD-85).

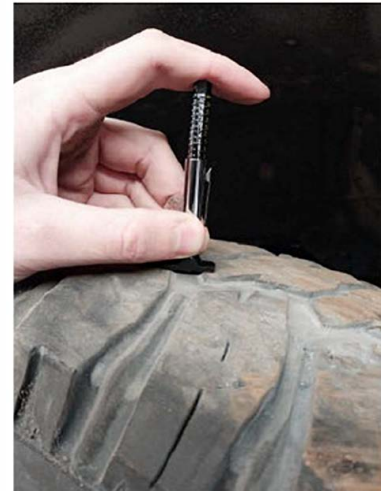
**Figure 6-4 (Tab DD-79)
Tire Tread at 1/16 in.**

(b) Analysis. The MV is equipped with four load range E Goodyear Wrangler MT tires (Tabs DD-66 to DD-78 and DD-85). The front right and rear left tire tread was exceptionally worn in comparison to the rest of the tires, but each met the minimum tread requirement of 1/16 in. (Tabs DD-79 to DD-82 and DD-85). During the mishap, the bead on the front right tire broke and a section between the wheel and bead filled with rocks (Tab S-186 and DD-85). No damage was noted prior to the mishap during the VMS courtesy check on 14 September 2024 (Tabs U-781 to U-782 and V-11.2).

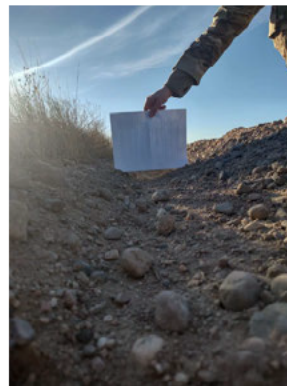
**Figure 7-4 (Tab DD-6)
Ditches – Standard 8.5” x 11” Copy Paper
6 December 2023**

The road on which the mishap occurred was level with flanking ditches approximate nine inches in depth and three ft wide (Tab DD-3 and DD-6 to DD-7). There was a leftward bend in the road with a downslope that decreases 10 ft in elevation extending west (Tabs DD-3 and DD-6 to DD-10). The United States Department of Transportation’s Federal Highway Administration (US DOT FHA) states that high shoulders and secondary ditches can create serious safety hazard (Tab BB-21).

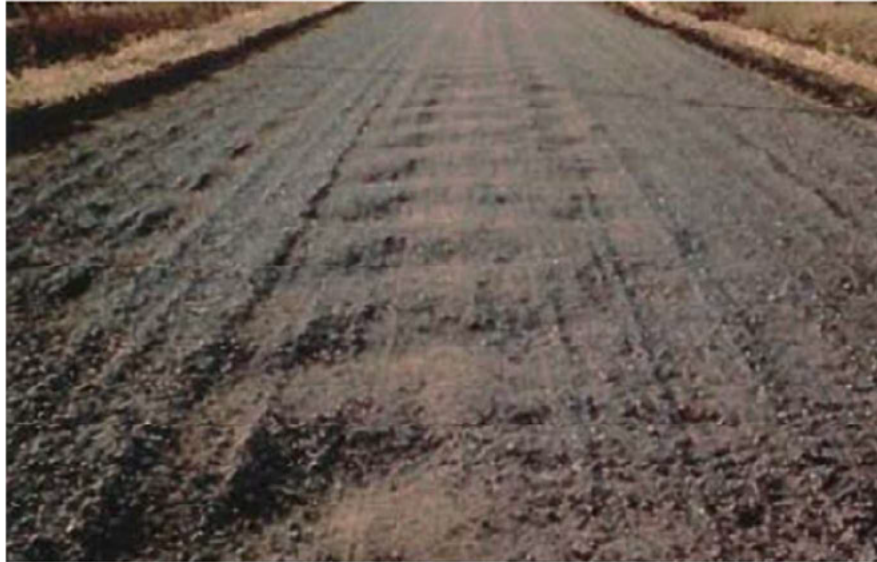
Figure 7-5 (Tab BB-22)
Example of Washboarding from US DOT FHA

The term for “washboarding” from the US DOT FHA is “corrugation,” and it is common on gravel roads and caused by lack of moisture, hard acceleration, aggressive braking, and poor-quality gravel (Tab BB-22). Severe washboarding can lead to the loss of vehicle control (Tab BB-22).

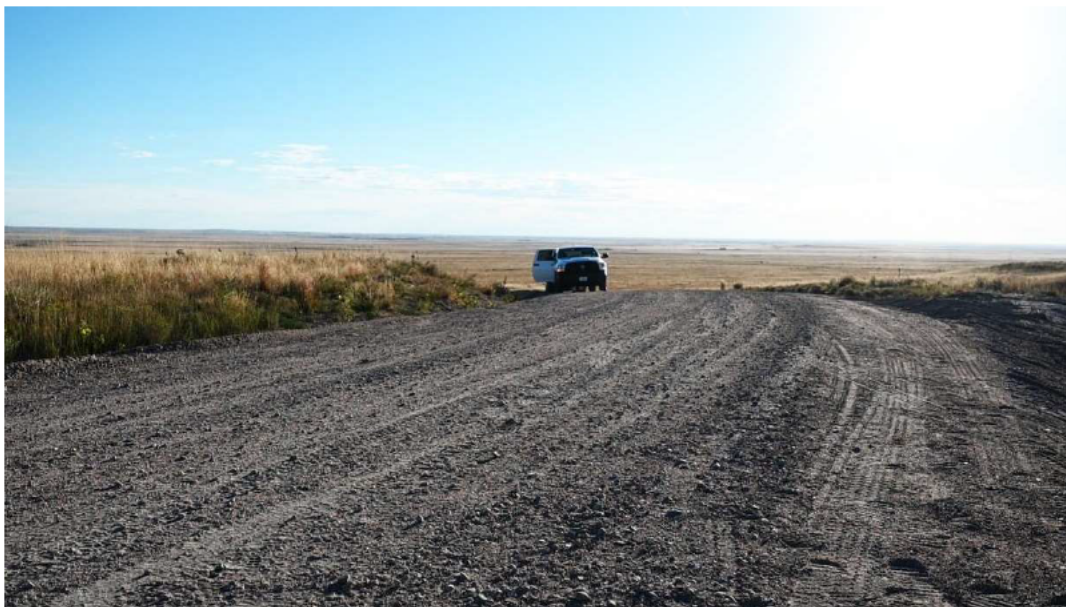
Figure 7-6 (Tab Z-2)
Mishap Site at 1459, 18 September 2023

On 16 September 2023, the roads were dry with calm winds and no precipitation. (Tabs F-6 and V-22.6). There was a minimal amount of precipitation (0.15 inches) on 15 September 2023 (Tab W-2). From 10 to 15 September 2023, there was light rain and mist observed at MS (Tab W-7 to W-12).
