UNITED STATES AIR FORCE
AIRCRAFT ACCIDENT INVESTIGATION
BOARD REPORT

KC-46, T/N 17-6028

DATE OF ACCIDENT: 21 AUGUST 2024

SUMMARY OF FACTS AND STATEMENT OF OPINION
KC-46, T/N 17-006028
TRAVIS AIR FORCE BASE, CALIFORNIA
21 AUGUST 2024

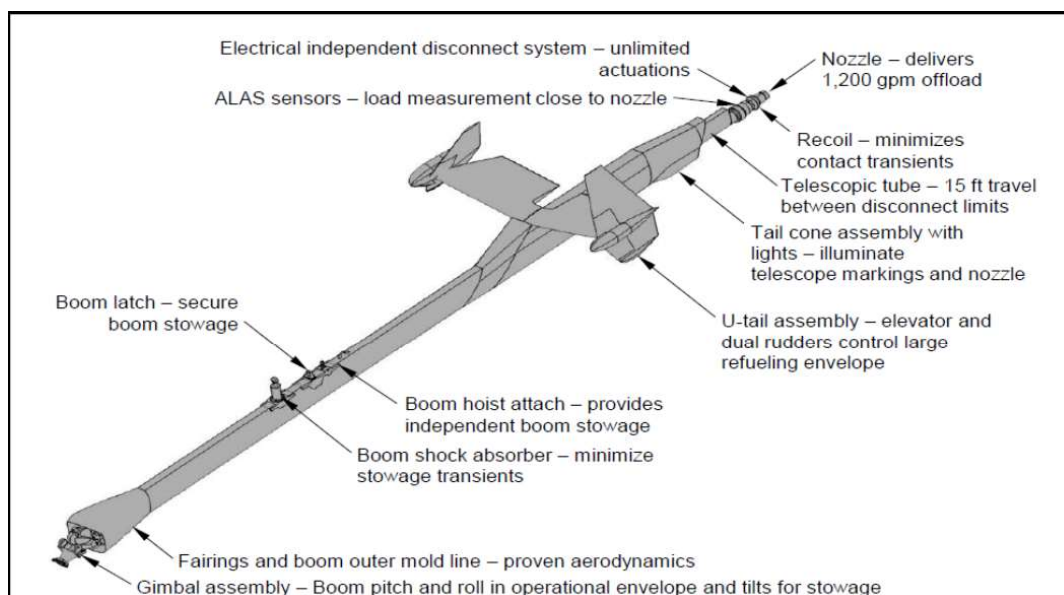
Figure 3.1 Boom Structure (Tab J-8)

Nozzle binding is defined as mechanical impedance on the boom nozzle that keeps it from free flight. This impedance occurs when the boom nozzle is stuck in the receiver's receptacle area, but the boom is not fully engaged by the toggles due to the geometric shape of the receptacle area (Tab BB-115).

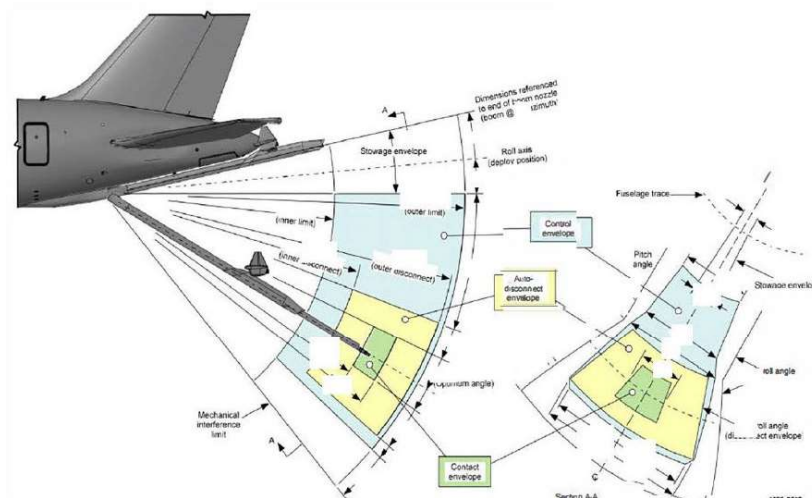
Figure 4.2 Boom Envelope (Tab J-9)

At approximately 0927L/1627Z, MA2 was cleared to contact again to obtain the last 6,500 pounds of fuel (Tab L-11). Upon approach to contact, the MBO did not recognize the receiver moving towards the limit of the boom envelope and attempted receptacle engagement outside the refueling envelope at 41.9 degrees pitch and 10.2 feet telescope length (Tab BB-5, Tab CC-5, Tab J-13). The lowest boom envelope limit is 40 degrees pitch (Tab BB-5). To achieve contact with the receptacle, the MBO was utilizing approximately full “fly down” input of the boom (Tab CC-5). At 09:27:33L/16:27:33.1Z, the boom system advanced to contact status, and immediately triggered a disconnect due to the boom being outside of the refueling envelope limit at approximately 42 degrees boom pitch (Tab CC-5). At the same time, the automated boom elevator tried to fly the boom upward to return to soft envelope limits, building the radial Z (vertical) load on the boom nozzle to -1246 lbs. (Tab CC-5).

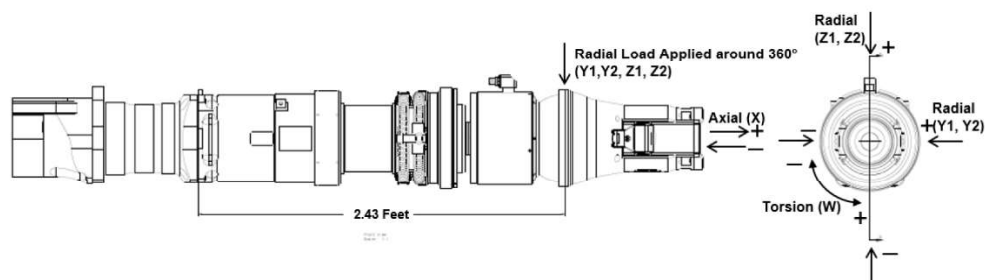
Figure 4.3 ALAS Force Convention Diagram (Tab J-9)

The MBO initially input “fly up” FCS deflection, compounding the ALAS nozzle force reduction inputs and the automated boom system fly up command to soft envelope limits (Tab CC-5). The MBO also induced axial loads of approximately 2500 lbs. as the MBO initiated telescope retraction (Tab CC-5). The boom telescope continued to be compressed as MA2 continued its forward
