United States Air Force Accident Investigation Board Report

CV-22B, T/N 17-0077
MELROSE AIR FORCE RANGE, NEW MEXICO
22 AUGUST 2023

**SUMMARY OF FACTS AND STATEMENT OF OPINION
CV-22B, T/N 17-0077
MELROSE AIR FORCE RANGE, NEW MEXICO
22 AUGUST 2023**

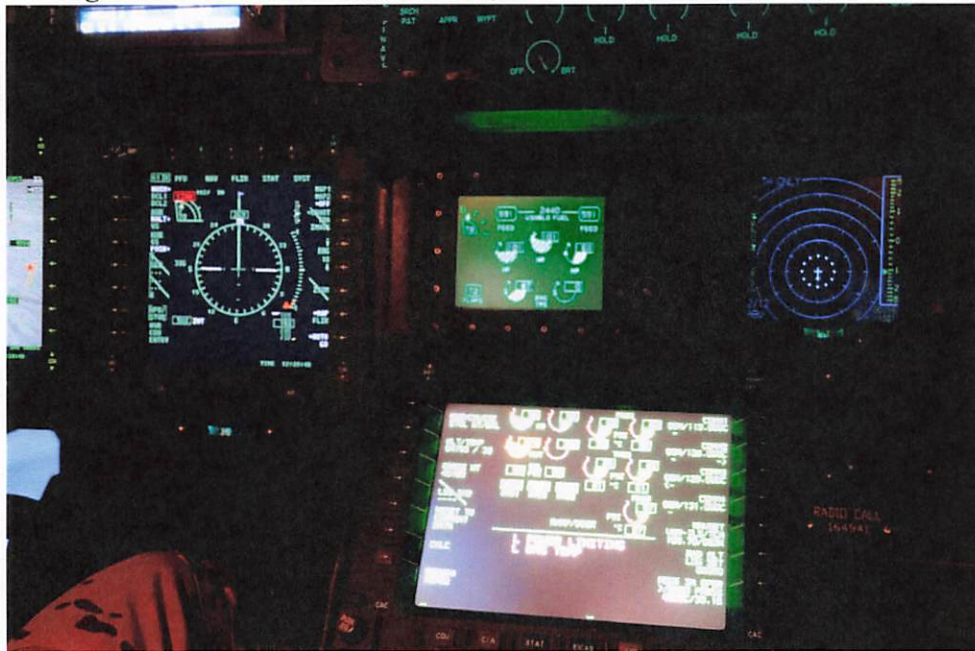
Figure 4-2. Simulator Recreation, ECL to OFF in hover (Tab Z-99)

MAC attempted to pull the nose of the aircraft up to reduce forward groundspeed at approximately 10 ft AGL (Tabs R-6.5 and FF-3). This combined with the MA entering ground effect reduced the descent rate to approximately 800 FPM just prior to the MA impacting the ground (Tab FF-3).

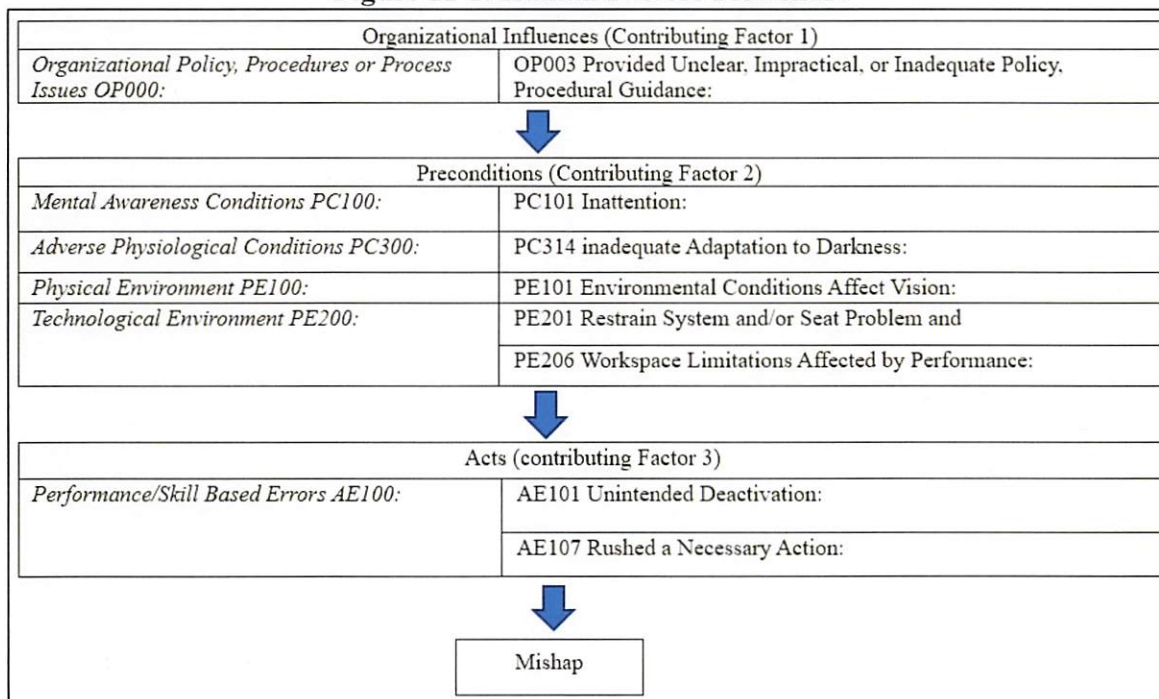
Figure 11-1. Human Factors Flowchart

There was no recorded mechanical, electrical, hydraulic, or flight control system faults during the mishap sortie for the MA (Tabs D-3 to D-10 and U-3 to U-132). The following three human factors contributed to the mishap: Organizational Influences, there is no written standard for FE movement during critical phases of flight or a standard dictating the method to secure the NVG battery pack cable to aircrew helmets used in the CV-22B; Preconditions, the MC failed to perceive unintentionally pulling the right ECL off in the dark as a threat as there were no documented events in the past; Acts, due to performance and judgement errors, MFE1 unintentionally deactivated the right ECL while he was getting into the seat during a critical phase of flight (Tabs Z-89 to Z-93, AA-107 to AA-108, AA-575 to AA-654, and DD-65 to DD-84).

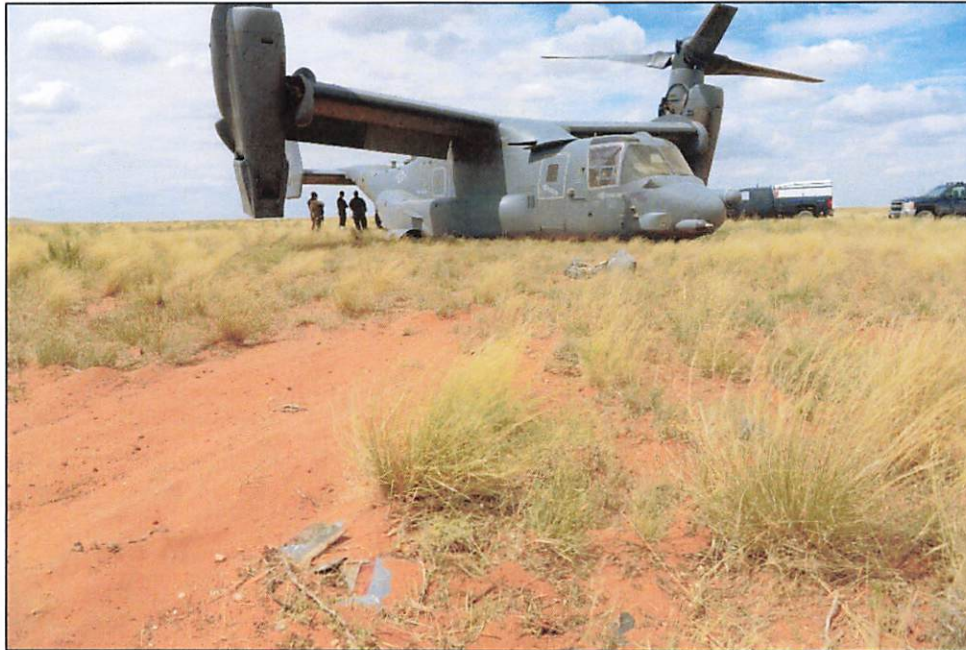
Figure 1-2. CV-22B, T/N 17-0077 Crash Site

The MC were accomplishing a local training sortie to complete a flight evaluation for MFE2, aerial gunnery recurrency for MFE1, and supporting Joint Tactical Air Controllers (JTACs) during an exercise on MAFR. The MC departed Cannon AFB, inserted the JTACS at Viper helicopter landing zone (HLZ), completed simulated alternate insertion/extraction (AIE) training at Corvette HLZ, and then proceeded to Jockey. The MA came to a hover at 150 feet (ft) above ground level (AGL) on the west edge of Jockey while MFE1, MFE2, and MFE3 completed night vision goggle (NVG) aerial gunnery training. After shooting, MFE1 began transitioning back into the Flight Engineer (FE) seat in the cockpit between the MAC and MCP. While doing so, the loop of MFE1's NVG battery cable caught on the right engine control lever (ECL), pulled the ECL from the FLY position to the OFF position, and shut off the right engine. Simultaneously, the MA began a transition from hover to forward flight and the aircraft experienced a loss of lift and received a sink rate warning. The aircraft descended from 190 ft AGL at a rate approaching 1,500 ft per minute (FPM) and impacted the ground with the landing gear up 100 meters west of Jockey. The MA bounced then skidded to a stop (figure 1-2). The MA traveled approximately 360 ft from the first point of impact to the final resting point. The MC performed an emergency shutdown and egressed the MA.

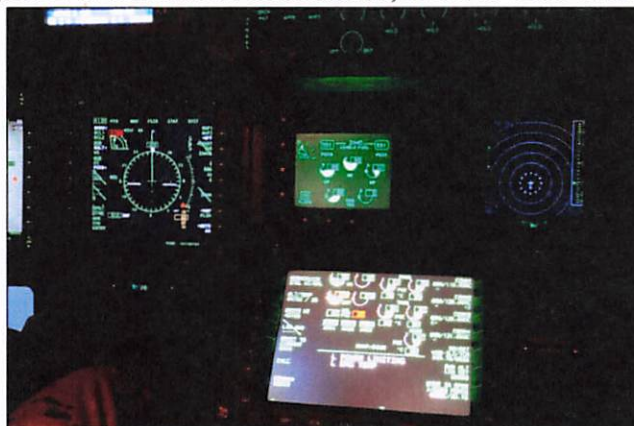
Figure 2-6. Simulator Recreation, ECL to OFF in Hover

The AIB pilot member ran multiple simulations in a CV-22 WST recreating the accident (Figure 2-6). Had the ECL been returned to the FLY position at any time prior to impact, it alone would not have prevented the mishap. Engine restart time requirements and limitations would have prevented the engine from providing useful power until the MA was already unrecoverable. The only variables that the AIB found that would have prevented impact with the ground were to begin at a higher altitude AGL, a higher forward airspeed, or have a headwind component of at least 10 knots.
