**UNITED STATES AIR FORCE**  
**AIRCRAFT ACCIDENT INVESTIGATION**  
**BOARD REPORT**

**KC-46A, T/N 18-6054**

**LOCATION: FAIRBANKS INTERNATIONAL AIRPORT, ALASKA**

**DATE OF ACCIDENT: 16 JULY 2025**

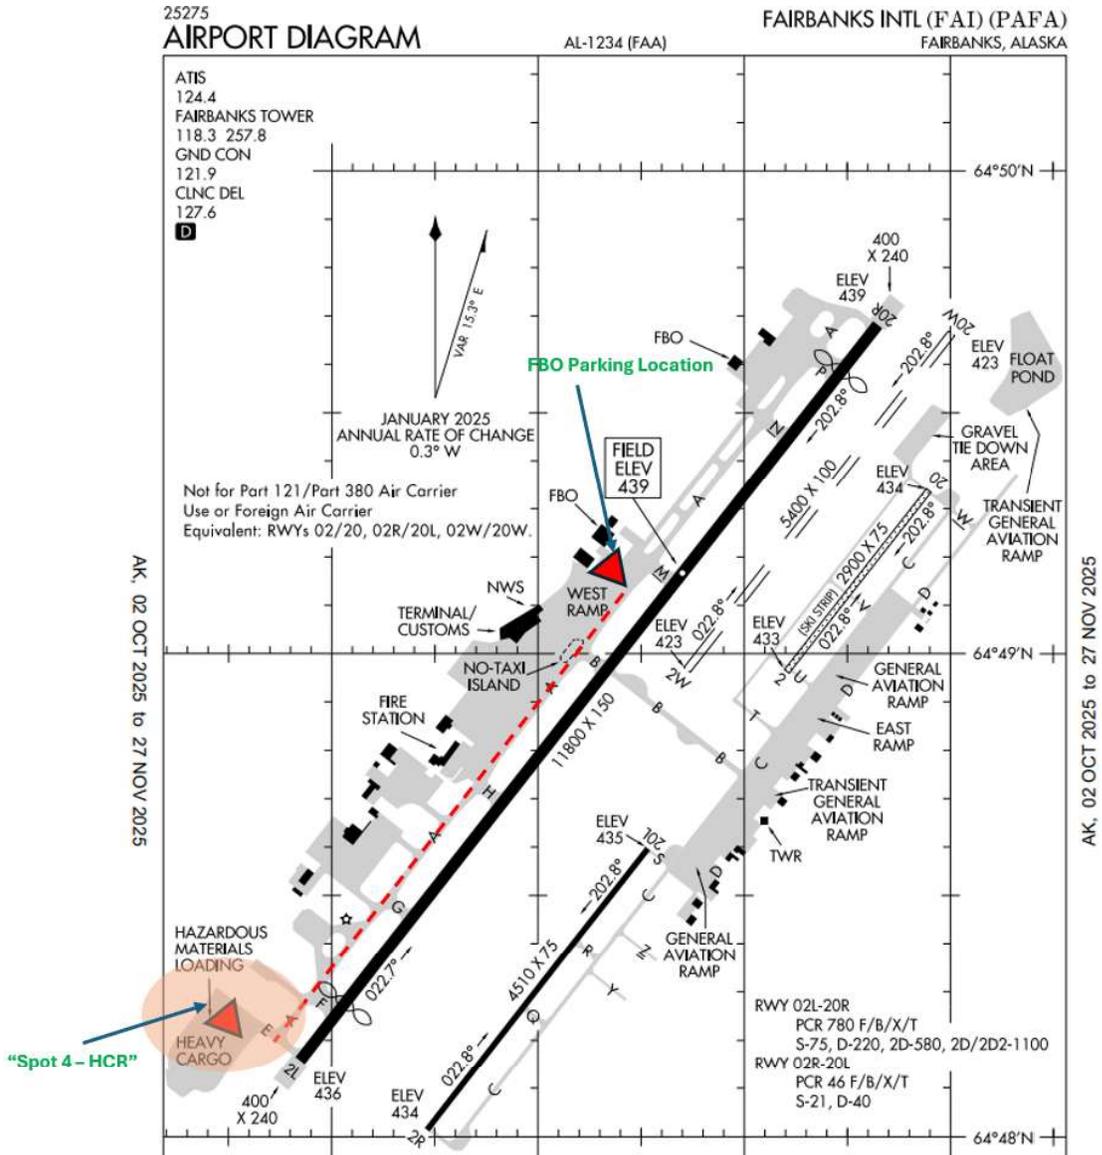
Figure 1: MA's Parking Location(s)

On 15 July 2025, after consultation with the support agency responsible for aircraft parking, towing and logistics (also known as the Fixed-Base Operator (FBO)), the MA was towed to the Heavy Cargo Ramp (HCR) and positioned in “Spot 4” (Tabs V-2.3 and Z-3).

engine propulsion specialists (EPS1, EPS2), and one aircraft structural maintainer (ASM) (Tabs V-1.5, V-2.2, V-4.1, V-4.2, and V-5.1). They were assisted by the aircraft's flying crew chief (FCC1) who was responsible for aircraft ground movement, preflight inspections, and general aircraft maintenance and logistics (Tab AA-6). At approximately 1000L, the MRT began the process of balancing the engines (Tab R-5). The process included EPS1 running the engines above idle power and to a high-power setting of approximately 1.40 engine pressure ratio (EPR) (Tabs R-3 and BB-154). While increasing the thrust, EPS2 was located behind EPS1 and monitored the computer readings to identify the correct balancing solution (Tabs V-5.2 and V-5.3). This balancing process was required for each engine, and throughout the HPER sequence EPS1 increased both engines simultaneously (Tab V-5.4). At approximately 1800L, during the tenth HPER of the day, two asphalt blocks, approximately 25 feet long by 25 feet wide, directly behind the right engine lifted into the air and landed behind the MA (Tabs R-3 and Z-4). Upon landing, the blocks broke into smaller debris which spread across the parking apron and onto the MA (Figure 1) (Tabs Z-3 and Z-4).

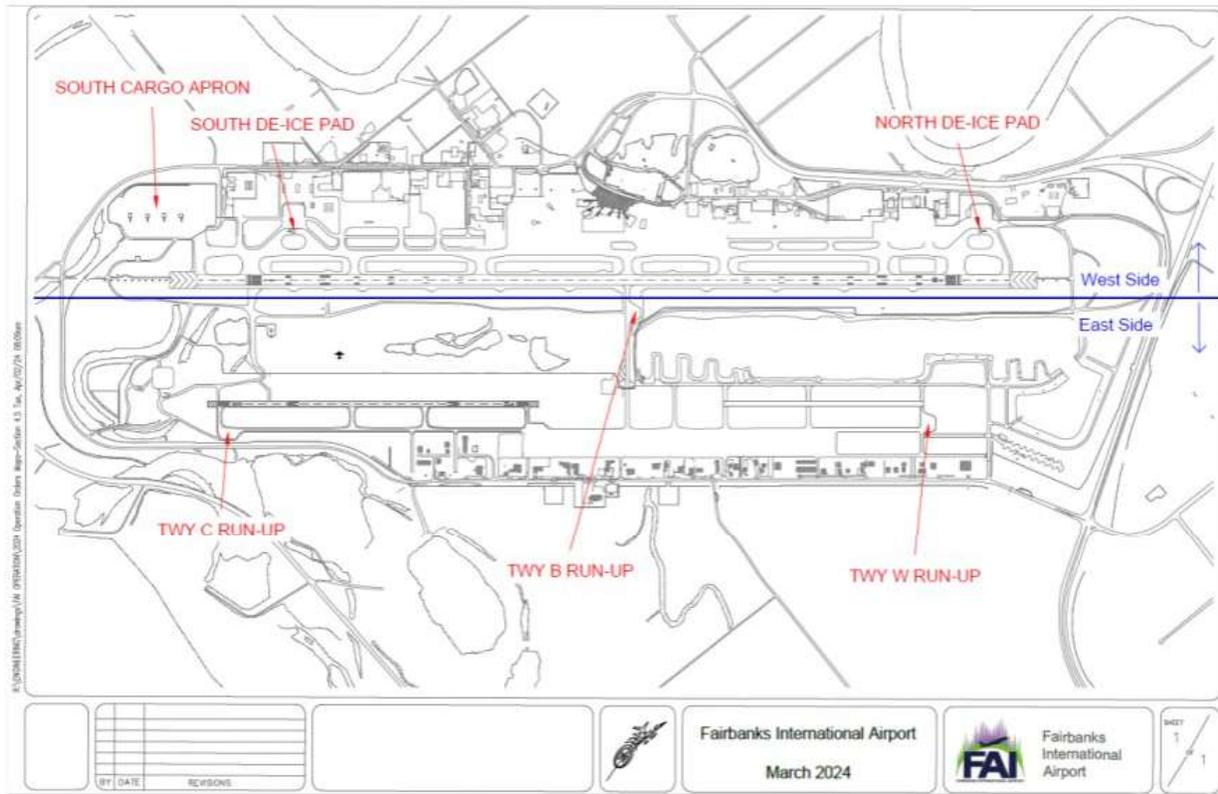
**Figure 4: Alaska DOT Operations Order Depicting Engine Run-up Locations**

To complete the required engine maintenance, FCC1, FCC2 and airport ground personnel towed the MA from the FBO parking area to the HCR (illustrated as the “south cargo apron” in Figure 4 (Tab Z-6). According to interviews, FCC1, FCC2, and the MRT communicated to the AGM that high power settings were to be utilized during the engine run process (Tab V-9.2). Additionally, they informed the AGM that they would have to complete multiple engine runs, and each would last approximately fifteen to twenty minutes in duration (Tab V-9.2).

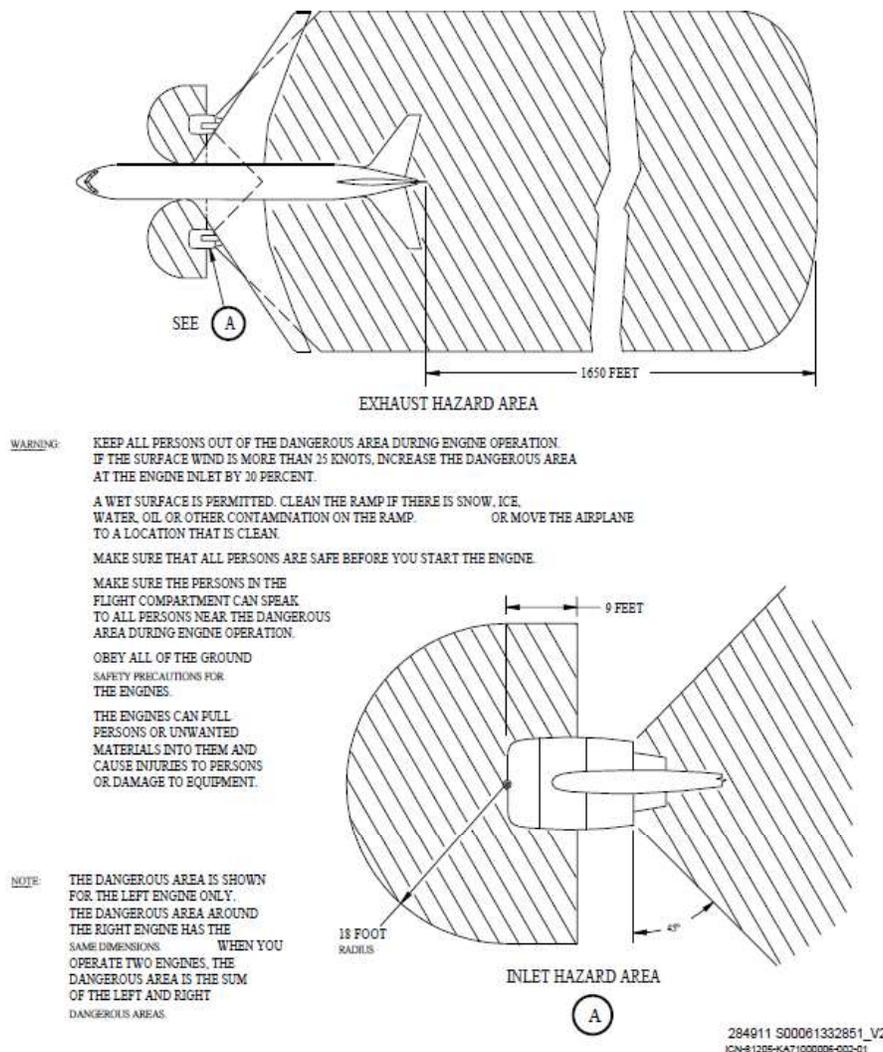
**Figure 7: Inlet and Exhaust Engine Danger Area at Takeoff Rated Thrust**

The KC-46A has two Pratt & Whitney PW4062/F139 High-Bypass engines capable of 62,000 pounds of takeoff thrust each, allowing for a maximum takeoff weight of 415,000 pounds and has a fuel capacity of 212,299 pounds (Tab CC-17). These engines provide enough power and fuel efficiency to the aircraft to fly a distance of 7,350 miles without aerial refueling at maximum speed of 637 mile per hour. (Tab CC-17).
