UNITED STATES AIR FORCE
AIRCRAFT ACCIDENT INVESTIGATION
BOARD REPORT

TH-1H, T/N 74-22313

LOCATION: SKELLY STAGEFIELD ARMY HELIPORT

DATE OF ACCIDENT: 3 APRIL 2024

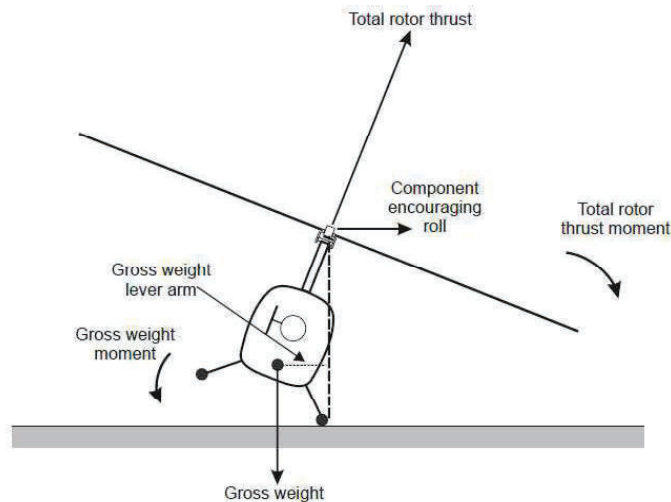
If the helicopter has one skid on the ground and there is horizontal thrust, the helicopter will begin to roll and pivot around the skid on the ground. (Tab O-7). If the thrust component is greater than the weight of the helicopter, then the rolling motion can pass a critical angle and the helicopter will roll over. (Tab O-7). This is referred to as dynamic rollover. (Tab O-7). When a rolling motion starts and the cyclic cannot stop the roll, the pilot must lower the collective smoothly to place both skids on the ground again. (Tab O-7).

Beginning of dynamic rollover (Tab O-7)

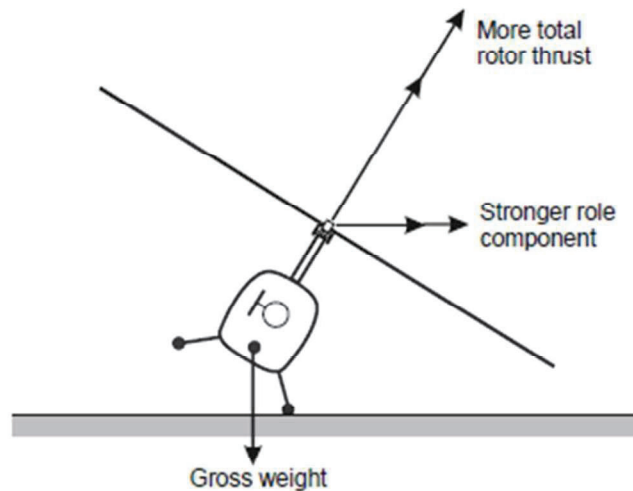
Increasing collective may increase risk of rollover (Tab O-8)

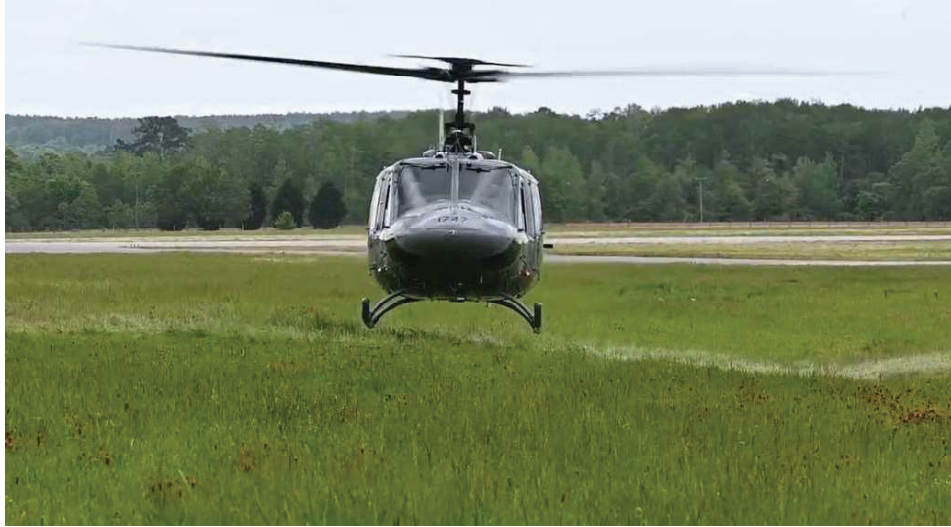
TH-1H helicopter performing slope work near mishap site (Tab S-9)

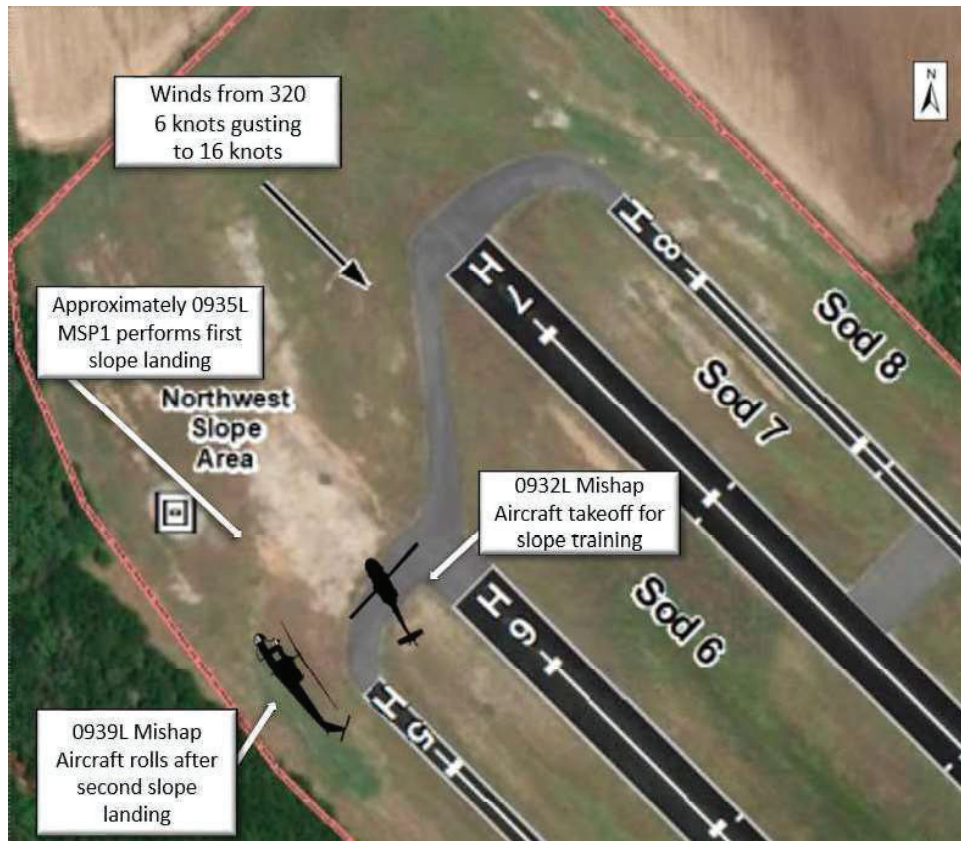
At approximately 0939L, MSP1 initiated takeoff by inputting right cyclic and slowly increasing the collective resulting in the left skid rising from ground. (Tabs R-4, R-18, V-2.9 and V-2.11). As MA rolled right, MSP1 perceived the MA as level when it was actually in a two-to-five-degree right bank. (Tabs V-2.11 and V-3.5). Once the left skid was off the ground, MSP1 misperceived the aircraft to be in a left slide and increased right cyclic to counter, resulting in a six-to-ten-degree right bank. (Tabs R-60, V-2.11 and V-3.5). As the MA rotated beyond a level attitude, the MIP put his right hand on the cyclic, said “No, no, no...”, the only corroborated verbal input from the MS, and applied left cyclic input while making no input to the collective. (Tabs R-4, R-8, and R-18). MIP’s left cyclic input was insufficient to counter the right roll due to MSP1 countering with right cyclic. (Tabs V-1.9 and V-2.17). MSP1 perceived the slide was halted and MA was level, then increased the collective to lift off when the MA was actually in a six-to-ten-degree right bank with the right skid on the ground and the left elevated. (Tabs R-60, V-2.16, and V-3.5). The MA rolled to the right and the main rotor blade contacted the ground. (Tabs R-53, R-62 and R-93 to R-94). The time from lift off to rollover was approximately three to five seconds. (Tabs V-1.12, V-2.17, V-3.7 and V-4.6).

Timeline of MS (Tab S-17)
