**UNITED STATES AIR FORCE**  
**AIRCRAFT ACCIDENT INVESTIGATION**  
**BOARD REPORT**

**CV-22B, T/N 11-0060**

**20TH SPECIAL OPERATIONS SQUADRON  
27TH SPECIAL OPERATIONS WING  
CANNON AIR FORCE BASE, NEW MEXICO**

**DATE OF ACCIDENT: 20 NOVEMBER 2024**

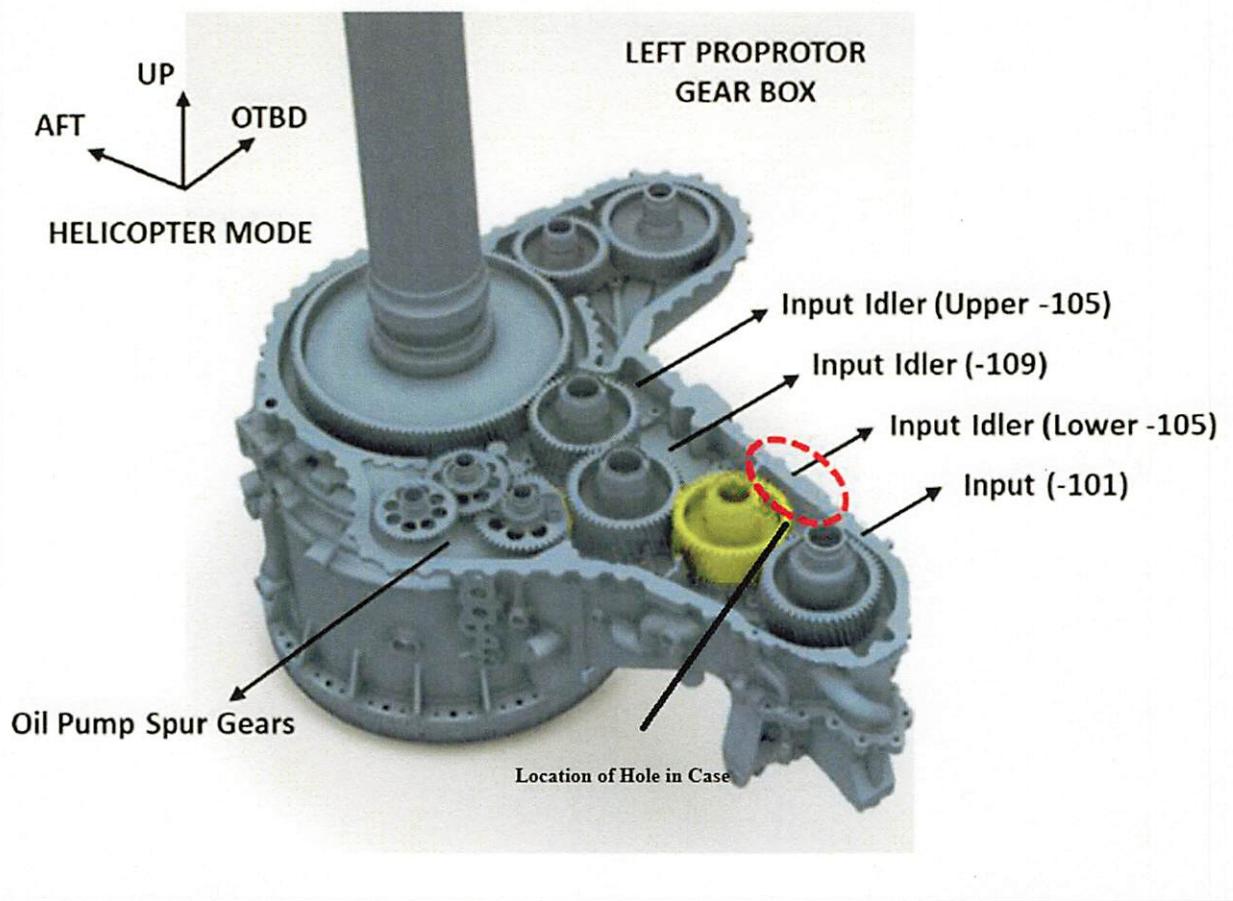
Figure 6-1. Diagram of LH PRGB (Tab J-36)

The MA's LH PRGB and IQA were removed and sent to Fleet Readiness Center (FRC) East for engineering investigation by the Fleet Support Team (FST) (Tab J-33 to J-65). The engineering investigation determined the following: The LH engine failure and LH PRGB chip indications that caused an EL to be executed for CV-22B T/N 11-0060 on 20 November 2024, were the result of a failure initiated at a material inclusion in the Lower Input Idler Helical Gear, P/N 901-044-105-101, S/N VL00205587, within LH PRGB S/N A-101 (Tab J-59).

Upon investigation of the LH PRGB, the following damage was identified (Tab J-39 to J-49). A hole in the LH PRGB case measuring approximately 12 inches by 6 inches on the outboard side of the helical section (Tab J-39). The PRGB cover internal surfaces exhibited significant damage and material loss in the vicinity of the failed -105 Lower Input Idler Helical Gear (Tab J-43). The shroud that covers the input helical gears was bent and mangled (Tab J-43). An 8-tooth piece of the -105 Lower Input Idler Helical Gear was found in the LH center body inlet assembly. (Tab J-40). The remaining 43-tooth section of the -105 Lower Input Idler Helical Gear was deformed into a "J" shape and wedged in the hole in the helical section of the PRGB (Tab J-39). The -105 Upper Input Idler Helical Gear exhibited minor tooth damage and evidence of debris processing (Tab J-48). The -109 Input Idler Helical Gear exhibited significant tooth damage, chipping, cracking, and material loss (Tab J-45). All four primary oil lubrication jets adjacent to the failed -105 Upper Input Idler Helical Gear exhibit damage (Tab J-43). Evidence of milling damage and material loss on the internal LH PRGB case under the bore of the Oil Pump Drive Roller Bearing was found (Tab J-43). The -101 Input Helical Gear exhibited minor tooth damage and chipping (Tab J-47). The -113 Bull Gear exhibits minor evidence of debris processing (Tab J-48). The Oil Pump Drive Spur and Helical Gear exhibited evidence of grinding/milling and material loss (Tab J-49).

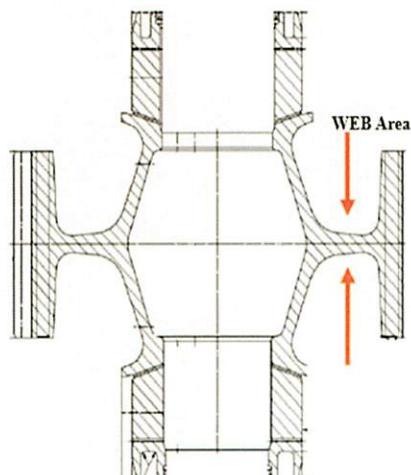
**Figure 6-18. Diagram of -105 Input Idler Helical Gear Web and Rim (Tab J-142)**

Fracture analysis of the failed -105 Input Idler Helical Gear pieces identified multiple locations with evidence of fatigue crack origination (Tab J-52). Analysis revealed one fatigue origination on the 43-tooth segment web to rim interface with corresponding evidence of fatigue on the gear shaft segment at the associated location (Tab J-52). This was determined to be the primary crack initiation site (Tab J-52). The crack propagated from the origin circumferentially both clockwise and counterclockwise around the gear (Tab J-52). A segment of the gear shaft was sectioned by FRC East to have the fatigue origin evaluated under Scanning Electron Microscope (SEM) (Tab J-54). The SEM chemical analysis identified the presence of a non-metallic inclusion consisting of aluminum, calcium, and oxygen measuring 0.055 inches long by 0.011 inches wide (Tab J-54). A material certification and process review of the raw material supplier for the failed -105 gear determined the X-53 bar stock conformed to all material specifications at the time of production and inspection (Tab J-59).
