UNITED STATES AIR FORCE
AIRCRAFT ACCIDENT INVESTIGATION
BOARD REPORT

MC-130H T/N 88-0194
SPECIAL TACTICS PARACHUTE MISHAP
23D SPECIAL TACTICS SQUADRON
24TH SPECIAL OPERATIONS WING
HURLBURT FIELD, FLORIDA

DATE OF ACCIDENT: 5 NOVEMBER 2019
BOARD PRESIDENT: MAJOR GENERAL L. KIP CLARK
Conducted IAW Air Force Instruction 51-307

**MC-130H T/N 88-0194
SPECIAL TACTICS PARACHUTE MISHAP
HURLBURT FIELD, FL
5 NOVEMBER 2019**

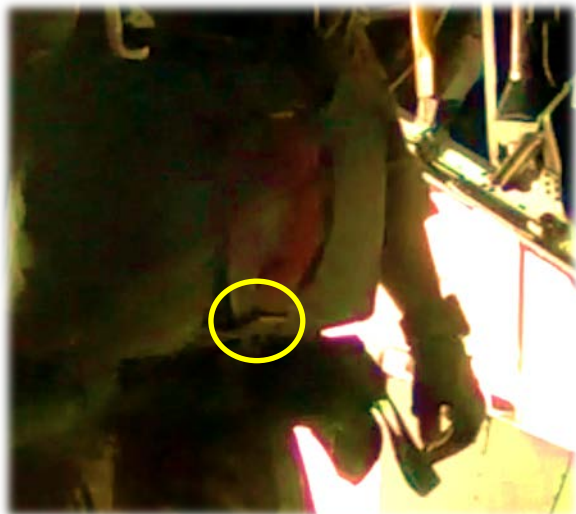
Figure 6. MJM first sortie (boarding aircraft)
(Tab Z-73)

After the participants donned their equipment, the teams reported to a designated STTS cadre member to receive a JMPI (Tabs V-35.3 and CC-168). JMPII conducted the official JMPI on the MJM (Tab V-35.8). He did not place the T-11R tuck tab inserts in the tuck tab pockets (Tab V-35.7 and V-35.11). According to JMPII, the MJM would have inserted his T-11R inserts after his JMPI (Tab V-35.10). Figures 6 and 7 show that the base of the yellow tab on the MJM's top and bottom tuck tab inserts was not flush with the green pockets on his T-11R parachute ripcord assembly before and after MJM's first jump (Tab Z-11 and Z-73). Additionally, Figure 7 shows that the MJM's T-11R parachute has enough loose material on his left side tuck tab so that a second seam was visible after his first jump (Tab Z-11).

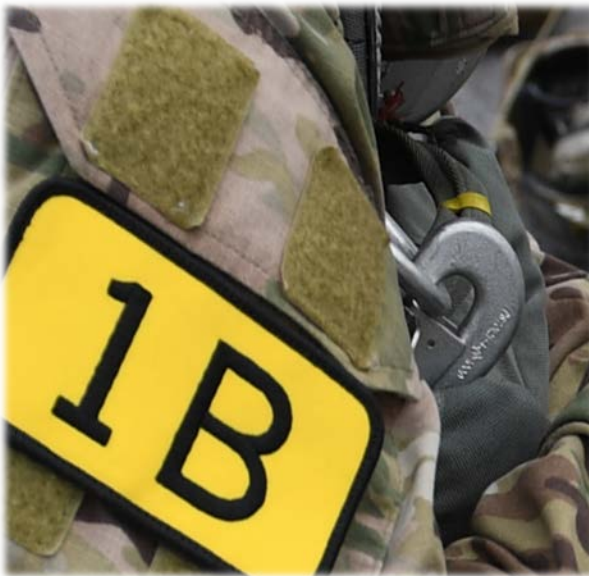
Figure 8. AJM/1B (pre-flight) yellow binding tape on T-11R (Tab Z-74)

AJM/G stated he and the PJM/S did not review the AFMAN 11-420 in preparation for the ST Rodeo (Tab V-20.16). Photographic evidence of the first sortie shows that the PJM/S allowed AJMs to perform duties in the door with T-11R inserts not fully seated or not present at all (Tab Z-73 to Z-74).

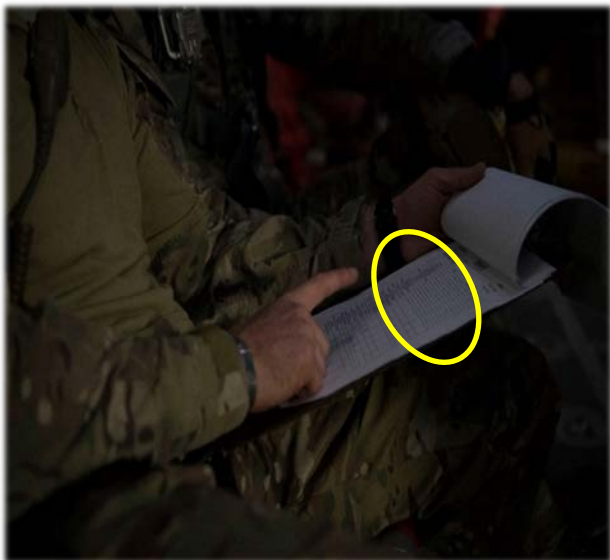
Following the mishap, the AJM/G’s PWAC grade sheets were lost and not available for review, but a photo in the aircraft shows the AJM/G filling out a sheet (Tabs V-20.14 and Z-75). The AJM/G testified that he was not familiar with any actions required by the PJM/S at the command “safety, control my static-line” (Tab V-20.21). The grade sheet in the photo shows no grade marks by the “safety control my static-line” line item (Tab Z-75). Evidence shows the PJM/S accepting an AJM’s static-line while the AJM had a T-11R bottom tuck tab so loose that light was visible underneath it (Tab Z-75).

Figure 10. AJM/G PWAC command “safety control my static-line” on the sheet but not graded (Tab Z-75)

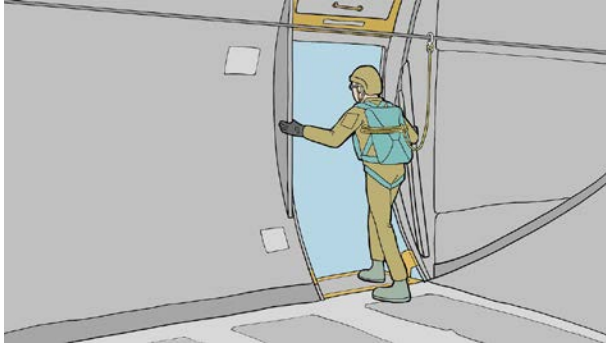
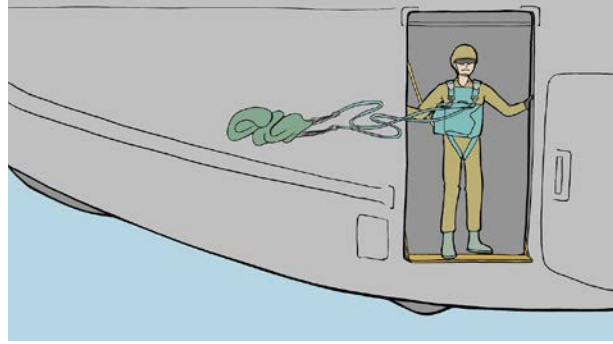
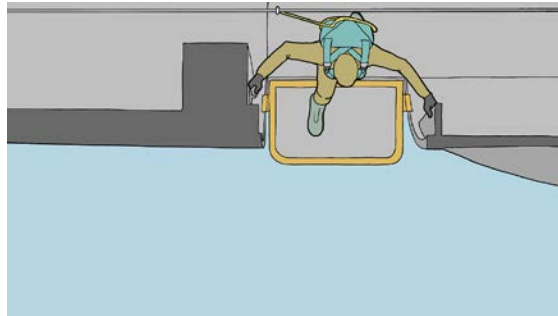
Figure 13:

The 23PJ1, PJM/S, and AJM/G provided specific details on the MJM's extraction from the aircraft (Tab V-18.3, V-20.3, and V-33.3). These witnesses were positioned within three to twelve feet from the MJM, and offered different vantage points: the 23PJ1 was four feet from the MJM's left, the AJM/G was approximately 12 feet behind the MJM, and the PJM/S was three feet from the MJM's right (Tabs V-20.4 to V-20.5, V-33.3, and Z-76). The MJM was generally midway in the doorframe and slightly interior to the aircraft (Tab V-18.3, V-18.16 to V-18.17, V-20.5, and V-33.3). The MJM maintained a forward-leaning stance, with both hands gripped onto the doorframe (Tab V-18.16 to V-18.17, V-33.3, and V-33.6).

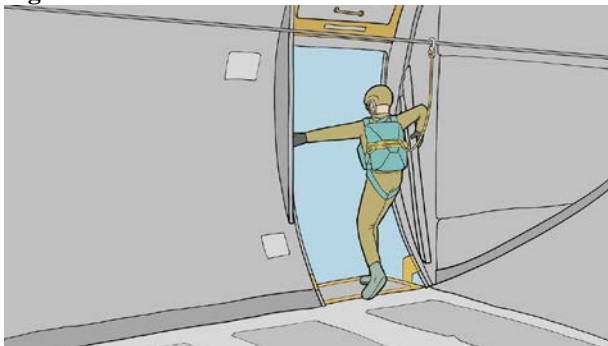
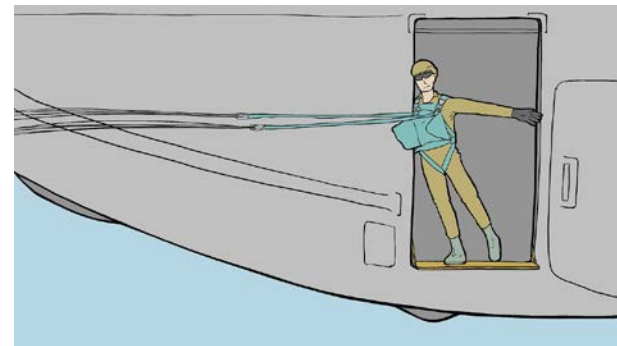
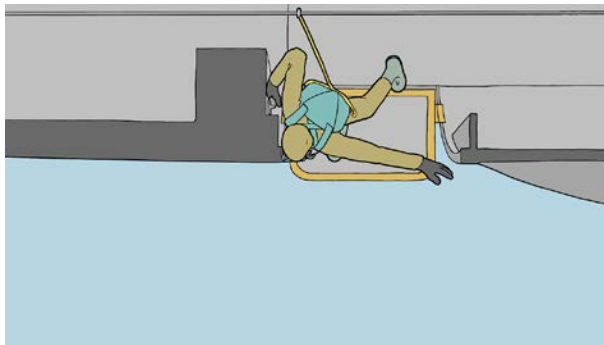
Figure 15:

The 23PJ1, PJM/S, and AJM/G observed the MJM rotate around the aft doorframe and out of the MA (Tab V-18.3, V-18.16 to V-18.17, V-18.20, V-20.29, V-33.3, V-33.7, V-33.14, and V-33.16 to V-33.17).

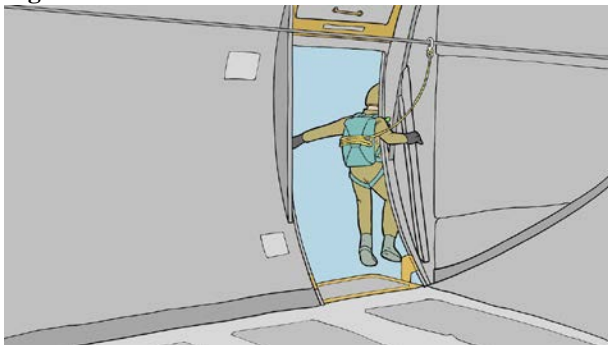
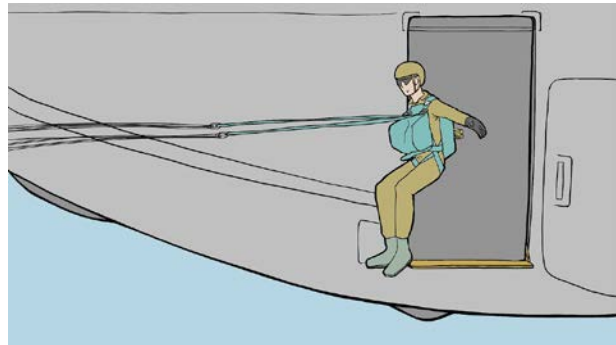
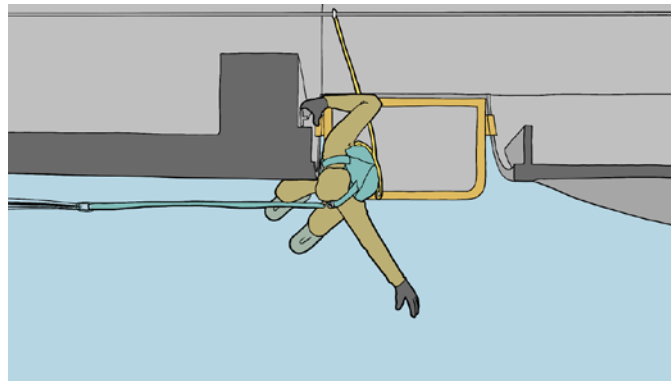
Figure 16:

As the MJM's hips and torso completed their rotation out of the aircraft, his legs began to arc upwards (Tab V-18.20, V-33.3, V-33.8, and V-33.14 to V-33.17).

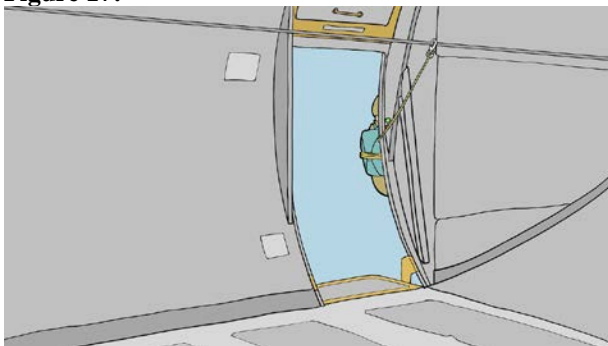
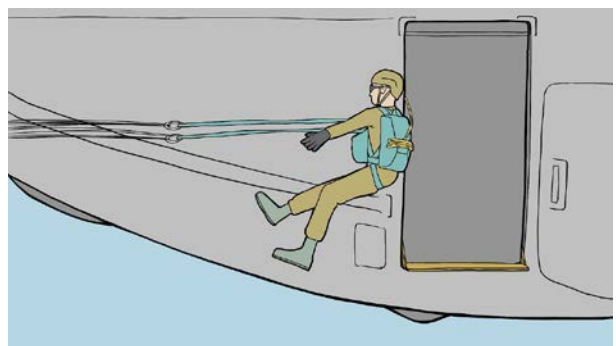
Figure 17:

Once out of the MA, the MJM's was roughly horizontal with a slight bent at the waist (Tab V-33.3, V-33.8, and V-33.16 to V-33.17).

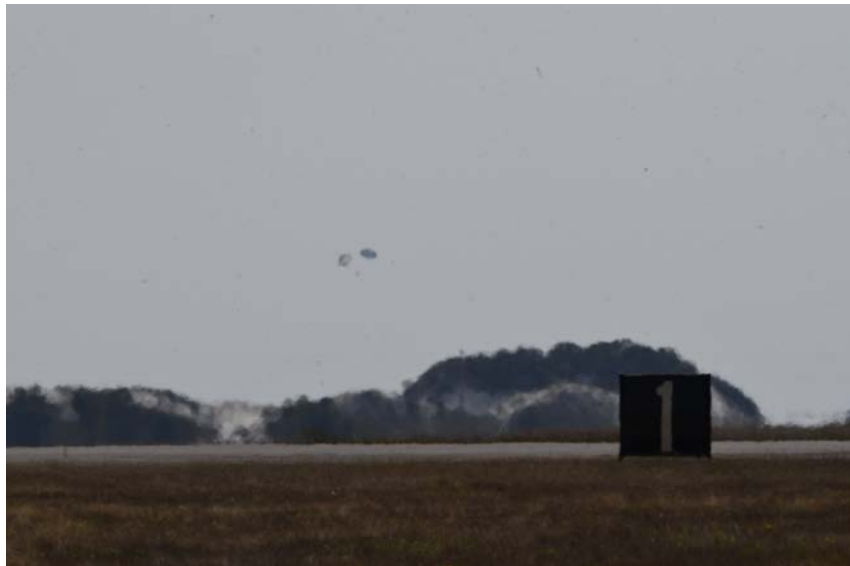
Figure 20. Photo from Air Commando DZ showing MJM under two parachute canopies (Tab Z-71)
