**UNITED STATES AIR FORCE**  
**AIRCRAFT ACCIDENT INVESTIGATION**  
**BOARD REPORT**

**F-16CM, T/N 94-0043**

**77TH FIGHTER SQUADRON  
20TH FIGHTER WING  
SHAW AIR FORCE BASE, SOUTH CAROLINA**

**DATE OF ACCIDENT: 30 June 2020**

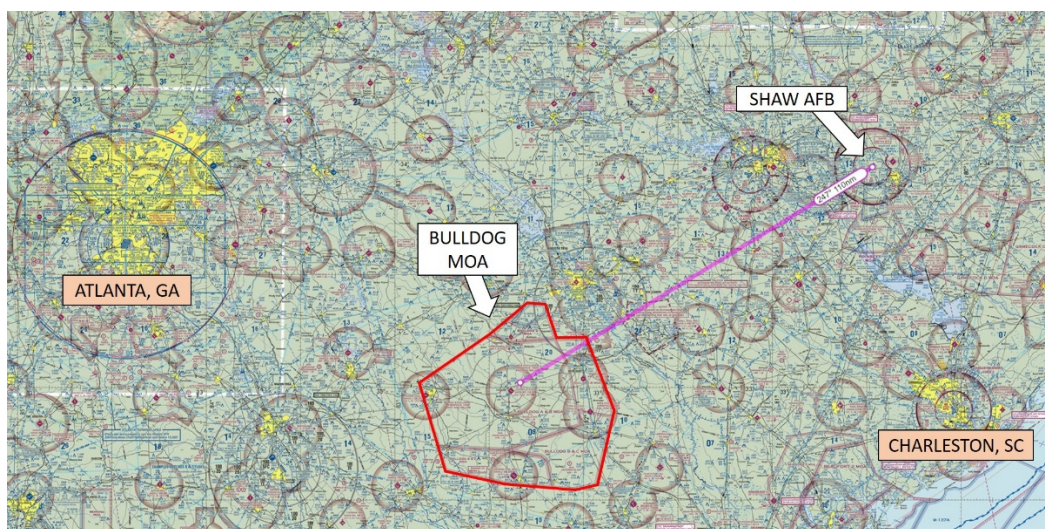
Figure 1: Mishap Flight Operating Area (Tab Z-8)

The mission was an MQT sortie planned to take off from Shaw AFB, fly to the Bulldog Military Operating Area (MOA) approximately 110 nautical miles (nm) southwest of Shaw AFB, execute air-to-air refueling (AAR) with a KC-135 Stratotanker, conduct Suppression of Enemy Air Defenses (SEAD) training, and return to Shaw AFB (Tabs K-3, Z-8, and FF-6). Due to the MP's inability to AAR, he was unable to perform SEAD training, which was the primary training focus of the mission (Tab AA-29 and AA-31).

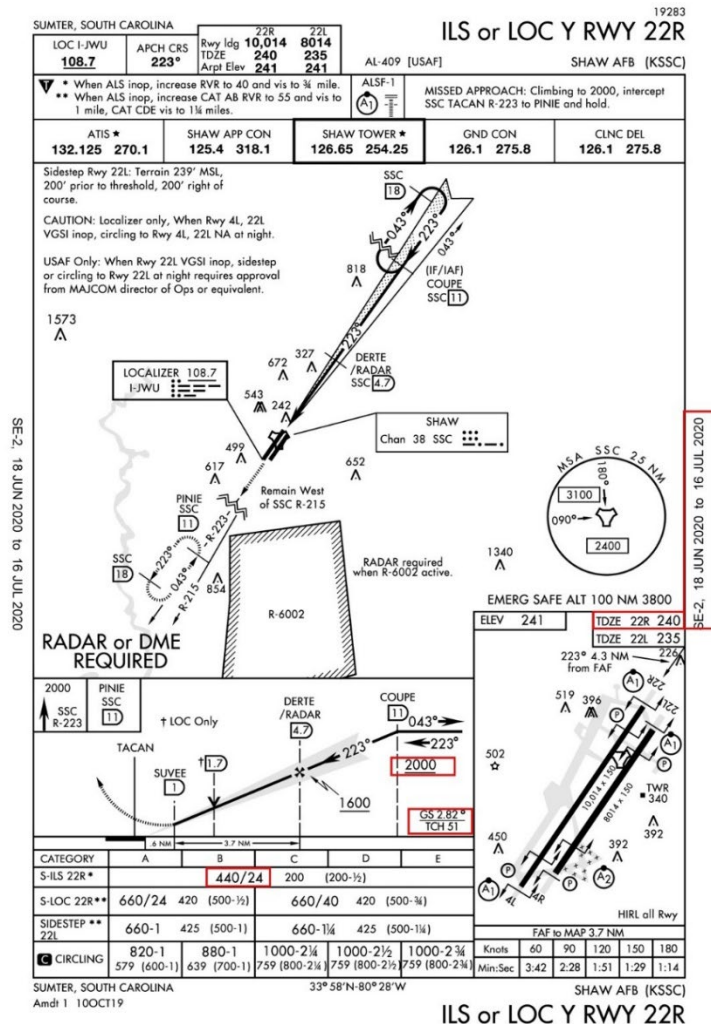
Figure 2: ILS Y 22R procedure (Tab AA-72)

Shaw AFB is equipped with an Instrument Landing System (ILS) approach to runways 22R and 04L (Tab AA-72). An ILS consists of two electronic beams which work together to steer approaching aircraft to the runway through clouds and other weather (Tabs BB-130 to BB-131 and CC-15). The localizer beam guides aircraft laterally along the runway extended centerline, and the glideslope beam guides aircraft vertically to a point approximately 1,000 feet beyond the runway threshold (Tabs AA-72, BB-131, and CC-15). The localizer also broadcasts a specific Morse code signal which aircraft can listen to in order to confirm the system is functioning and they are receiving the signal properly (Tabs AA-72, BB-130, and CC-15). On the night of the mishap, the runway 22R ILS components were operating normally with no faults detected, reported, or logged, and the MP successfully tuned, identified, and monitored the ILS signal (Tabs V-2.2 and FF-3). The final approach portion of the ILS to runway 22R begins 4.3 nm from the end of the runway (Tab AA-72). At that point, the procedure directs a 2.82-degree descent until transitioning to the runway visual environment for landing or arriving at the Decision Altitude (DA) of 440 feet MSL (Tab AA-72).

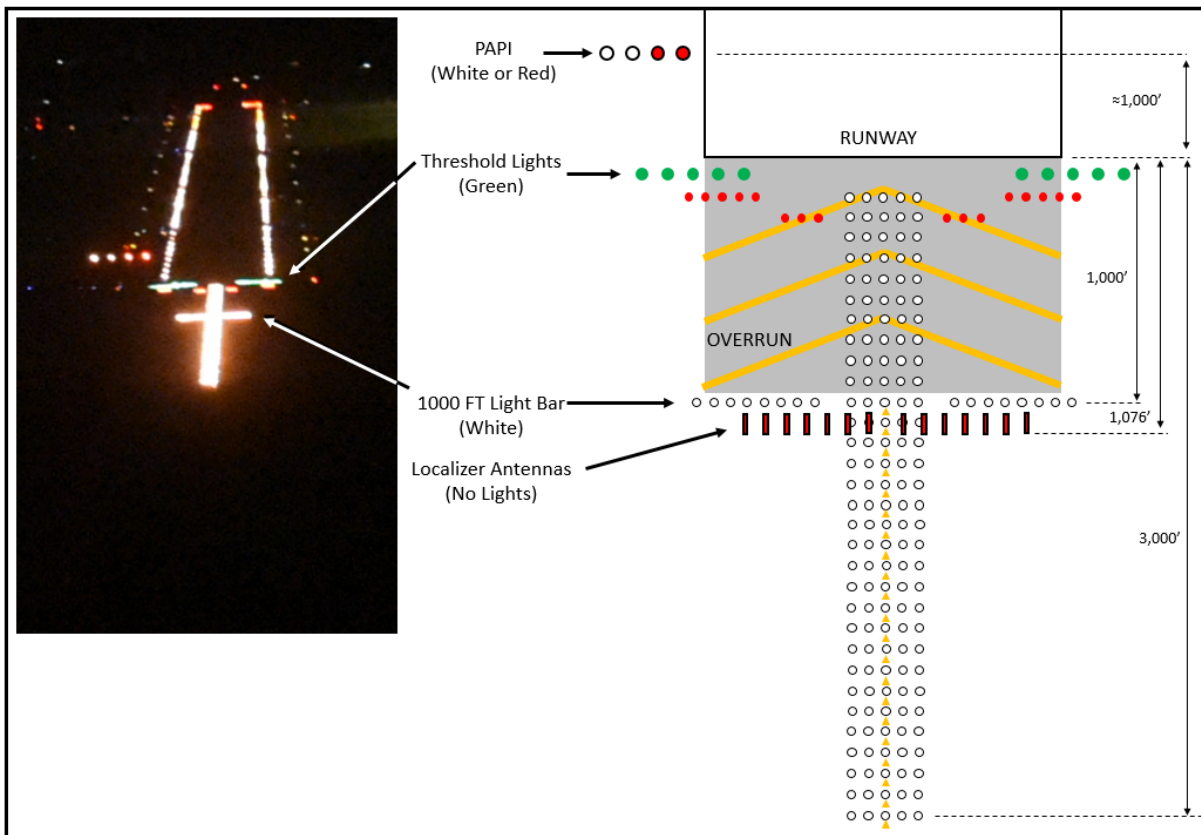
Figure 3: Runway 22R Approach-End Lighting Environment (Tab Z-4)

Runway 22R at Shaw AFB is equipped with a precision approach path indicator (PAPI) and an approach lighting system (ALS) with sequenced flashing lights 1 (ALSF-1) (Tab AA-72). Along with other lighting elements, this system includes a line of green lights along the threshold of the runway (Threshold Lights) and a line of white lights oriented the same direction, approximately

1,000 feet prior to the threshold (1000 FT Light Bar), see figure 3 (Tab Z-4). On runway 22R, there is an array of localizer antennas approximately 82 inches tall located 76 feet in front of the 1000 FT Light Bar (1,076 feet before the runway threshold) (Tabs V-2.3, Z-5, and FF-5). All runway lights were in good working order on the night of the mishap, they were inspected one hour prior to the mishap, and there were no pilot requests to change ALS intensity settings (Tabs V-7.6 to V-7.7, V-13.3, V-13.6, and AA-70).

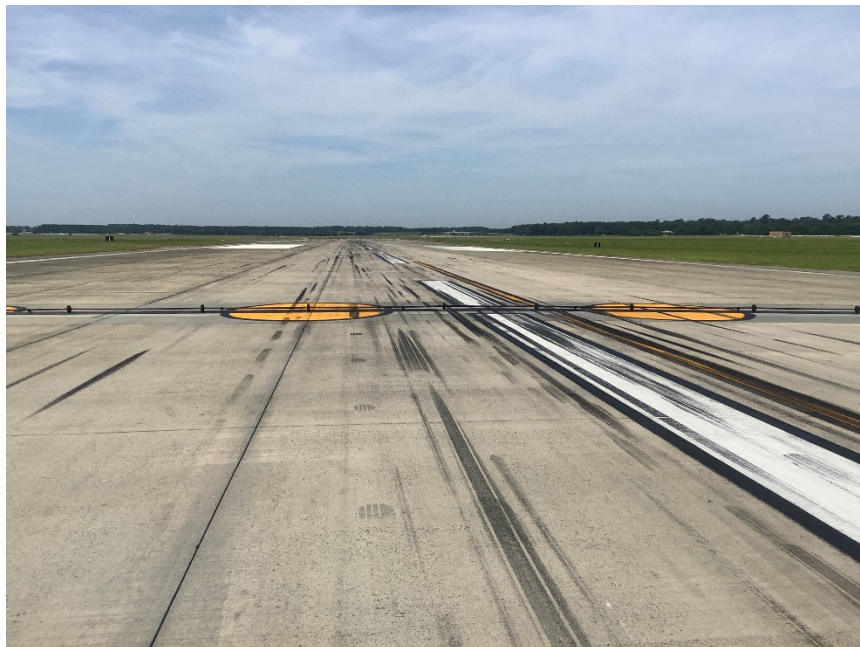
*Figure 7: Runway 04L approach cable (Tab Z-10).*

The F-16 is equipped with an arresting gear system, which allows the pilot to engage ("catch") a steel cable placed across a runway using a hook (Tab BB-112 to BB-113 and BB-124). When a cable is located at the beginning of a runway, it is called an "approach-end" cable, and when a cable is located at the end of a runway, it is called a "departure-end" cable (Tabs BB-124 and FF-6). Procedures dictating how and when to engage a cable vary widely based on the type of emergency, phase of flight, and available cable geometry, but approach-end cables during landing

emergencies are generally specified for use during situations when the integrity of the landing gear is in question (Tabs BB-124, BB-127, and FF-5). For any cable engagement, it is essential that the pilot engage the cable perpendicularly and as near to the center as possible (Tabs BB-124 and FF-5).

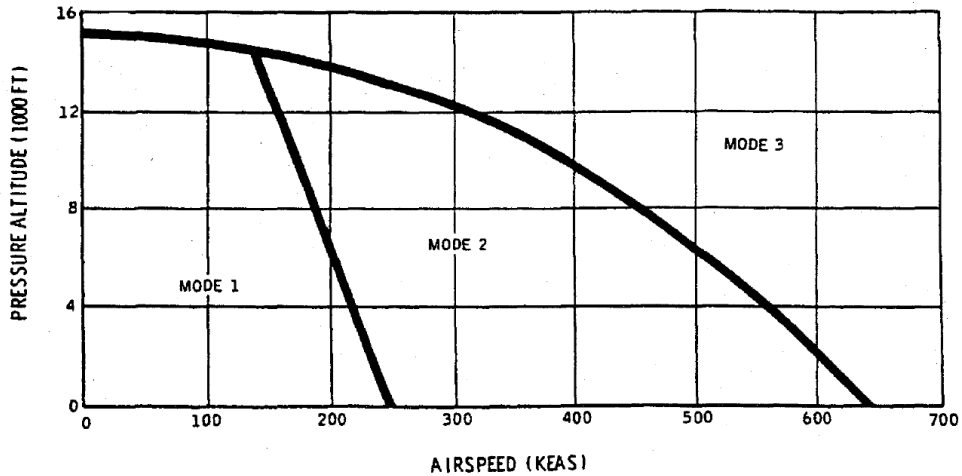
Figure 11: Ejection mode envelopes (Tab BB-93)

At 2259:33L, approximately 751 feet past the cable, the MP pulled the ejection handle, initiating the ejection sequence at 129 knots ground speed, with the nose at 8 degrees nose high and in a 16-degree left bank (Tabs J-33, BB-116, and FF-6). Based on the airspeed and altitude of the ejection, the mishap seat (MS) should have initiated a Mode 1 ejection (Tab J-3).

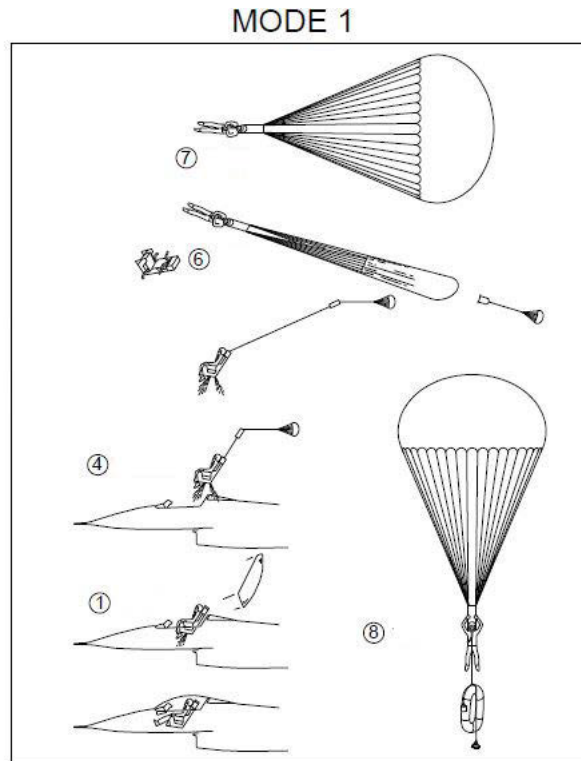
Figure 12: Mode 1 Ejection Sequence (Tab BB-119)

During a nominal ejection, pulling the ejection handle retracts the shoulder harness straps and locks the inertia reel (similar to how a car seatbelt locks when you brake hard), fires initiators to jettison the canopy, and ignites two rockets to remove the canopy (Tab BB-116). Once the canopy has left the aircraft, two ejection seat initiators are activated, and a rocket catapult propels the seat from the aircraft (Tab BB-116). As the seat exits the aircraft, the Digital Recovery Sequencer (DRS) is activated, which is responsible for providing seat stabilization, pilot/seat separation, and parachute deployment (Tab J-3). For a Mode 1 ejection, the seat's drogue chute is not used, expediting the deployment and inflation of the personnel parachute (Tabs J-3, BB-92 to BB-93, BB-116, and BB-118).

When the MP initiated ejection, the sequence proceeded as expected until the MS left the aircraft, at which point a critical failure of the DRS occurred, resulting in its failure to sequence or control all subsequent actions (Tab J-8 to J-10). Six of seven pyrotechnic devices in the seat should have activated during the MP's ejection; however, the DRS failure resulted in none of them activating, and the subsequent failure of the stabilization gyro, trajectory divergence rocket motor, the harness release thruster, two drogue chute severance cutters, and primary parachute deployment cartridge (Tab J-8 to J-10). The failure of the DRS to initiate multiple devices resulted in the MP remaining in the MS and following a parabolic flight path until impacting the ground (Tabs J-8 to J-10 and EE-8).
