**UNITED STATES AIR FORCE**  
**AIRCRAFT ACCIDENT INVESTIGATION**  
**BOARD REPORT**

**F-16C, T/N 86-0317**

**176TH FIGHTER SQUADRON**  
**115TH FIGHTER WING**  
**TRUAX FIELD AIR NATIONAL GUARD BASE, WISCONSIN**

**DATE OF ACCIDENT: 8 DECEMBER 2020**

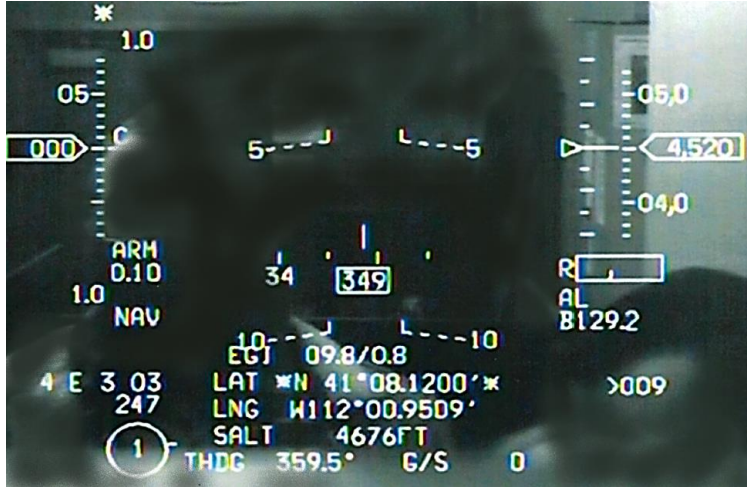
Figure 5: Simulated Fully Capable HUD (Tab T-16)

On the ground, while performing preflight checks, the MP reported having a sufficiently aligned EGI system (Tab T-40). Without the MP's HUD/DVR data, it cannot be determined whether the MA was tracking satellites during ground operations (Tab T-41). Under the circumstances, GPS is not required for the INS to achieve a full and accurate alignment (Tab T-15). Figures 5 and 6 (below) illustrate a fully aligned system with satellites tracking (Tab T-16). A fully aligned system without satellites tracking would appear the same, with the exception of the '4 E 3 03' symbology in the lower left corner of the HUD (Tabs T-15 to T-16).

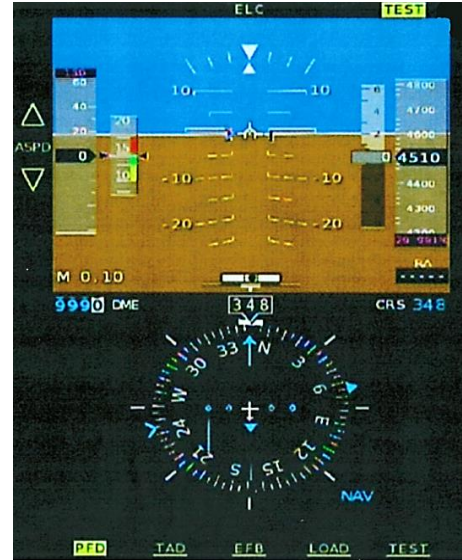
Figure 6: Simulated Fully Capable PFD (Tab T-16)

Once airborne, the MP stated the MA was not tracking any GPS satellites and the MP would attempt an IFA (Tab T-40). Assuming a full performance alignment, GPS satellite tracking is not required for safe flight; although, INS drift may lead to navigation errors over time (Tab BB-16). Several possible reasons exist for difficulty in tracking GPS satellites or not tracking GPS satellites at all (Tabs T-15 to T-16). Those reasons include erroneous alignment coordinates or outdated/corrupted almanac data (Tabs T-15 to T-16). SME consultation and inflight testing confirmed a system date error does not affect EGI satellite tracking ability (Tabs T-15 to T-16). Almanac data is current for up to six months (Tabs T-15 to T-16). Without the MA's recorded system data, the cause of the MA's inability to track GPS satellites cannot be determined (Tabs T-15 to T-16). However, the MP's communications revealed the MA's GPS was not tracking satellites throughout the duration of the MF (Tabs T-40 to T-41).

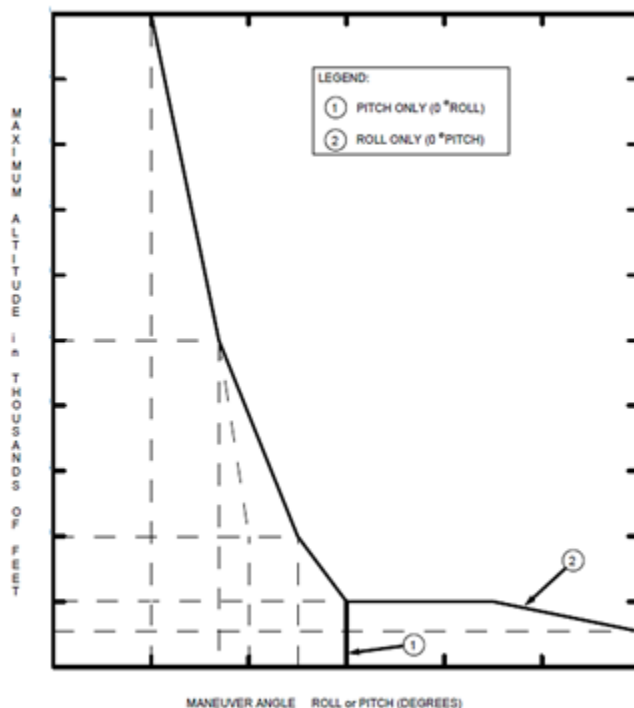
Figure 13: CARA Tracking Capabilities (Tab BB-13)

a clearance buffer (Tab BB-19). Moreover, the ground advisory utilizes combined altitude radar altimeter (CARA) data as long as the aircraft is within the CARA ground track envelope (Tab BB-21). The radar altimeter is located on the bottom of the F-16C, and in extreme attitudes the radar altimeter readings are outside of the ground track envelope (Tab BB-21). Based on the recreation, the MA was outside of the CARA envelope throughout the mishap event up until impact (Tabs T-42 and BB-13). As such, the MP would not receive a GAAF advisory cue (Tab BB-21). Figure 13 (below) provides CARA ground tracking capabilities (Tab BB-13).

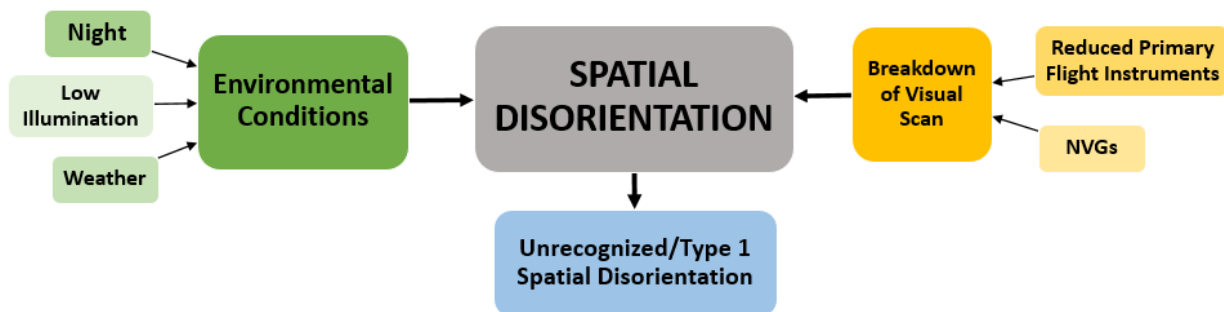
Figure 15: Human Factors Breakdown (Tab Y-57)

DoD HFACS 7.0 are divided into four parts: acts, preconditions, supervision, and organizational influences (Tab Y-6). Four human factors were identified as relevant to the mishap: (1) Environmental Conditions Affecting Vision; (2) Instrumentation & Warning System Issues; (3) Breakdown in Visual Scan; and (4) Spatial Disorientation (Tabs Y-4 to Y-26).

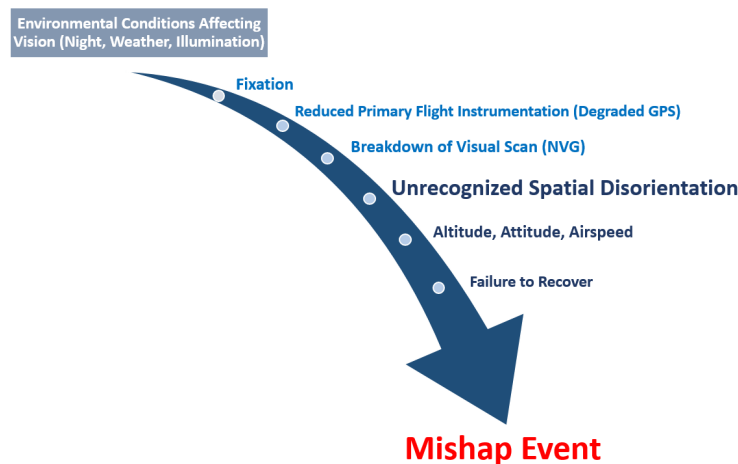
Figure 16: Human Factor Chain (Tab Y-58)

Spatial disorientation is a failure to correctly sense a position, motion, or attitude of the aircraft or of oneself within the fixed coordinate system provided by the surface of the earth and the gravitational vertical (Tab Y-28). It is a factor when perceptual confusion or an illusion is induced through one or more of the following senses: visual, vestibular, auditory, tactile, proprioception, or kinesthetic (Tab Y-16). Spatial disorientation may be recognized or unrecognized and result in partial or total incapacitation (Tab Y-31).

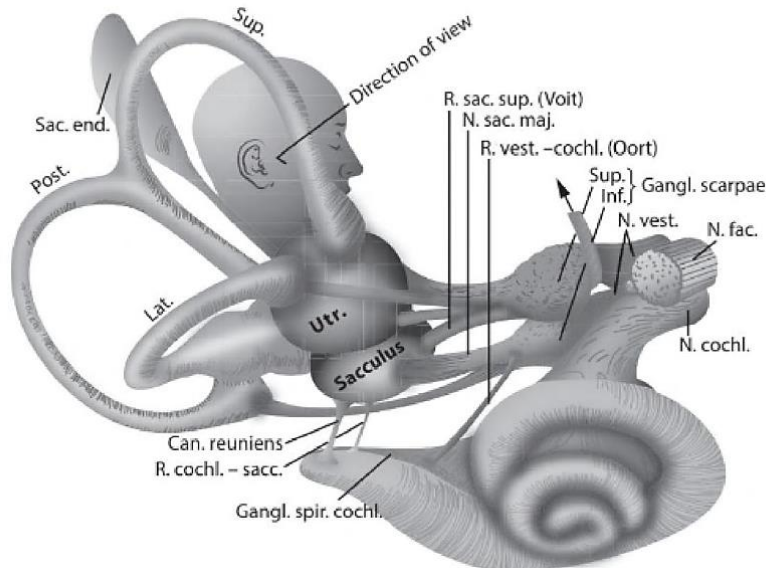
*Figure 17: The Human Inner Ear (Tab Y-37)*

the pants”), and acceleration inputs from the vestibular system (Tabs Y-45 to Y-48). The vestibular system consists of three semi-circular canals to detect rotational movements and the otolith organs to sense translational acceleration (Tabs Y-37 to Y-40). Because humans have learned to trust this system, it is difficult to override and accept that the actual orientation is not what is perceived (Tab Y-45). Despite the capability, accuracy, reliability, and flexibility of modern flight displays, pilots can feel themselves questioning what the aircraft instruments are telling them, simply because the “seat of their pants” or gut feeling is saying something else (Tab Y-29).

After losing visual contact with the MW, the MP queried the MW asking “are you making a left hand turn now?” (Tab T-41). At that point in time, the MW was in straight and level flight (Tab T-41). Next, the MP entered in a subthreshold or unrecognized series of turns, one of which the MP initially perceived as the MW moving away in a perceived left turn (Tab T-41). Simultaneously, the MP’s unrecognized right turn would initially be correctly perceived by the cupulae of the semicircular canals, but when overridden by visual cues, an unrecognized vestibular illusion would be created (Tabs T-41 and Y-37 to Y-40). As the turn continues, the sensation of angular motion subsides in the cupulae and the otolith organs return to their neutral positions, creating a sensation of straight and level flight within this organ (Tabs Y-37 to Y-40). When a pilot attempts to recover from this turn, usually following a cross-check of flight instruments, the rotation is slowed or stopped, and the canal-cupula-endolymph system deflects the cupulae in the direction opposite to their initial deflection (Tabs Y-38 to Y-39). The second deflection causes a sensation of spinning in the opposite direction of the initial turn, to the left (Tab T-41). If the MP had succumb to this false sense of rotation, the MP would feel as though the MA was turning to the left and make more severe corrections into a right bank to achieve what is perceived as straight and level flight (Tab Y-46). This sensory illusion is termed the graveyard spiral illusion (Tabs Y-47 to Y-48).
