**UNITED STATES AIR FORCE**  
**GROUND ACCIDENT INVESTIGATION**  
**BOARD REPORT**

**Polaris Ranger Model 800 Crew All-Terrain Utility Vehicle**  
**VIN: 4XAWH76A8D2707361**

**386TH EXPEDITIONARY LOGISTICS READINESS SQUADRON**  
**386TH AIR EXPEDITIONARY WING**  
**ALI AL SALEM AIR BASE, KUWAIT**

**TYPE OF ACCIDENT: Motor Vehicle Fatality**

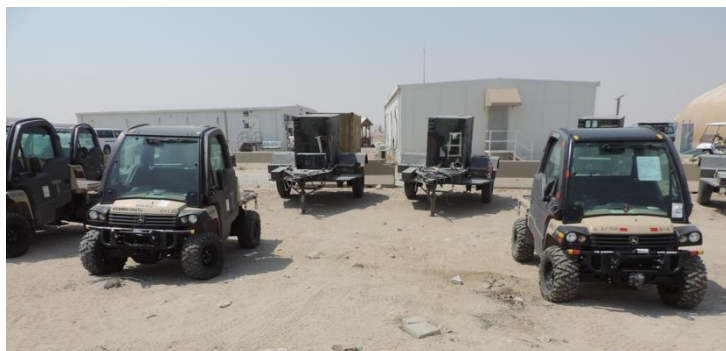
**Figure 6 – MV's Terminally Parked Location (Tab S-7)**

MA parked the Jeep next to the MV in the northwest corner of the lot, and both Airman exited the vehicle (Tab R-158 and R-191). The MVO then started driving the MV with the MA as the front-seat passenger (Tab R-160).

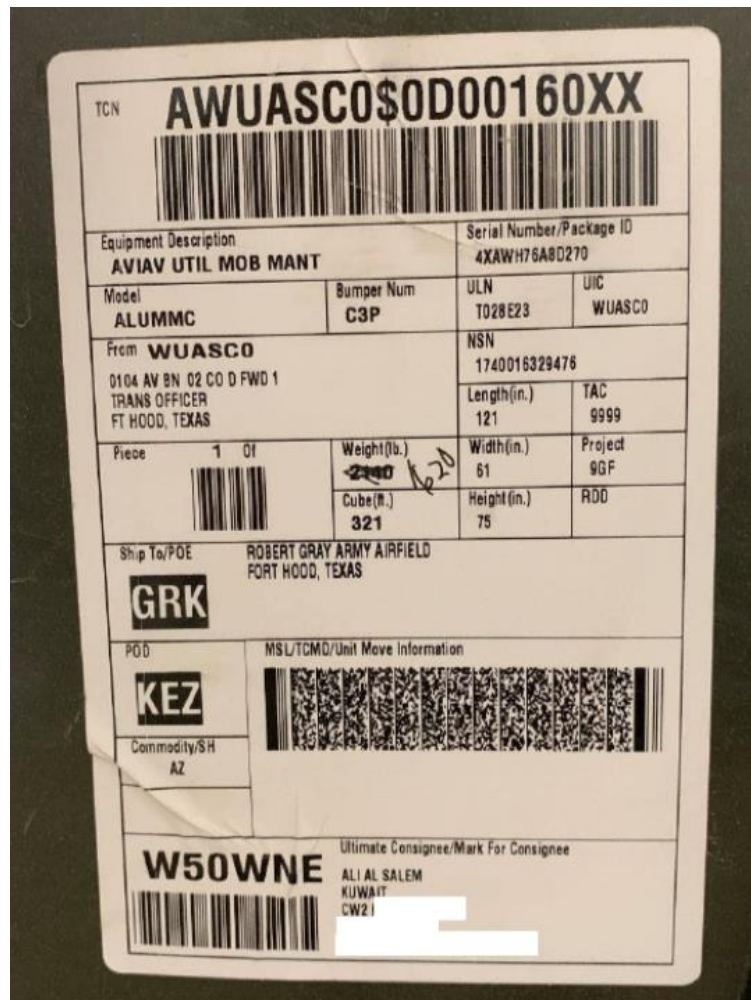
**Figure 14 – MV Identification and Shipping Label (Tab Z-17)**

- (1) Polaris Owner and Operator Manual, 100 pages (Tab BB-127 to BB-133).
- (2) Polaris Certificate of Pre-Delivery Inspection (blank and undated), 1 page (Tab D-17).
- (3) Invoice for Maintenance and Repair on MV from Commercial Vendor, dated 28 January 2020, 3 pages (Tab P-5 to P- 7).
- (4) Shipper’s Declaration for Dangerous Goods, dated [sic] 20 September 2020, 1 page (Tab D-19).
- (5) Department of Defense Form 2977 (DD 2977), Deliberate Risk Assessment Worksheet, dated 11 June 2020, approved by TF ANVIL Brigade Commander, USA, 15 pages (Tab D-3 to D-15).

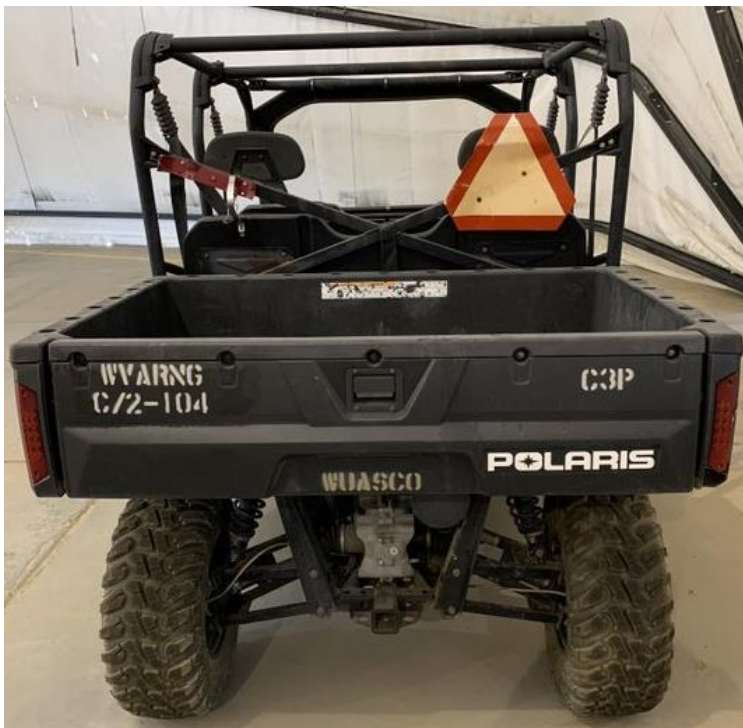
**Figure 16 – MV Vehicle Identification Number (VIN) Plate (Tab S-3)**

No documentation or evidence of unscheduled maintenance was present on the MV to determine if the prescribed maintenance had been completed. The cumulative mileage for the MV listed on the invoice in February 2020 was 2,977 miles (Tab P-5). At the time of the 14 September 2020, the MV had accumulated an additional 250 miles (3,277 miles total) and seven (7) months had passed since the previously documented service (Tab S-15). According to the original equipment manufacturer (OEM) maintenance schedule, additional maintenance would have been required at fifty (50) operating hours or six (6) months’ time (Tab BB-132 to BB-133).
