UNITED STATES AIR FORCE
ABBREVIATED AIRCRAFT ACCIDENT INVESTIGATION
BOARD REPORT

MQ-9A, T/N 15-4295

**108th ATTACK SQUADRON
174th ATTACK WING
HANCOCK FIELD AIR NATIONAL GUARD BASE, NEW YORK**

DATE OF ACCIDENT: 25 JUNE 2020

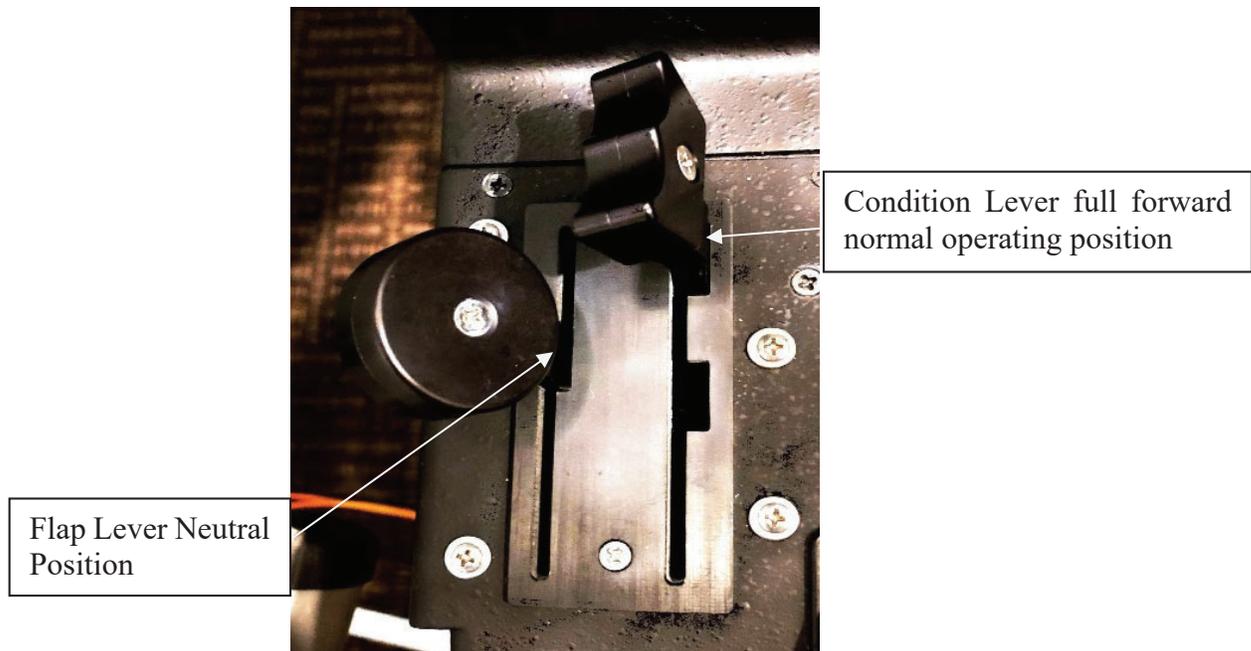
Figure 3. Flaps Neutral Position and Condition Lever Full Forward Example (Tab DD - 7)

At 13:05:04Z the MP started the MA engine (Tab K-3). The MC completed the MA engine start, preflight checklist procedures, and preflight checks without incident (Tabs V-11.1 and V-12.5). After engine start the Condition Lever should be in the full forward position and the Flap Lever in the neutral position, see figure 3 (Tab DD-3). The MP moved the Flap and Condition Levers into the correct positions for after engine start (Tab EE-8 to EE-9).

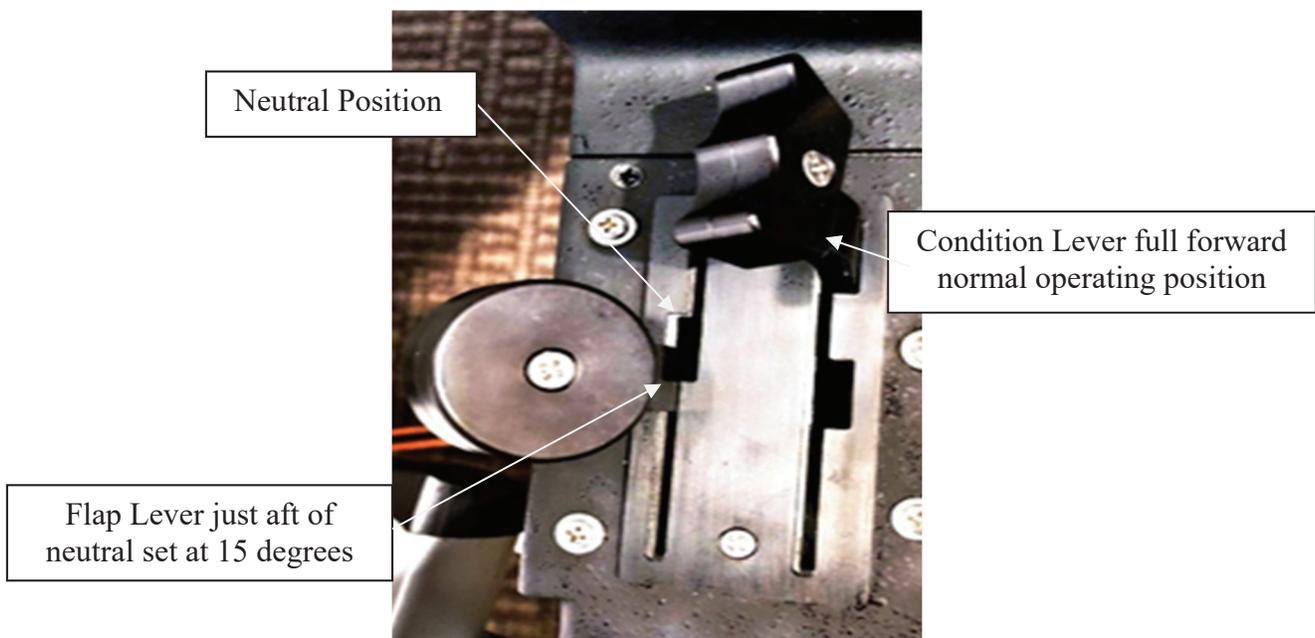
Figure 4. Flap Lever Aft of Neutral/15 Degrees & Condition Lever Full Forward Example (Tab DD - 9)

The proper positions during takeoff of the Condition Lever is full forward and Flap Lever is just aft or back of the neutral position in order to configure the flaps to 15 degrees, see figure 4 (Tab DD-3). The MP moved the Flap and Condition Levers into the correct positions for takeoff (Tab EE-8 to EE-9).

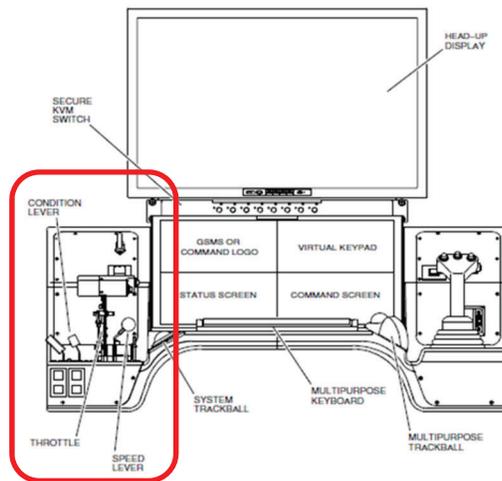
Figure 9. Engine Controls Diagram Example (Tab EE-15)

The MA and MGCS structure and systems were operating as intended (Tabs Q-10, V-1.1 to V-11.1 and V-12.4). Figure 9 below shows the layout of the GCS Control Console and Throttle Quadrant (Tab EE-15).

The design layout of the Control Console places the Flap Lever and the Condition Lever, forward and left of the Throttle Quadrant (Tab DD-11). The Flap Lever and Condition Lever are located approximately an inch apart, without labels, markings, and are the same color, see figure 10 (Tab DD-3 to DD-5).
