UNITED STATES AIR FORCE
AIRCRAFT ACCIDENT INVESTIGATION
BOARD REPORT

RQ-4B BLOCK 40, T/N 08-2035

LOCATION:
6.8 MILES NORTH OF GRAND FORKS AIR FORCE BASE, NORTH DAKOTA

DATE OF ACCIDENT: 6 AUGUST 2021

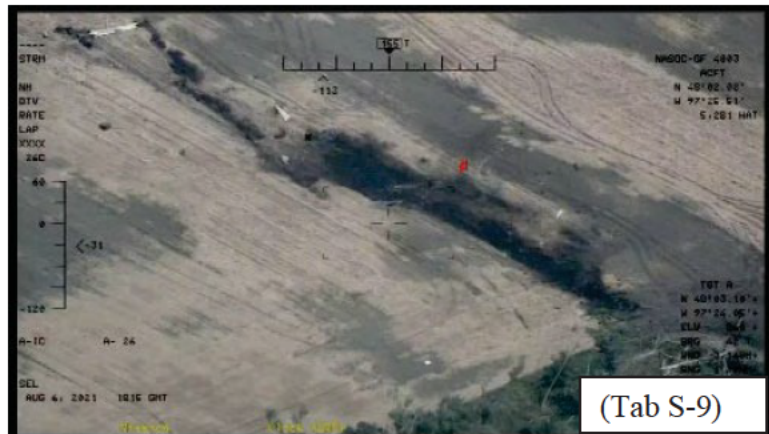
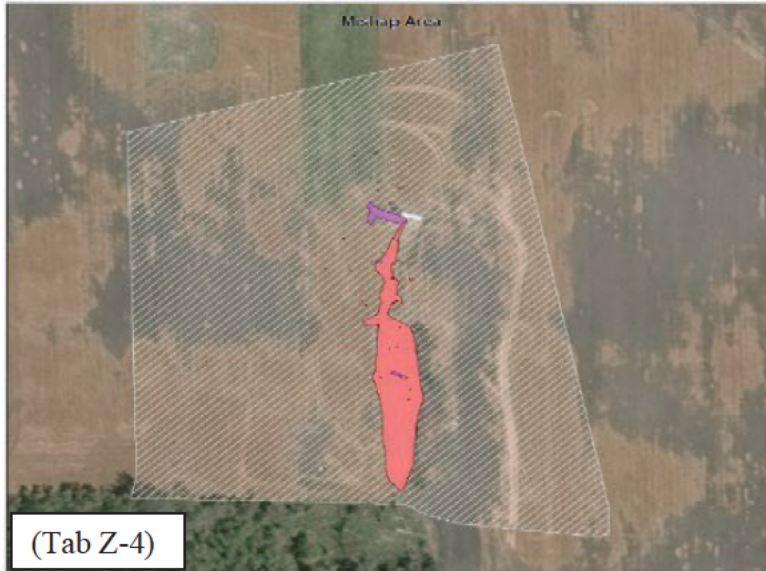
(Tab Z-4)

At 0829L, GFAFB FD confirmed two fires with black smoke approximately 8 miles west of initial coordinates and were attempting to access the site of the fires (Tab DD-8). The actual impact site was non-government property, specifically a barley farm field, and a National Defense Area was initiated (Tab V-11.2 to V-11.3, V-11.11 to V-11.14, and DD-11). After arriving, GFAFB FD established incident command (IC), and civilian fire departments aided (Tab DD-8). 319 SFS established a perimeter

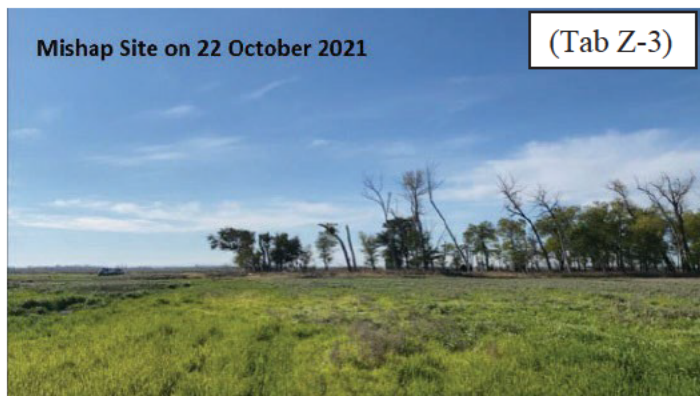
The CRT used the following equipment during the recovery process: two all-terrain forklifts capable of 10,000 pounds, two tractor trailer flatbeds, a Kubota, a 30 gallon sprayer, four wooden crates, and self-contained breathing apparatuses (Tabs V-11.8 to V-11.10, and V-11.14 and DD-8). Over the 16 days, a number of rain days caused the CRT to experience some difficulty during the recovery efforts because of the mud at the crash site (Tab V-11.9).
