UNITED STATES AIR FORCE
GROUND ACCIDENT INVESTIGATION
BOARD REPORT

**M1165A1 High Mobility Multipurpose Wheeled Vehicle (HMMWV),
S/N 337321**

**284th Air Support Operations Squadron
184th Wing
McConnell AFB, Wichita, Kansas**

TYPE OF ACCIDENT: Motor Vehicle Fatality

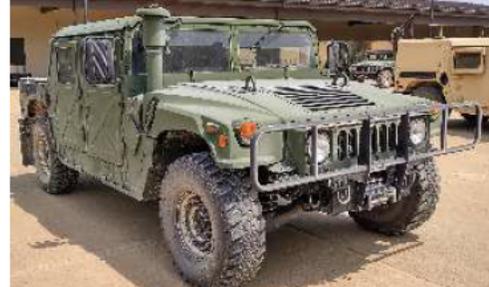
Figure 2 - High Mobility Multipurpose Wheeled Vehicle (Tab Z-2)

The HMMWV is a four-wheel drive vehicle that is used to transport personnel (see Figure 2) (Tab BB-24). It can be equipped with integrated armor protection which provides added ballistic protection for armament components, crew, and ammunition (Tab BB-19). The M1165A1 vehicles are capable of transporting a four-man crew (Tab BB-19).

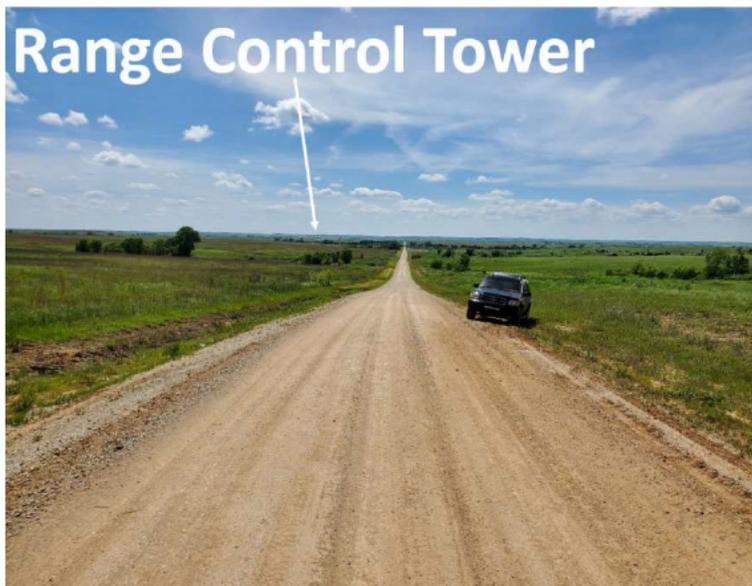
Figure 3 - Parsons Road Facing West (Tab Z-4)

10 minutes west from the vehicle yard to RCT, arriving at approximately 1200L (see Figures 3 and 4) (Tabs V-3.35 and Z-3 to Z-4). After entering RCT, MT validated targets and aircraft flight profiles with RCO (Tabs V-3.34 to V-3.35 and V-7.31 to V-7.32).
