UNITED STATES AIR FORCE
ABBREVIATED AIRCRAFT ACCIDENT INVESTIGATION
BOARD REPORT

B-2A, T/N 89-0129

**393d BOMB SQUADRON
509th BOMB WING
WHITEMAN AFB, MISSOURI**

DATE OF ACCIDENT: 14 SEPTEMBER 2021

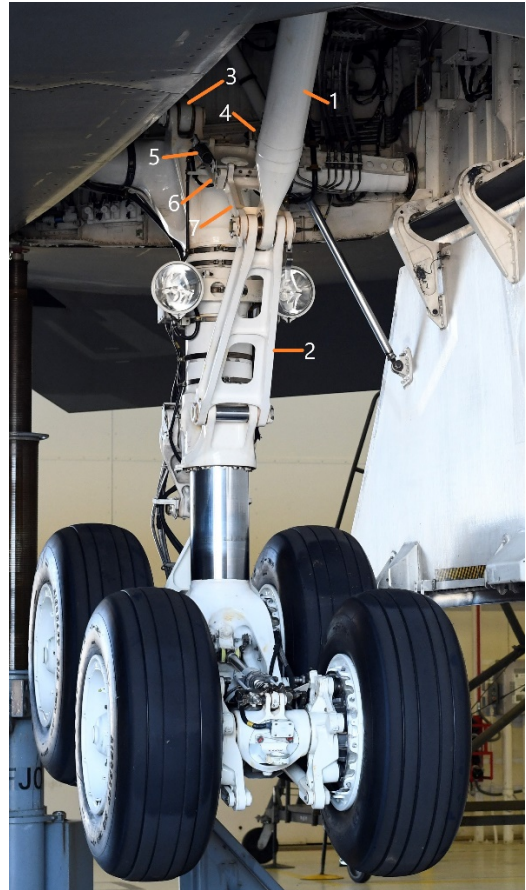
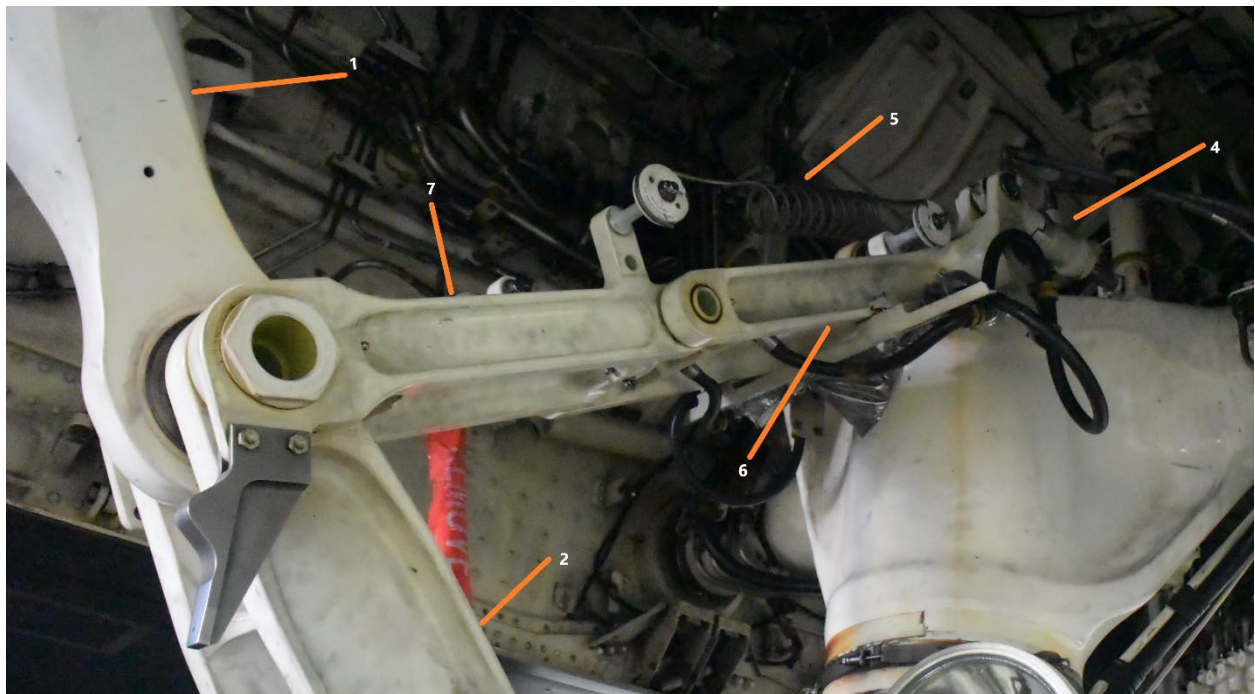
Left Main Landing Gear Components

1. Upper Drag Brace
2. Lower Drag Brace
3. Retract Actuator
4. Lock Link Actuator
5. Lock Link Springs
6. Aft Lock Link
7. Forward Lock Link

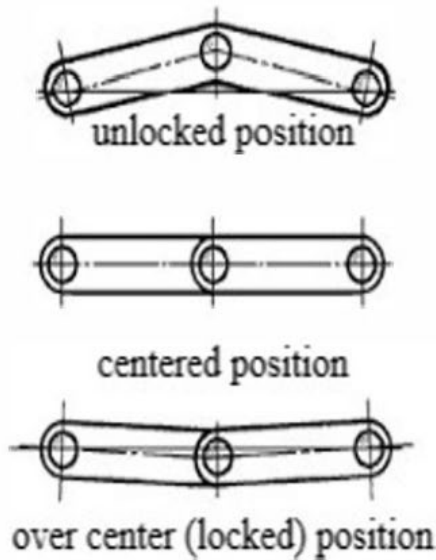
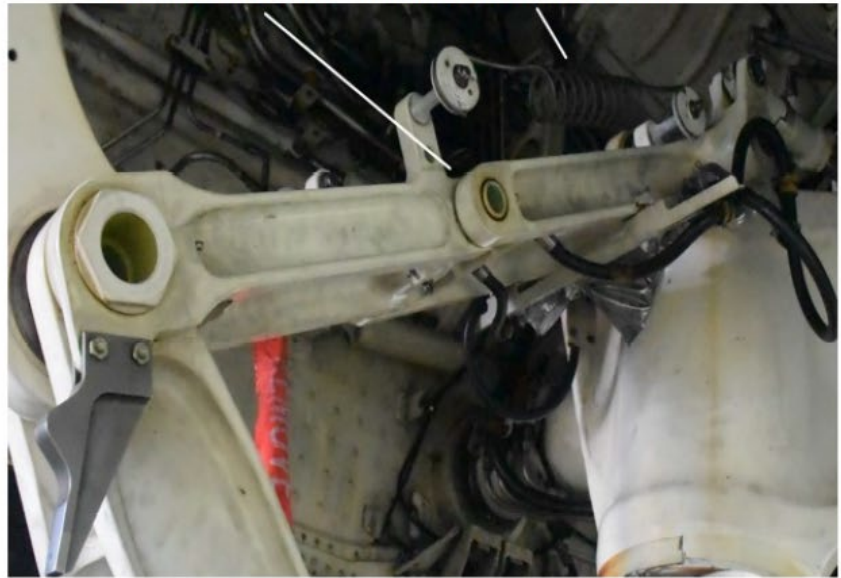
Lock link in the over center (locked) position with spring tension.

The function of a lock link illustrating the over center (locked) position.
