UNITED STATES AIR FORCE
AIRCRAFT ACCIDENT INVESTIGATION
BOARD REPORT

B-2A, T/N 90-0041

393d BOMB SQUADRON
509th BOMB WING
WHITEMAN AIR FORCE BASE, MISSOURI

SUMMARY OF FACTS AND STATEMENT OF OPINION
B-2A, T/N 90-0041
WHITEMAN AFB, MISSOURI
10 DECEMBER 2022

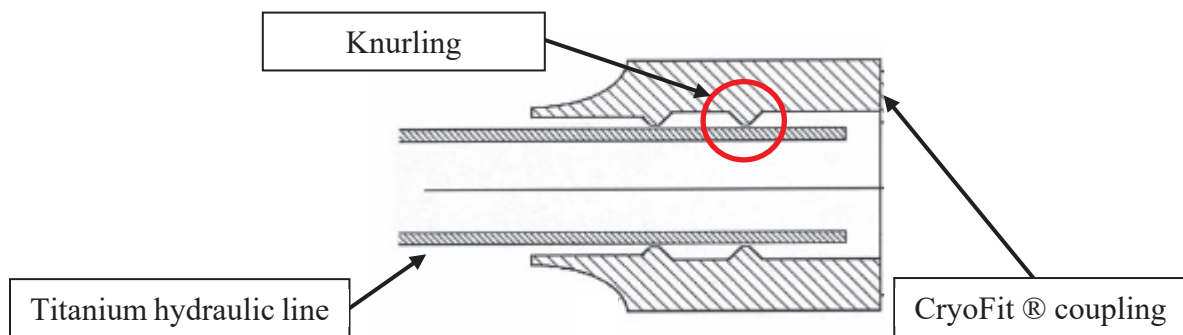
Figure 1: CryoFit ® Coupling Cross Section in Expanded Condition (Tab CC-81)

The hydraulic system plumbing uses titanium tubing, and CryoFit ® fittings are used for many of the tubing joints (Tab CC-81). Externally, a CryoFit ® coupling is a cylindrical sleeve that fits around the outside of the two lines which it is joining. Internally, a CryoFit ® coupling has knurling (i.e., small ridges) to add tensile strength to the joint. CryoFit ® couplings need to be submerged in liquid nitrogen prior to installation. While in liquid nitrogen, the coupling is mechanically expanded by pulling a tapered mandrel through the center bore. The coupling will maintain the expanded size while in the liquid nitrogen. This is known as the expanded condition. The coupling is then fitted over the titanium hydraulic lines, as seen in Figure 1 below (Tab CC-81).

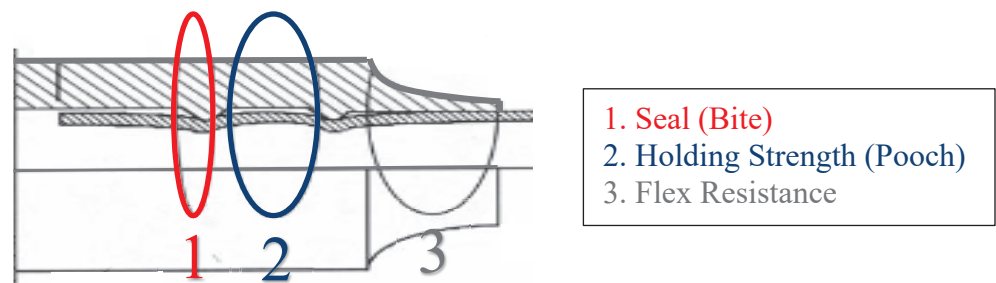
Figure 2: CryoFit ® Coupling Cross Section in Relaxed Condition (Tab CC-81)

When the CryoFit ® coupling is returned to room temperature, it returns to its originally machined dimensions (Tab CC-81). Coupling shrinking is resisted by the titanium of the hydraulic line or T-fitting (Tab CC-81). A fluid-tight seal is formed when the machined teeth inside the CryoFit ® coupling “bite” into the hydraulic line or T-fitting as the coupling warms. This creates a “pooch,” which resists tension pullout loads, as seen in Figure 2 below (Tab CC-81).

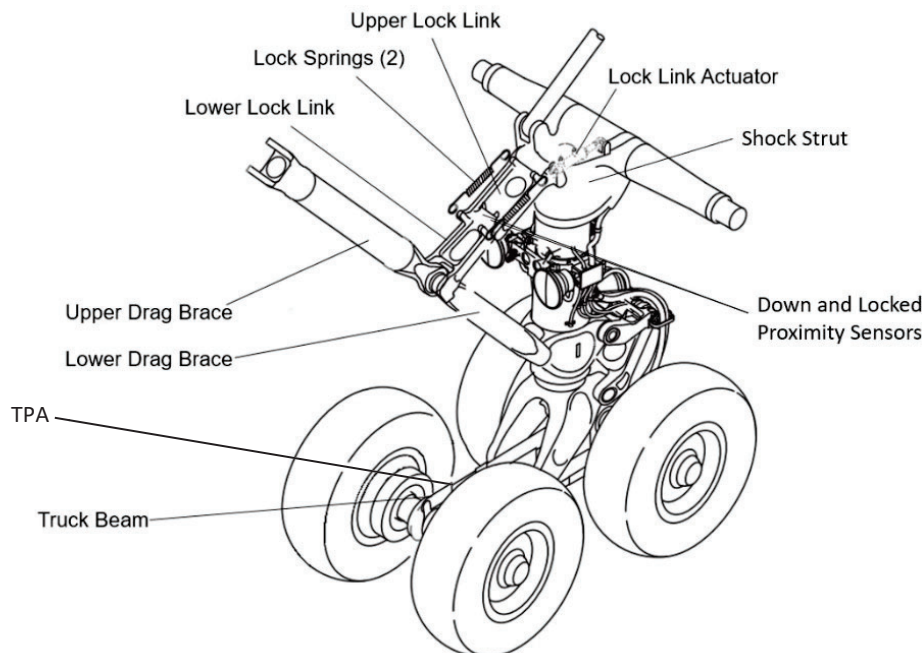
Figure 3: First view of MLG Components (Tab CC-82)

MLG components include the Truck Beam, Shock Strut, Upper and Lower Drag Braces, and the Lock Link Assembly, which is comprised of the Upper and Lower Lock Links, Lock Springs, and the MLG Lock Actuator and the Truck Position Actuator (TPA) as seen in Figure 3 below. MLG extension and retraction is initiated by the Landing Gear Control Handle or the Landing Gear Emergency Lowering Switch. Extension and retraction are monitored and controlled by the FCCs, PSLUs, and proximity sensors, which are actuated by the hydraulic system (Tab CC-81 to CC-82).

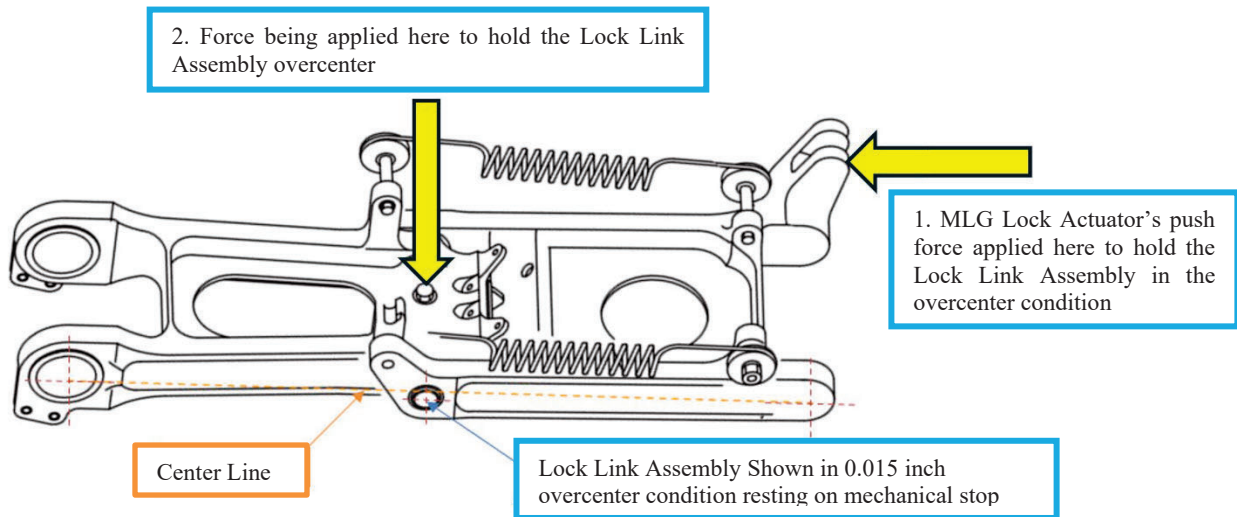
Once the landing gear is extended normally, the MLG is held down and locked by gravity, air load, landing gear geometric design, the Lock Link Assembly being held locked/overcenter by the MLG Lock Springs, and a MLG Lock Actuator applying force, as seen in Figure 4 below (Tab CC-82 to CC-83).

Figure 4: MLG Lock Link Assembly pictured with an orange dashed center line to highlight the degree of overcenter required for the gear to be safe in the down and locked configuration. The yellow arrows indicate the location and direction of the force applied. The overcenter position also exists in the up and locked position (Tab CC-83).
