UNITED STATES AIR FORCE
AIRCRAFT ACCIDENT INVESTIGATION
BOARD REPORT

F-35A, T/N 15-5197

**421ST FIGHTER SQUADRON
388TH FIGHTER WING
HILL AFB, UTAH**

DATE OF ACCIDENT: 19 OCTOBER 2022

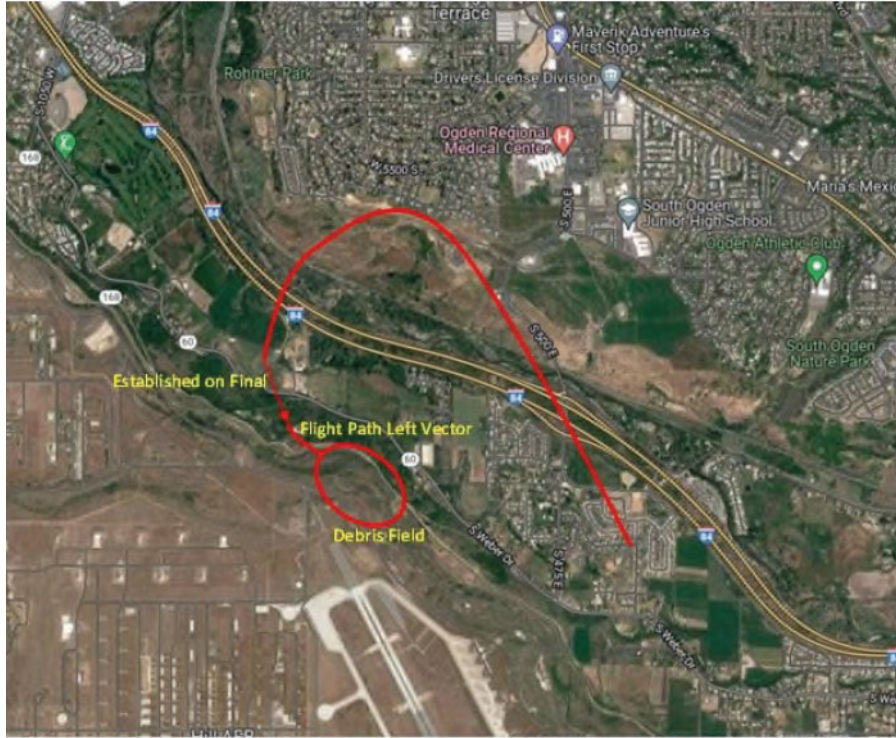
The MP ejected at approximately 18:08:36L, the MA continued into the terrain just north of the approach end of RWY 14 at Hill AFB in full afterburner with the left wing striking the ground first (Tab J-1.22 and J-1.48).

Figure 8: MA approach to attempt landing (Tab J-1.10)

The debris field fanned out with most of the aircraft disintegrating within airfield boundaries (Tab J-1.9). Parts of the cockpit, canopy and ejection seat were located just outside the airfield boundary fence line (Tab J-1.9).

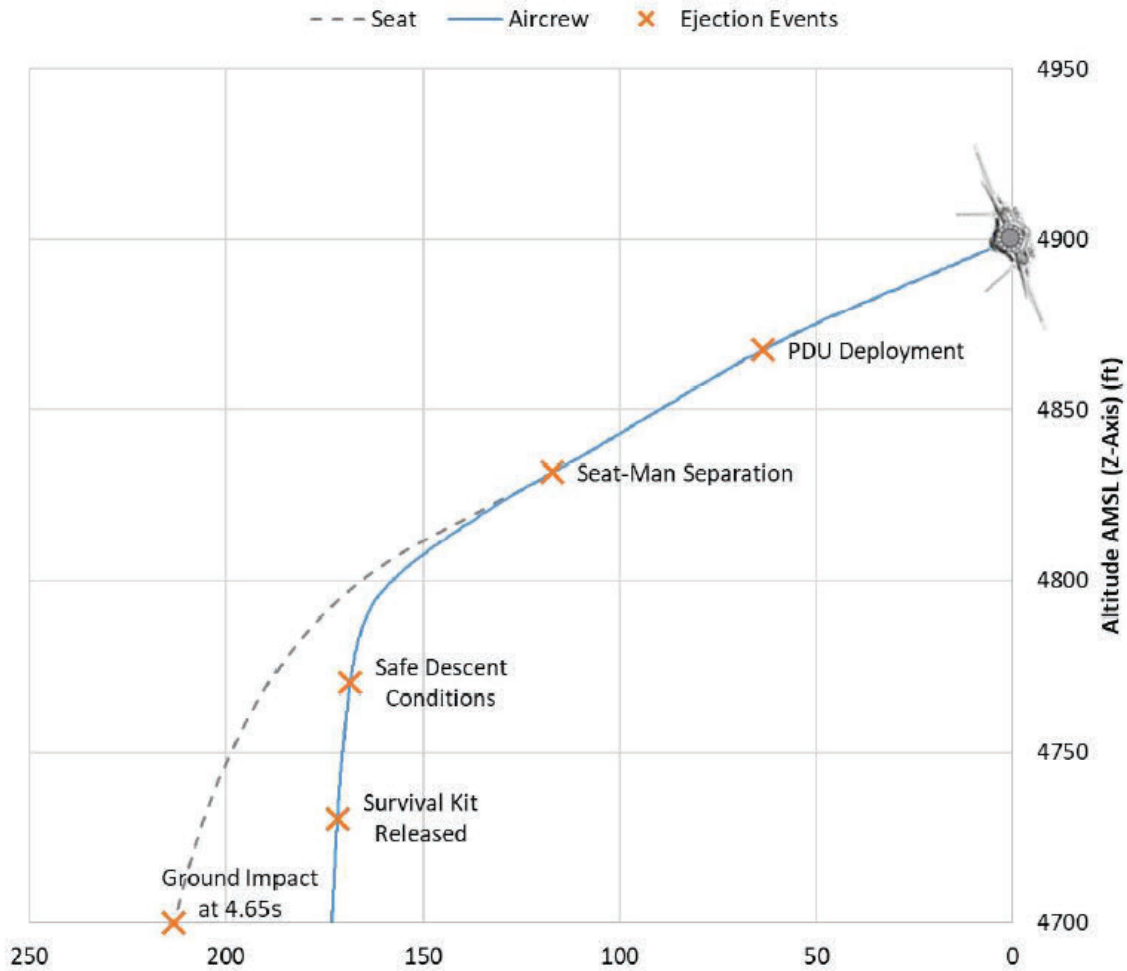
All AFE performed its intended function, without incident or hindrance to pilot recovery (Tabs J-1.63 and J-5.15). The MP initiated ejection at approximately 4,900 above ground level or 200 ft above the ground (Tab J-2.7 and J-2.10). The MP initiated a successful ejection conducted at low speed and low altitude (Tab J-2.43). The ejection seat automatic sequencer functioned correctly, resulting in a successful ejection for the MP (Tab J-2.14).

Figure 11: Ejection Trajectory (Tab J-2.10)

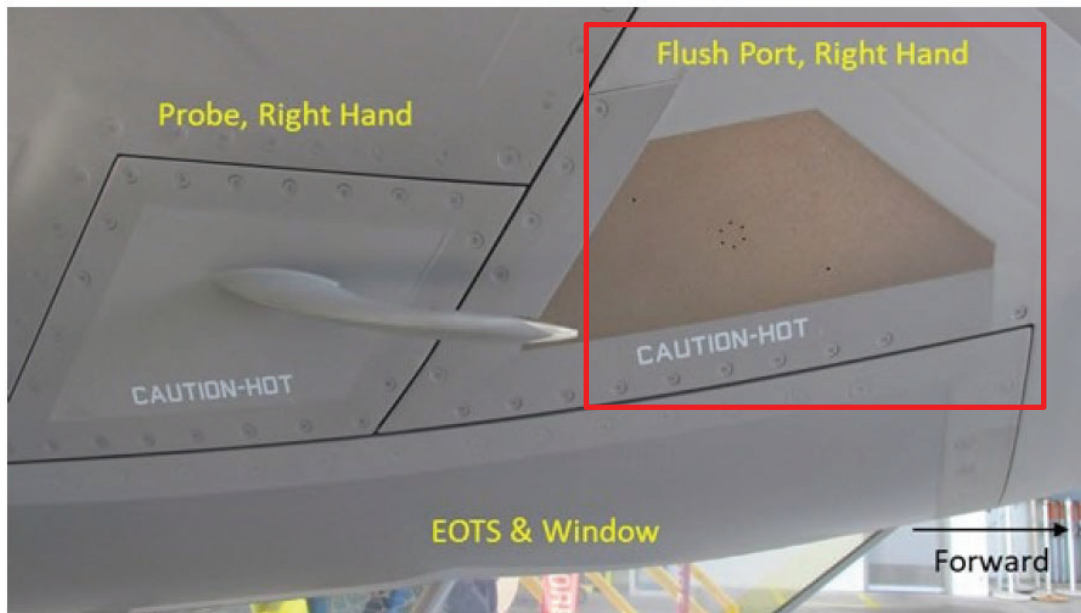
Air Data System (ADS): The ADS consists of sensors that collect information from outside of the aircraft and feed it into the ADA for use by other systems and the pilot (Tab CC-1.2). The F-35 ADS consists of one left hand and one right hand multi-function probe (MFP), and one left hand and one right hand flush port module (Tab J-1.39). The left-hand side and right-hand side are mirror images (Tab J-1.39).

Figure 14: Flush Port (Tab J-1.39)

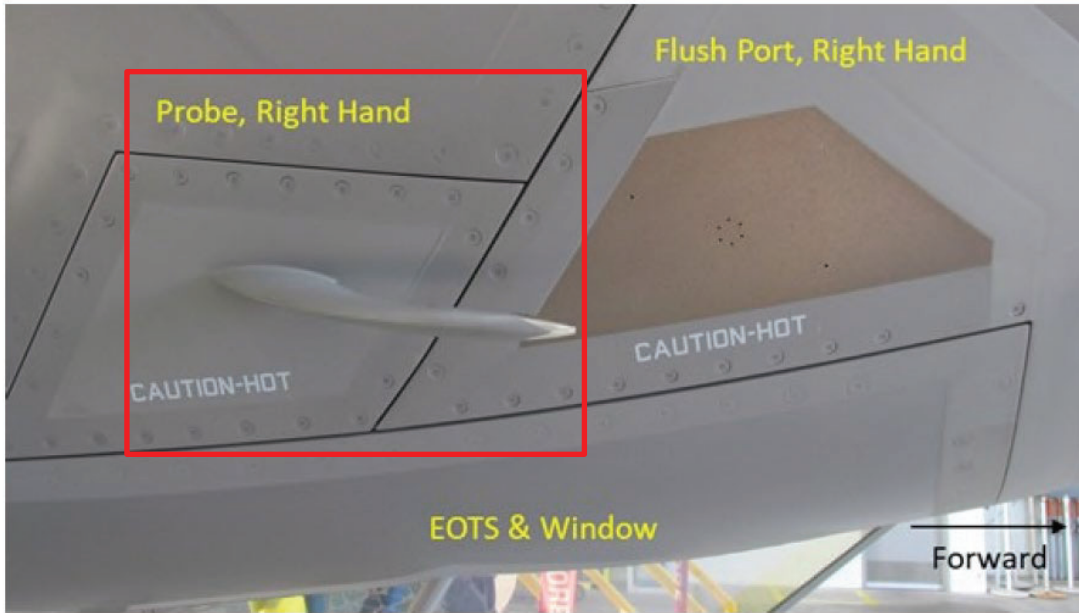
Figure 15: Probe (Tab J-1.39)

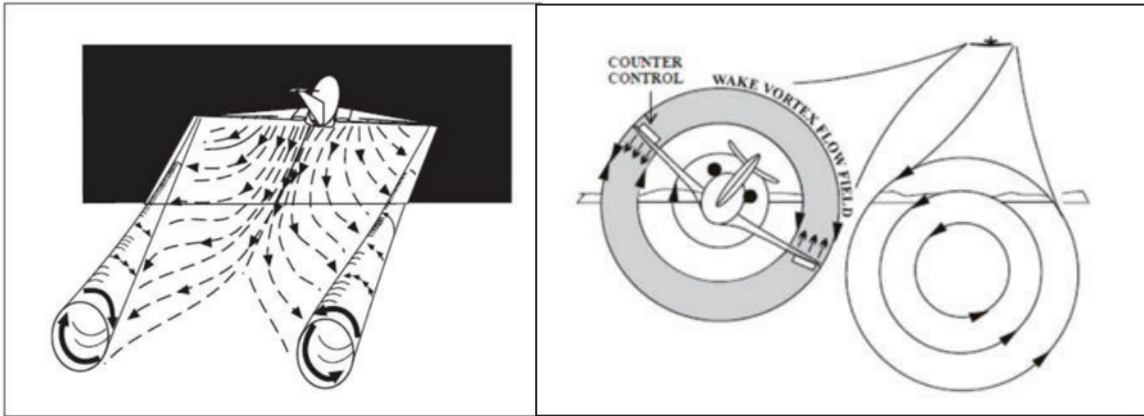
Every aircraft generates wake turbulence while in flight (Tab BB-7.1). Wake turbulence is a function of an aircraft producing lift, resulting in the formation of two counter-rotating vortices trailing behind the aircraft (Tab BB-7.1). Wake turbulence from an aircraft can affect other aircraft due to the strength, duration, and direction of the vortices (Tab BB-7.1). Pilots should always be aware of the possibility of a wake turbulence encounter when flying through the wake of another aircraft and adjust the flight path accordingly (Tab BB-7.1).

Figure 20: Wake vortex generation and impact on trailing aircraft (Tab BB-7.1 to BB-7.2)

Wake turbulence procedures at Hill AFB are intended to reduce the likelihood of following aircraft from entering wake turbulence vortices with the primary danger being an unexpected rolling motion close to the ground due to flight within the vortex, not because of an impact to the air data system of the F-35 (Tab CC-1.1 to CC-1.2). Most F-35 pilots interviewed for this investigation and the accident investigation board's F-35A Pilot Member, regularly experience wake turbulence while flying the aircraft (Tab CC-1.2). The F-35 has over 600,000 flight hours and this is the first known occurrence of wake turbulence having a catastrophic impact on the Air Data System (Tabs V-2.1.6 and CC-1.2).
