UNITED STATES AIR FORCE
AIRCRAFT ACCIDENT INVESTIGATION
BOARD REPORT

F-16CM, T/N 89-2142

LOCATION: BEAUREGARD PARISH, LOUISIANA

DATE OF ACCIDENT: 23 MARCH 2022

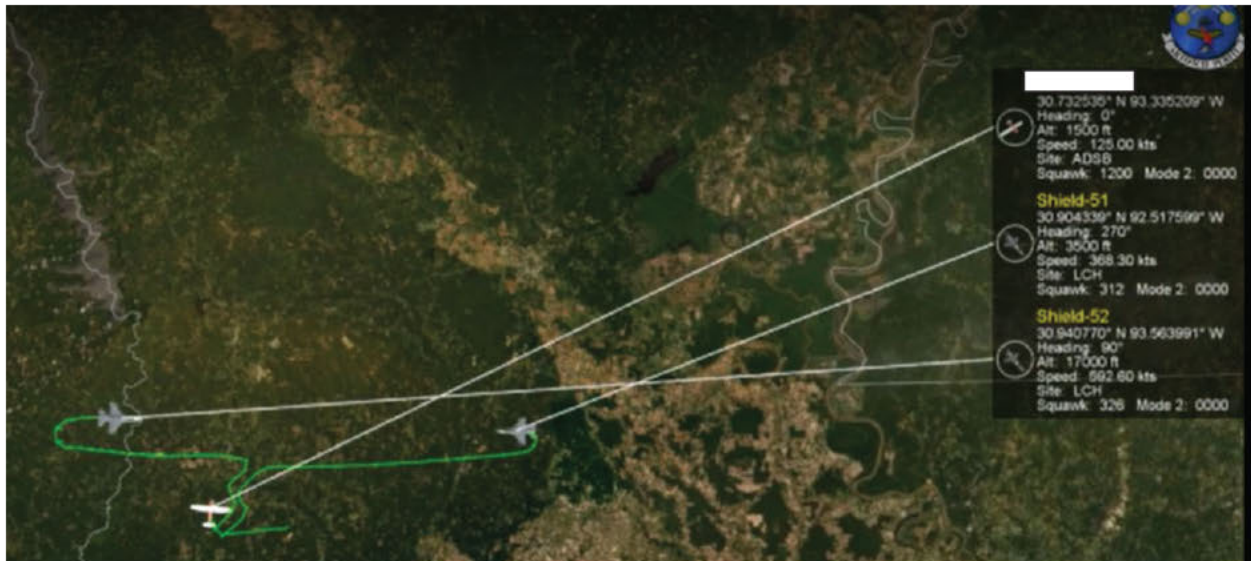
Figure 2: MF Training Intercept and GA location (Tab AA-3)

The first training event started at 10:43 a.m., with the MP and MFL splitting the MF formation and establishing approximately 30 nautical miles (NM) in range for a practice intercept of a simulated defecting foreign military aircraft (Tabs V-2.26 and AA-3). The MP executed the single-ship intercept of the MFL, while practicing alert intercept radio procedures (Tab V-1.31, V-2.26 and V-8.38). The visual intercept resulted in the MP verbalizing the MFL's aircraft configuration, followed by a terminate call from the MFL (Tab V-1.31 and V-2.26).

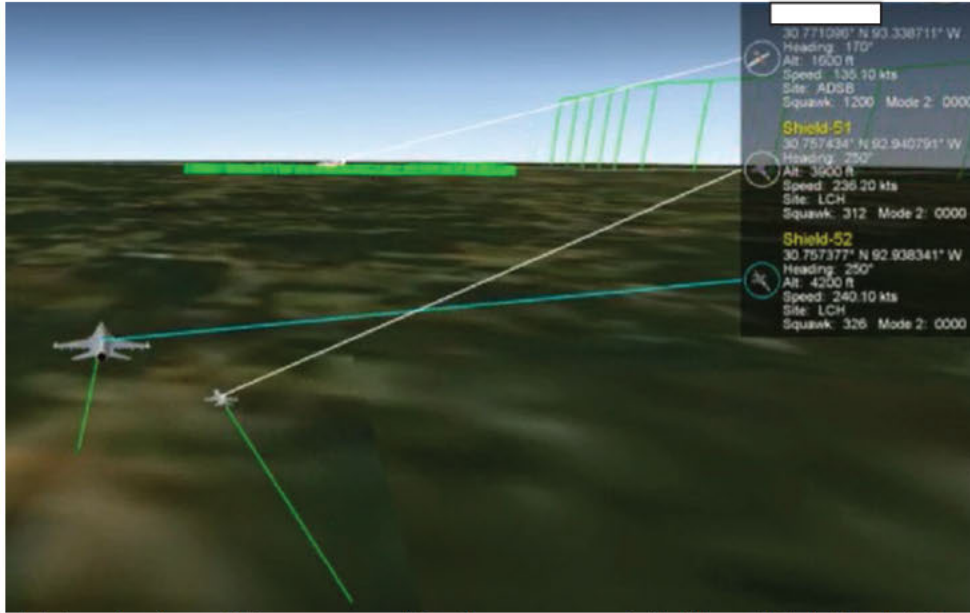
Figure 3: Termination of Intercept and Radar contact of civilian A/C (Tab AA-2 to AA-4)

The GA aircraft's north to south holding pattern complicated the intercept geometry for the MF by compressing the range between the MFL and MP (Tabs R-27 to R-28 and AA-3). At 10:54 a.m., Fort Polk Control gave their first radio call highlighting the proximity of the GA aircraft to the MF (Tab N-4). At this time, the MF had visually acquired the GA aircraft and was approaching 1.2 NM of the GA aircraft (Tabs N-4 and AA-3). Based on attempting to maintain position behind the GA aircraft, the MFL flew below the required minimum airspeed for approximately 90

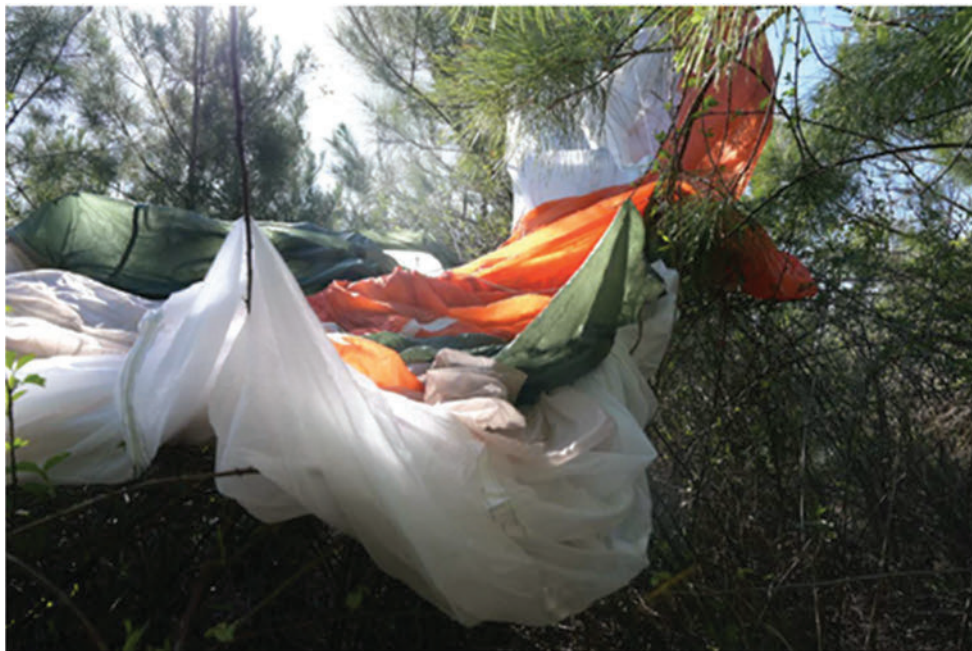
Figure 10: Parachute Post-Ejection Resting Position (Tab J-31)

The MP landed in a tree, disconnected his AFE gear, and retrieved his personal cell phone (Tabs J-32 and V-8.49). The MP's first action was to use his cell phone to call squadron operations at Ellington Field (Tab V-8.46). At no point during the recovery did the MP utilize his survival radio or any of the survival equipment, as it was left suspended in the trees (Tab V-8.49). The MP notified the squadron Supervisor of Flying (SOF) of his ejection and his condition (Tab V-8.48 and V-8.50). The SOF then called Fort Polk Control to relay this information (Tab V-8.49 and N-8). The SOF directed Fort Polk Control to contact the MFL to relay a notification that squadron
