**UNITED STATES AIR FORCE**  
**GROUND ACCIDENT INVESTIGATION**  
**BOARD REPORT**

**M1097A2 High Mobility Multipurpose Wheeled Vehicle  
S/N 157874**

**TYPE OF ACCIDENT: MOTOR VEHICLE FATALITY**

**DATE OF ACCIDENT: 24 JUNE 2022**

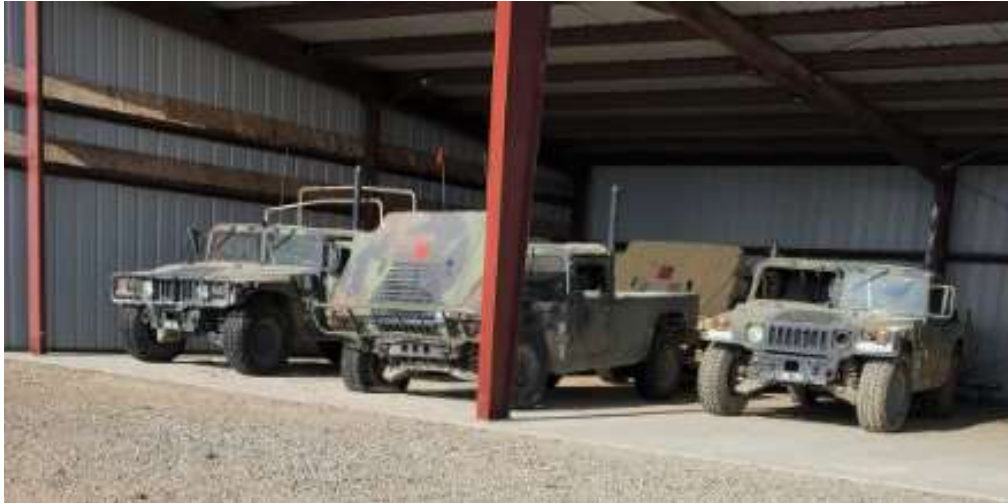
**Figure 7 - Spare Part HMMWVs (Tab S-14)**

Multiple deficiencies were found that, until repaired, would have barred the use of MV as a drivable asset (Tab BB-12). Nonetheless, there is no evidence to indicate that vehicle maintenance or the lack thereof played a significant role in the mishap.
