UNITED STATES AIR FORCE
AIRCRAFT ACCIDENT INVESTIGATION
BOARD REPORT

MQ-9A, T/N AF 12-4209
AFLCMC, Detachment 3
GRAY BUTTE AIRFIELD, CALIFORNIA

LOCATION: GRAY BUTTE AIRFIELD, CALIFORNIA
DATE OF ACCIDENT: 7 SEPTEMBER 2023
BOARD PRESIDENT: BRIGADIER GENERAL LANCE R. FRENCH
Conducted IAW Air Force Instruction 51-307
Volume One of Five

**MQ-9A, T/N 12-4209
GRAY BUTTE AIRFIELD, CALIFORNIA (CA)
07 SEPTEMBER 2023**

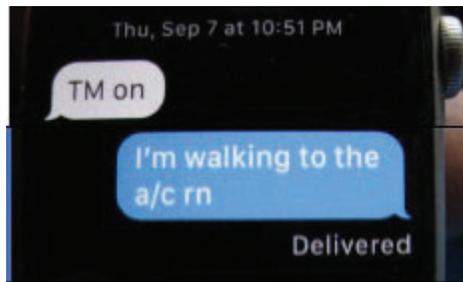
Figure #3: Text Message (Tab Z-16, DC3 Apple Watch Recovery)

MTD testified that he had MTE1 out at the MA “to look for any uncommanded movement on the turrets or on the control surfaces” (Tab V-32.21). MTE1 had no direct communication with the aircrew or MM1 to hear what control movements the aircrew was inputting (Tabs V-12.15 and V-23.13). The only communication MTE1 had with the GCS was through MTD via text on MTE1’s personal cell phone (Figure 3, Tab Z-16).

At 7:51p.m. MTD sent a text to MTE1 that “TM on” (Figure 3, Tab Z-16). This indicated to MTE1 that it was time to take telemetry readings on the weapons (MTD). At 7:53p.m. MTE1 responded via text to MTD that “I’m walking to a/c rn” indicating she ‘is walking to the aircraft right now’ to take the telemetry readings (Figure 3, Tab Z-16).
