UNITED STATES AIR FORCE AIRCRAFT ACCIDENT INVESTIGATION BOARD REPORT

F-16CM, T/N 88-0479

35TH FIGHTER SQUADRON 8TH FIGHTER WING KUNSAN AIR BASE, REPUBLIC OF KOREA

LOCATION: KUNSAN AIR BASE, REPUBLIC OF KOREA DATE OF ACCIDENT: 11 DECEMBER 2023 BOARD PRESIDENT: COLONEL PHILIP D. LANCASTER Conducted IAW Air Force Instruction 51-307

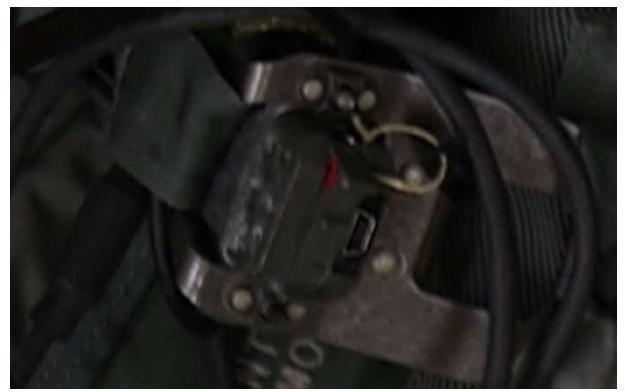
Once the MA AFTO 781 forms were approved, the MP climbed into the aircraft to continue to prepare it for flight. (Tab V-1). The MP properly strapped into the ejection seat and secured the electronic flight book (EFB) to the MP's leg. (Tab V-1). The MP does not recall checking the position of the rocker switch assembly on the seat for the AN/URT-46 beacon, which is designed to send post-ejection alerts, although it was found in the correct position of "automatic" during recovery. *See Figure 1 below.* (Tabs V-1; Z-7).

Figure 1. Beacon in Automatic Position. (Tab Z-7).

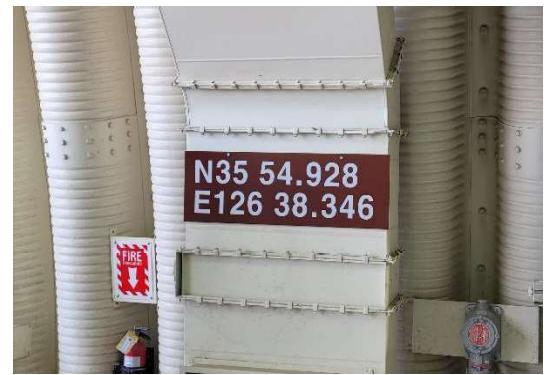
Despite being delayed, the MP testified to not feeling rushed while completing required checklist procedures before leaving parking. These procedures were mostly routine. (Tab V-1). Due to the inability of the MA to receive Global Positioning System (GPS) reception while parked in the GEN 15 hangar, as well as a lack of GPS repeater operation, after the flight control built in test was completed, the MP conducted a Shelter OPS-PEC (Pilot Entered Coordinates) of the embedded GPS and inertial navigation system (EGI). (Tabs V-1; Z-1). In accordance with technical order (TO) 1F-16CM-1, the MP removed GPS input from the EGI to not induce errors based on lack of satellite reception, and then manually entered the aircraft location. *See Figure 2 below.* (Tabs V-1; Z-1; BB-7). The GPS coordinates the MP entered were displayed on the wall

inside the hangar. *See Figure 2 below.* (Tab Z-1). The MP noted the MA did not have GPS keys and received a GPS re-key by an 80 FGS specialist, allowing the MA's GPS to receive the encrypted precision code. (Tab V-1). The re-key process is routine, and the EGI will function without a re-key.

Figure 2. Coordinates of GEN 15 Hangar. (Tab Z-1).
