UNITED STATES AIR FORCE
AIRCRAFT ACCIDENT INVESTIGATION
BOARD REPORT

PD Sabre2 Parachute, Serial Number 021700

412TH OPERATIONS SUPPORT SQUADRON
412TH TEST WING
EDWARDS AIR FORCE BASE, CALIFORNIA

**PD Sabre2, S#021700
PERRIS, CALIFORNIA
10 SEPTEMBER 2019**

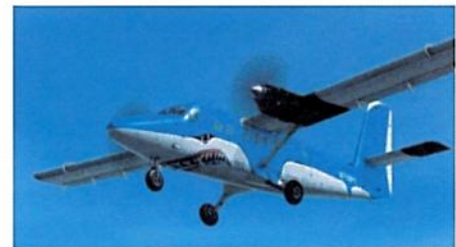
h. De Havilland Canada DHC-6-200 Twin Otter

The De Havilland Canada DHC-6 Twin Otter is a Canadian Short Takeoff and Landing (STOL) utility aircraft developed by De Havilland Canada (Tab DD-26). The aircraft has a fixed tricycle undercarriage, STOL capabilities, twin turboprop engines and high rate of climb (Tab DD-26).

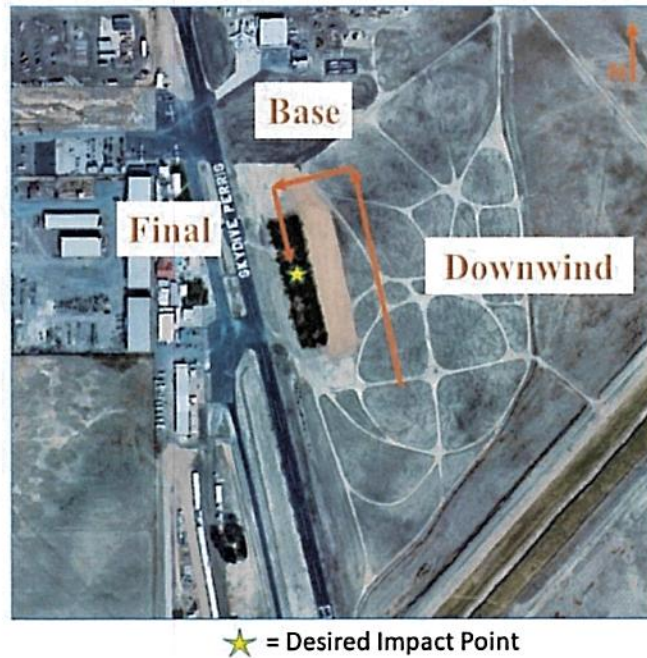
Map of Skydive Perris DZ with basic landing pattern (Tab Z-5)

At approximately 3,350 ft AGL, MJ1 successfully deployed his parachute and opened to full canopy. (Tab CC-45). MJ1 began flying toward the Desired Impact Point (DIP), setting up a basic landing pattern (Tab V-4.7 to V-4.8 and V-4.14).
