UNITED STATES AIR FORCE
ABBREVIATED AIRCRAFT ACCIDENT
INVESTIGATION BOARD REPORT

MQ-9A, T/N 13-4230

DATE OF ACCIDENT: 01 MARCH 2023

SUMMARY OF FACTS AND STATEMENT OF OPINION
MQ-9A, T/N 13-4230
UNITED STATES AFRICA COMMAND AREA OF RESPONSIBILITY
01 MARCH 2023

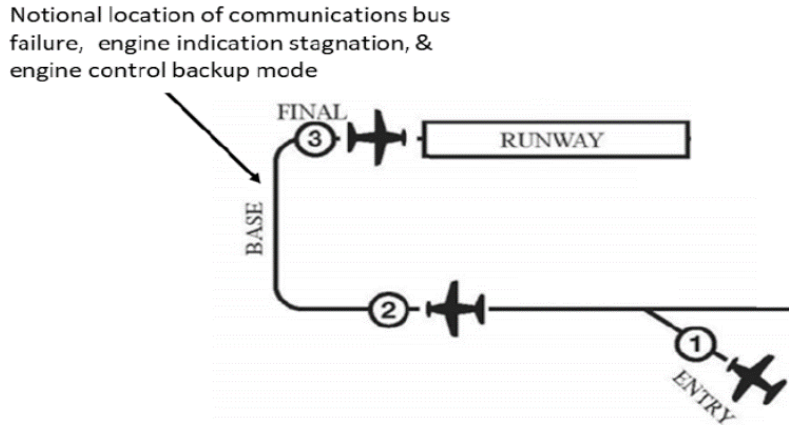
Figure 1. Components of a Traffic Pattern (Tab DD-38)

Prior to the mishap, the MC completed all descent, recovery, and pre-landing checklists and navigated the MA to the airfield traffic pattern (Tabs R-4 and DD-11). The MC set up for and attempted an automatic landing which was aborted for a known altitude error at this airfield (Tabs R-4 and DD-10). The MA reentered the traffic pattern for a normal, manually-piloted approach and landing starting at prescribed pattern altitude, on downwind and beginning a descending right-hand turn to base (Tabs R-4, DD-10, DD-25 to DD-33, and Figure 1). While descending on base leg, the MP initiated a descending right turn from base leg to final. (Tabs R-4, DD-10 to DD-11, and DD-13). A critical component of the MA's primary communications bus failed due to pre-existing damage to a key cable connection (Tabs R-4, DD-15 to DD-16, and

DD-21). This failure caused engine indications in the HUD to stagnate and forced the electrical engine control system into backup mode (Tabs R-4 and DD-10, and DD-26). While the MP assessed the situation presented by this compound emergency, the MA airspeed decreased below stall speed as the descent rate rapidly increased (Tabs R-4, DD-10, and DD-25 to DD-26). The MP initially increased the throttle just above that setting required to maintain level flight under normal conditions while continuing the final turn (Tabs DD-10 and DD-15 to DD-26). The MP commanded full throttle followed by loss of datalink a few seconds later, resulting in impact with terrain well short of the runway threshold (Tabs DD-10 and DD-25 to DD-26).
